Trans-Alaska Oil Pipeline--Information on Construction, Technical, and Environmental Matters through Spring 1977. EMD-77-44; B-180224. August 23, 1977. 31 pp. + appendix (1 pp.).

## **Trans-Alaska Oil Pipeline -- Information On Construction, Technical, And Environmental Matters Through Spring 1977**

**Department of the Interior**

EMD-77-44

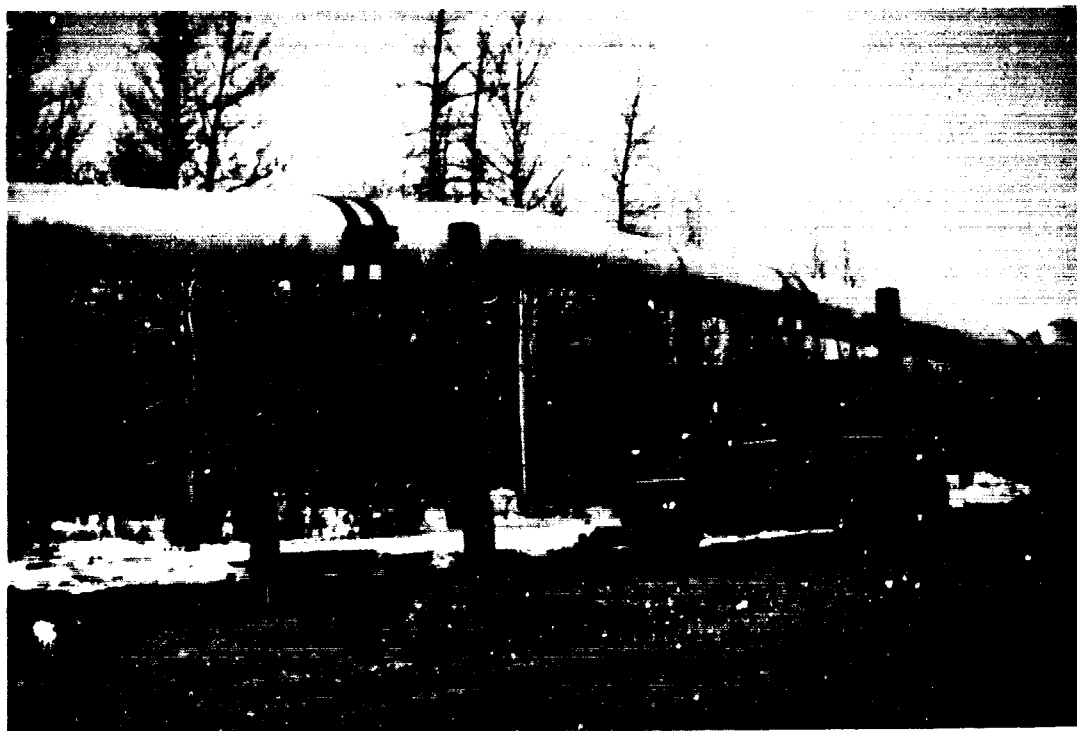
The pipeline design, submitted by Alyeska and approved by the Authorized Officer, includes over 500 elevated crossings. (See photograph 5 on p. 20.) In May of 1975 and throughout the 1975 and 1976 construction seasons, Fish and Wildlife advisors noted many instances where the elevated crossings had not been constructed to the minimum clearance. A February 1976 audit revealed that 88 of 224, or 39 percent, of the elevated crossings constructed during 1975 did not meet the required construction standards. Alyeska agreed, and in conjunction with the Fish and Wildlife advisors, developed a plan to correct the deficiencies for the 88 game crossings that did not meet the specifications. During the 1976 construction season, 69 of the 326 game crossings constructed did not meet specifications.

**Elevated big game crossing. (5)**

Alyeska was required to correct these problems and completed remedial work on the big game crossings in June of this year.

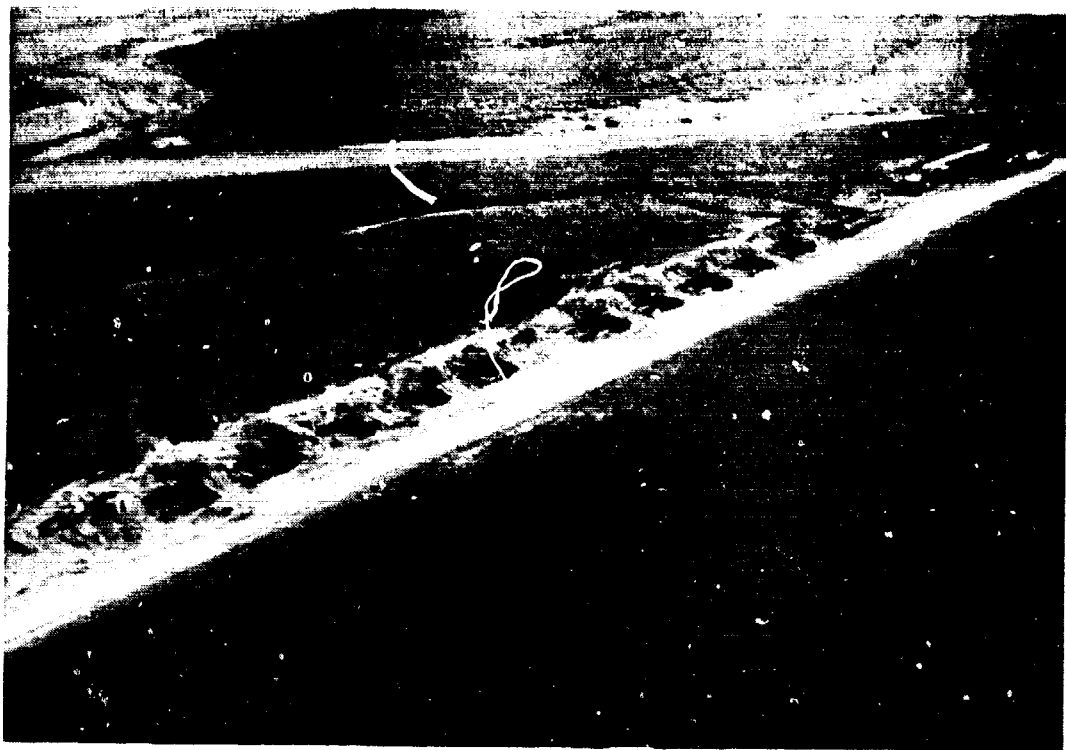
Excavations to expose below-ground pipe for remedial weld work. (6)

Alyeska completed remedial work on the defective welds in May 1977. (See photograph 6 on p. 28.)
