OPERATION DESERT STORM

Investigation of a U.S. Army Fratricide Incident

B-260897

April 7, 1995

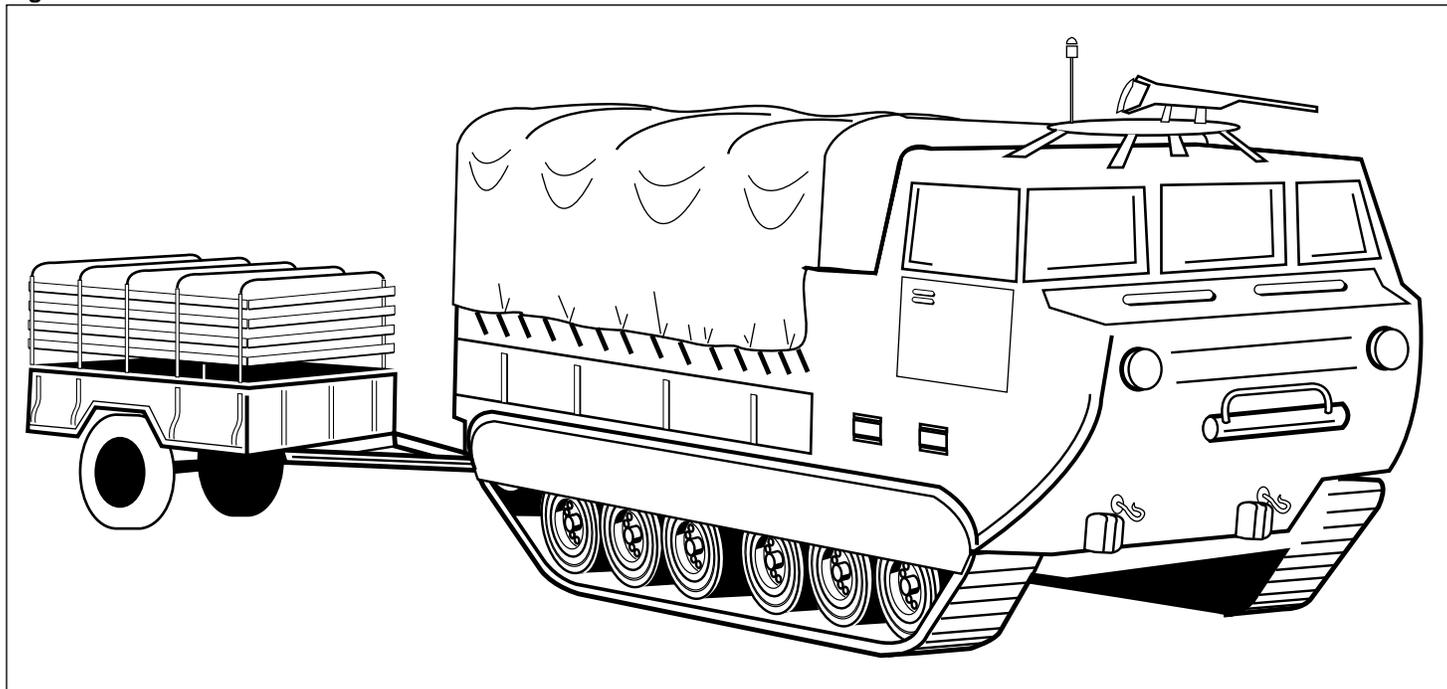
Figure 1.3: M548 Ammunition Carrier and Trailer

At approximately 1700 hours on February 26, 1991, an M548 Ammunition Carrier (M548), towing a 1.5-ton trailer full of explosives (see fig. 1.3), broke down while traveling as part of the combat support “trains” along the logistics line. The M548 was attached to Charlie Company, 54th Engineer Battalion. Once it was determined the M548 could no longer operate, Charlie Company’s Executive Officer, 1st Lieutenant Kevin Wessels, notified his commanding officer of the situation and his exact location.

d-f. Prior to the fatal shots being fired, the M548 Ammunition Carrier (see fig. 1.3) was visible to crew members aboard Lt. Colonel Daly's Bradley. Additionally, the gunner for Colonel Starr had detected the M548 and the HMMWV from approximately 2 kilometers and advised the Colonel. Later, the 3rd ACR Fire Support Officer was also able to detect the burning M548 with binoculars from a distance of about 2 kilometers.

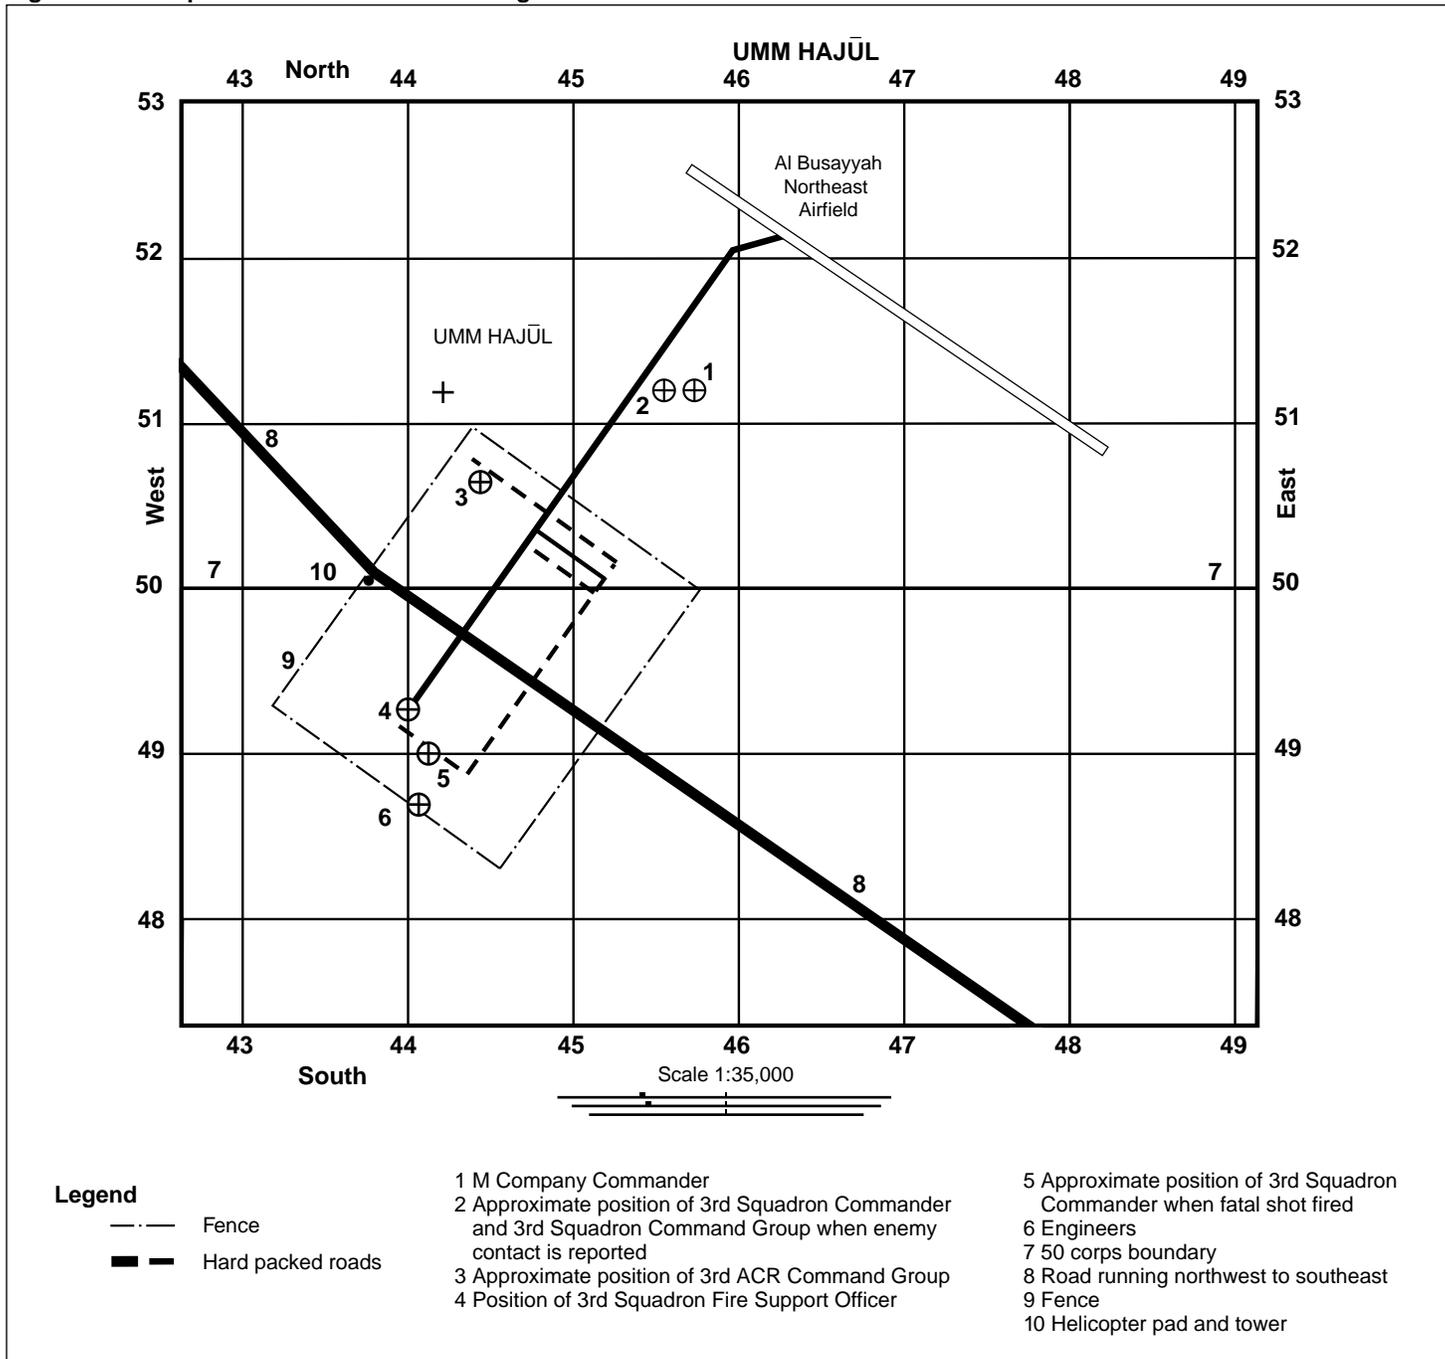
Figure 2.5: Troop Positions Before and During the Fratricide Incident

As the wedge's point moved forward, I Troop's Red Platoon Leader—the far right element of the 3rd Squadron wedge formation—reported to the I Troop Commander, Captain Bodo Friesen, that he saw a fence and spotted a tower in the distance. (See fig. 2.5, legends 9 and 10.) Captain Friesen reported to the 3rd Squadron Commander, Lt. Colonel Daly, that I Troop had found the airfield and, according to Captain Friesen, received Lt. Colonel Daly's permission to break the fence perimeter and secure the area. The White Platoon, an I Troop tank platoon, breached the fence and moved directly towards the tower. Other platoon elements of I Troop also moved inside the fence.

Meanwhile, Lt. Colonel Daly positioned his Bradley approximately 200 meters from the target area, forward and left of Captain Friesen’s position. (See fig. 2.5, legend 5.) His gunner, who was scanning the area through the Bradley’s thermal sights, described the scene to Lt. Colonel Daly: Two soldiers were running to the left, away from the burning vehicle; one appeared to be “carrying something” that “looks like an RPG [rocket-propelled grenade]” on his back; one soldier went down to his knees while yelling at the other soldier; then one continued running through some bushes; and one soldier appeared to be moving around to the Bradley’s front.

M Company Commander. (See fig. 2.5, legends 1 and 2.) Colonel Starr, the 3rd ACR Commander, directed Lt. Colonel Daly to move to the area. As Lt. Colonel Daly and the 3rd Squadron Command Group moved south towards the area, Captain Friesen fired the warning shots, just as Lt. Colonel Daly was moving through the fenced area, approximately 1.8 kilometers from Captain Friesen's position. This caused the engineers on guard to alert the other engineers that they were receiving friendly fire and seek immediate cover. Based on what Captain Friesen thought was return fire, he ordered Bradley Fighting Vehicles Blue 35 and Blue 36, along with his own gunner to engage. During this volley of fire the Small Emplacement Excavator was hit, wounding Sergeant Napier.

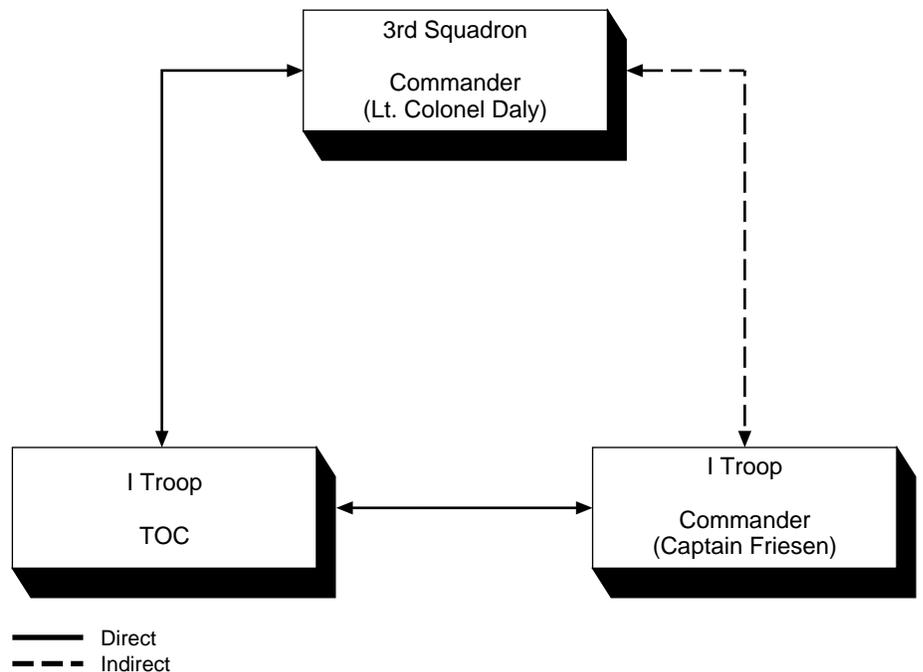
Figure 2.6: 3rd Squadron's Line of Communication

Once inside the fence, the I Troop elements fanned out while moving south, unaware that they were approaching the XVIII Airborne Corps/VII Corps' 50 east/west boundary line. (During reconnaissance, one I Troop tank erroneously reported that Chevrolet vans were fleeing the area; the supposed vehicles were actually two jackasses.) As the I Troop elements continued their movement, Captain Friesen detected two human "hot spots," which were believed to be enemy, moving in and around what were believed to be buildings. Captain Friesen reported the detection to Lt. Colonel Daly, through the I Troop TOC Commander. (See fig. 2.6.)

Approximately 3 minutes and 45 seconds before Lt. Colonel Daly's gunner fired the fatal shots, Captain Friesen noted Bradley vehicles (which we now know included Lt. Colonel Daly's) to his left. Approximately 22 seconds before the fatal shots, Captain Friesen was informed that the 3rd Squadron Command Group was near him. After the shots were fired, Captain Friesen immediately inquired of his own troop. He was then directed (by Lt. Colonel Daly) to switch radio frequencies and speak directly with Lt. Colonel Daly. (See fig. 2.6.)

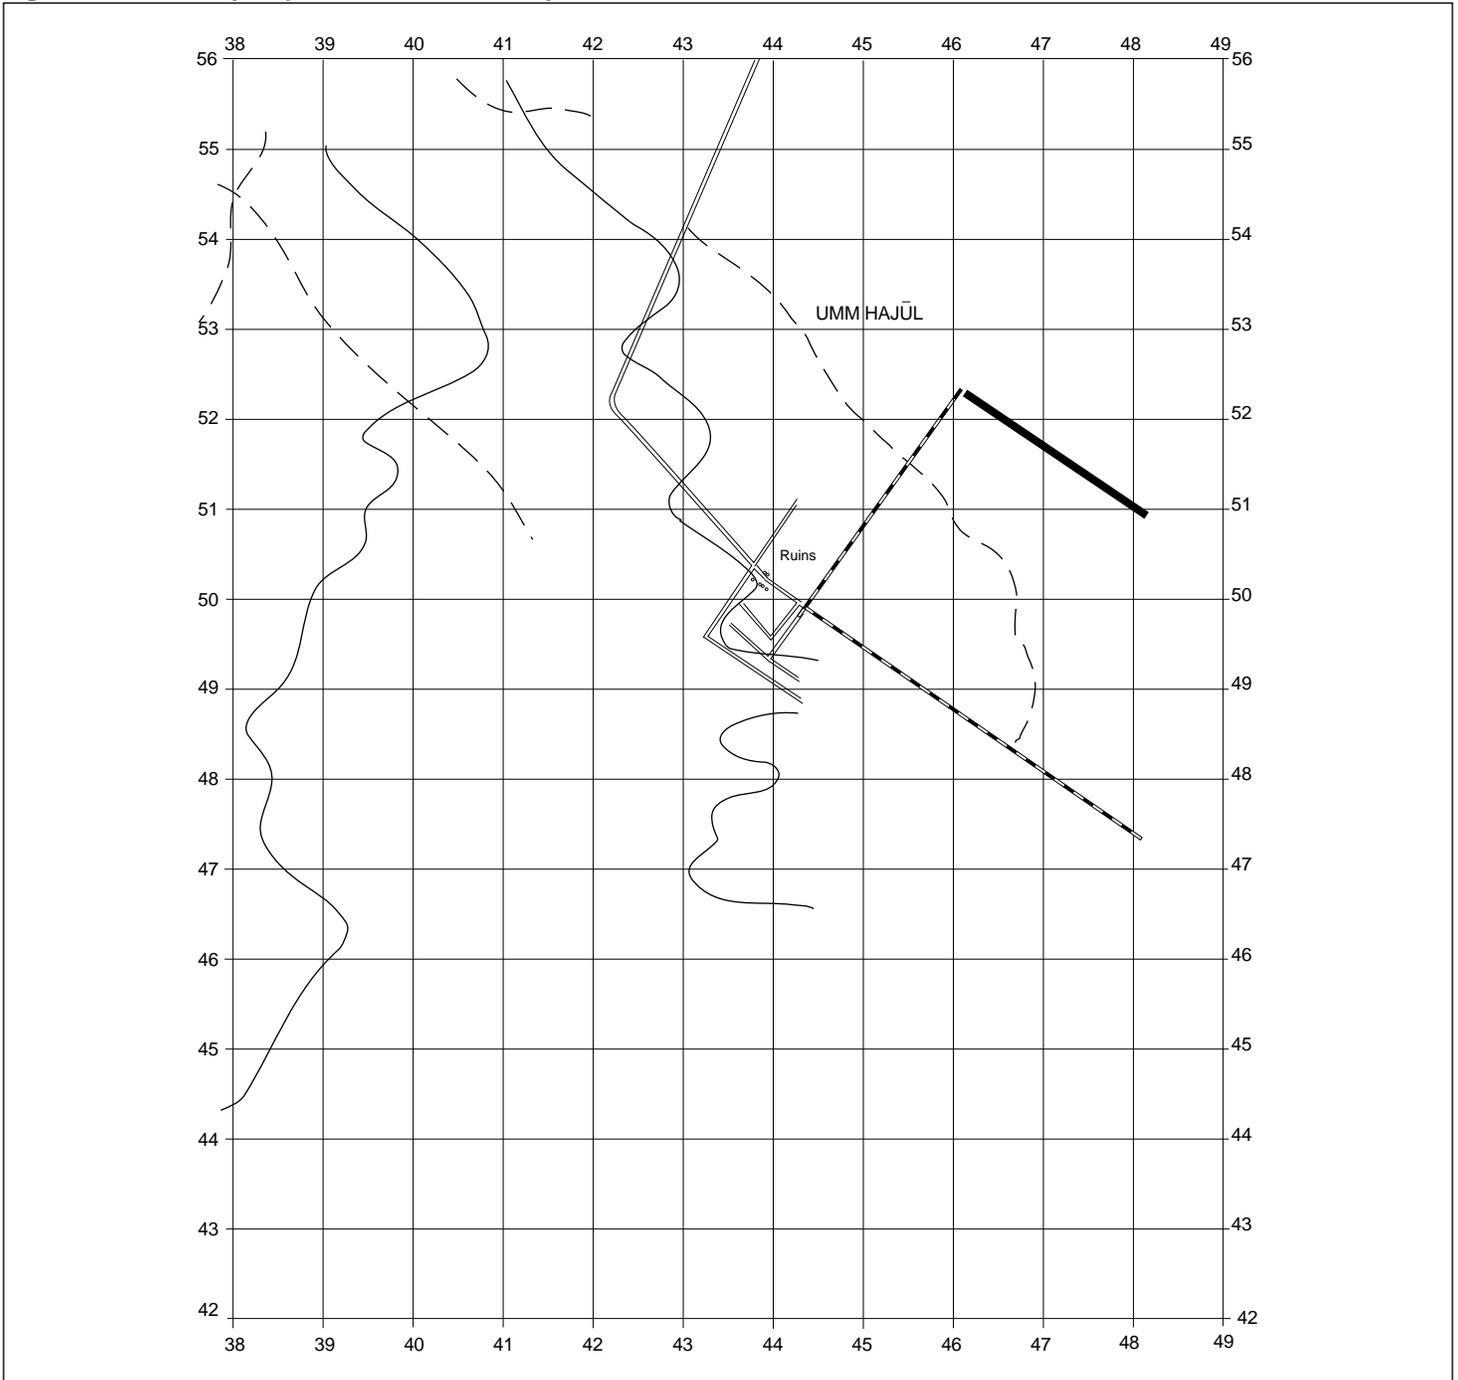
Figure 4.1: U.S. Army Map of Attack Area for Objective Bill

“a. BOUNDARY PLACEMENT: The boundary between the two Corps passed through the southern tip of Objective Bill. U.S. Army doctrine is to place an objective solely within the zone of the attacking force. Efforts to deconflict the attack on this objective were not successful. Although some safeguards to prevent friendly fire incidents were taken by the Commander of the 3d ACR (shift of the artillery preparation, cancellation of the direct fire preparation, and attack parallel to the boundary), they proved to be inadequate.

As the 3rd Squadron advanced, I Troop encountered a fence and saw a tower in the distance. (See fig. 2.5.) I Troop then reported that it had identified the airstrip even though the maps that the 3rd ACR and the 3rd Squadron used did not depict a fenced area within the area of the attack. The attention of the 3rd Squadron focused on this report.²² Lt. Colonel Daly believed the fenced area was the airstrip. All 3rd Squadron troop units, except I Troop, stopped.
