GAO

July 1987

HAZARDOUS WASTE

Tinker Air Force Base Is Making Progress in Cleaning Up Abandoned Sites

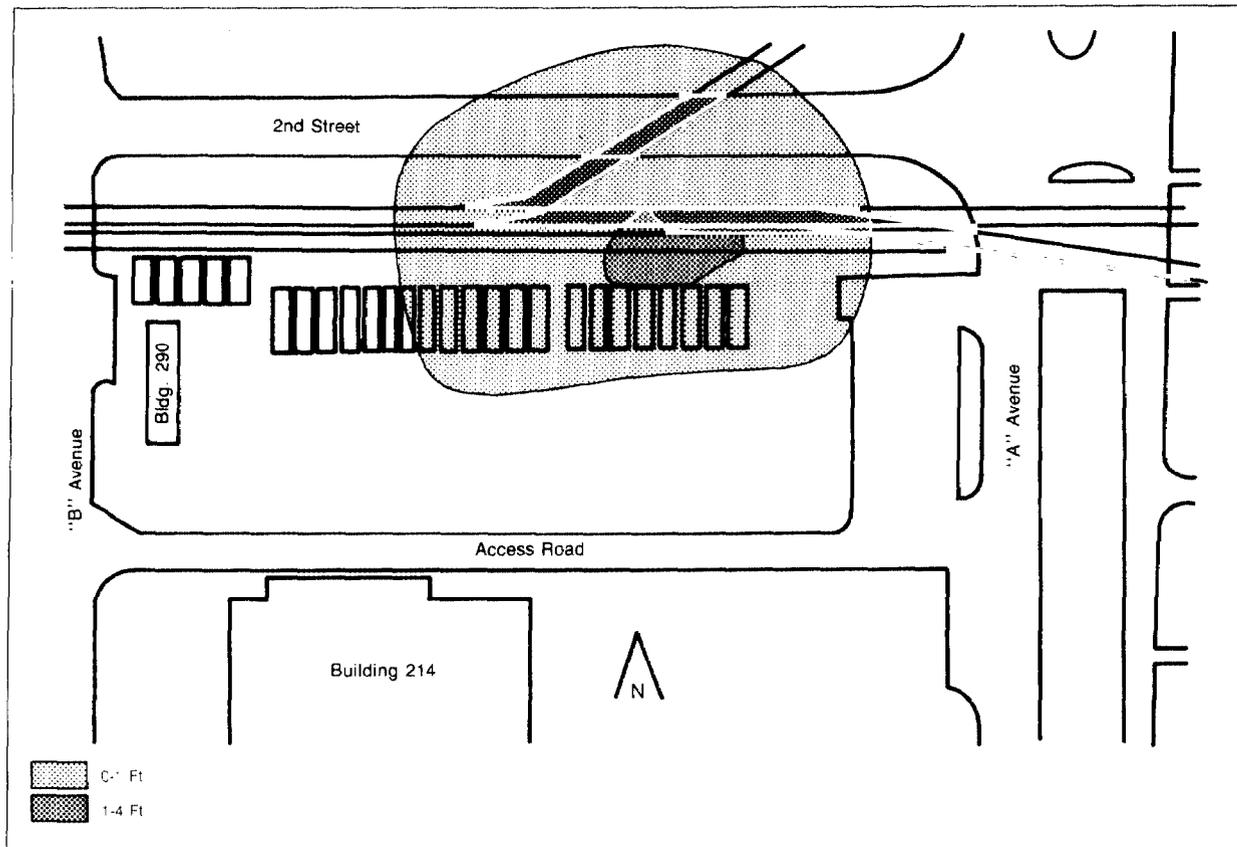
Figure II.1: Groundwater Contamination Under the Fuel Farm Area

The number of sites with possible contamination has grown from 14 identified in Phase I to 17, including the base streams (grouped as 1 site) as identified by the Corps of Engineers. The base streams and building 3001 were added to the investigations in Phase II. The Corps has now added a new site, the fuel farm area, which is an underground fuel storage area. Due to leaking fuel tanks, the aquifer beneath the site is contaminated with fuel and other petroleum products. The groundwater contamination under the fuel farm area, shown in figure II.1, is estimated to be up to 4 feet deep, contain 40,000 to 50,000 gallons of fuel, and cover 150,000 square feet.

Remedial actions to pump out the fuel have been designed and will be performed soon.

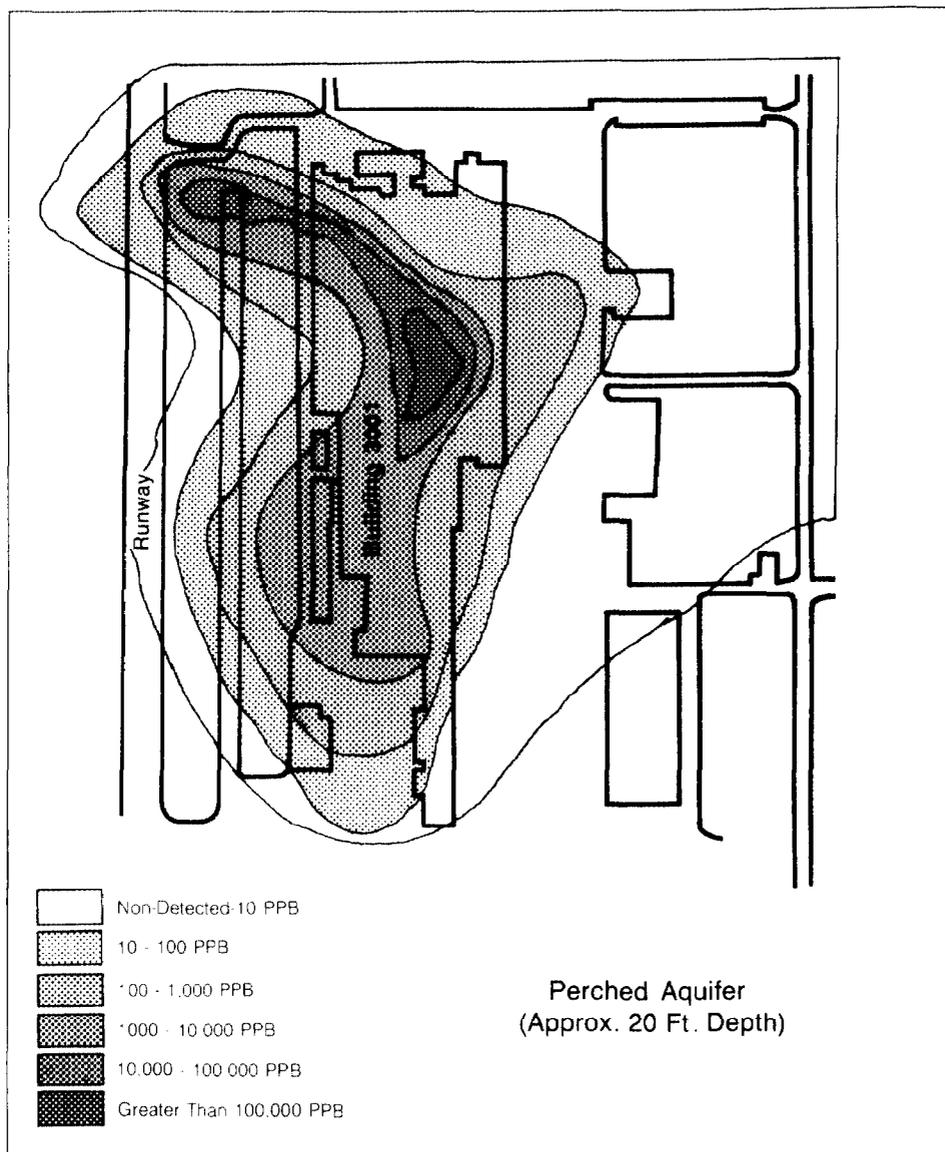
Figure II.2: Trichloroethylene Contamination Under Building 3001

An Air Force monitoring program found the Garber Wellington Aquifer to be contaminated when it discovered trichloroethylene (TCE) in water supply wells 18 and 19 located in building 3001. Radian's investigation of well 18 revealed TCE as high as 4,600 parts per billion (compared to EPA's proposed standard of 5 parts per billion). The TCE contamination level in well 19 was 8.7 parts per billion.

Water supply wells 18 and 19 were taken out of service in the latter part of 1983 and permanently plugged in September 1986 to prevent further contamination to the aquifer. Sample results, as depicted in figure II.2, indicate severe contamination in the upper levels of the aquifer, as high as 330,000 parts of TCE per billion. As stated earlier, EPA's proposed standard for drinking water is 5 parts per billion. The Corps of Engineers is currently designing the plans and specifications to remove the contaminated groundwater.

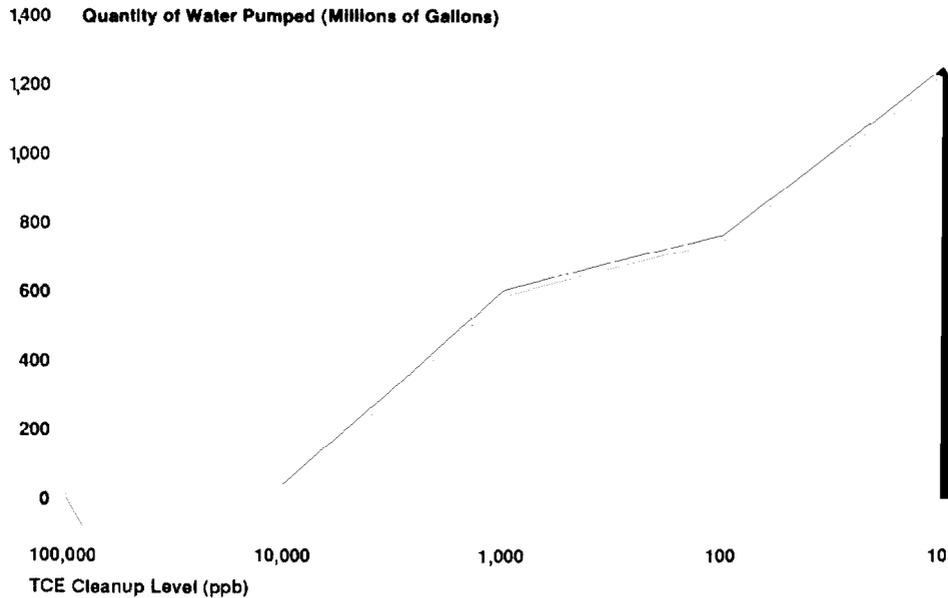
Figure II.3: Quantity of Trichloroethylene-Contaminated Water to Be Pumped at Various Cleanup Levels

The cost of removing TCE from the groundwater increases dramatically as target cleanup levels of TCE decrease. Figure II.3 shows the number of gallons required to be pumped out, treated, and returned to the aquifer to reduce TCE contamination to various levels. The Garber Wellington aquifer covers over 2,200 square miles and contains 22.8 trillion gallons of water. The desired level of TCE contamination has yet to be determined by the Technical Review Committee.
