United States Government Accountability Office Report to Congressional Requesters

BORDER INFRASTRUCTURE

Actions Needed to Improve Information on Facilities and Capital Planning at Land Border Crossings

Highlights of GAO-19-534, a report to congressional requesters

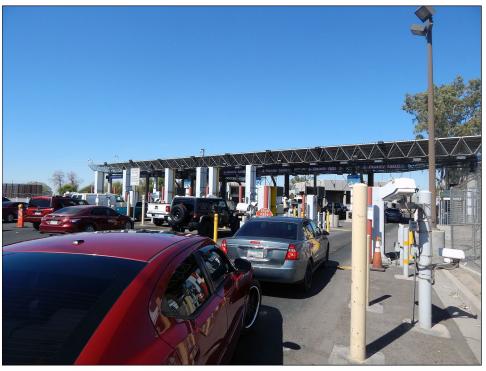
Figure 10: Example of a U.S. Land Border Crossing With Limited Space in the Preprimary Area

Photo of the primary inspection area at a land border crossing on the southern border taken from the international border line showing limited space in the preprimary area—approximately two car lengths.

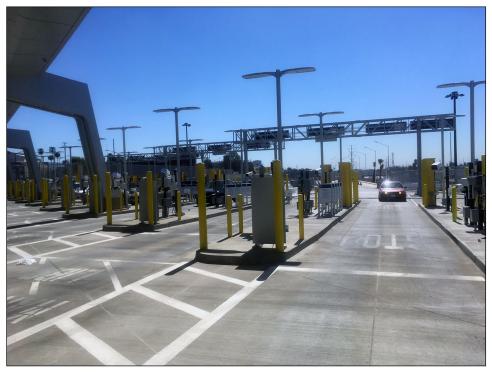
Figure 11: License Plate Readers and Radiation Portal Monitors on the Southern Border

Technology in the preprimary area that CBP officers identified as experiencing periods of inoperability due to high temperatures and exposure to sunlight.

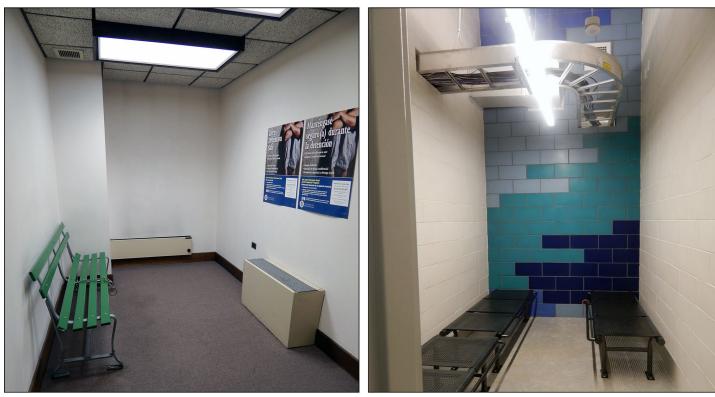
Figure 12: Examples of Holding Facility Constraints at U.S. Land Border Crossings

- Inadequate holding facilities in the secondary inspection area. Holding facilities at several land border crossings we visited had holding rooms that did not meet current CBP safety requirements, according to CBP officers. Officers at two land border crossings stated that safety concerns included inadequate ventilation. Officers at

another land border crossing identified exposed wiring in a holding room as a safety hazard. Other land border crossings we visited did not have holding rooms and officers stated they detain individuals in the lobby of the administration building as a result.

Park bench bolted to the floor with attached handcuffs located in the waiting area at a land border crossing on the northern border that CBP uses in place of a holding room.

CBP officers identified that exposed cabling accessible to detainees as seen in this photo is a safety hazard at a land border crossing on the southern border.

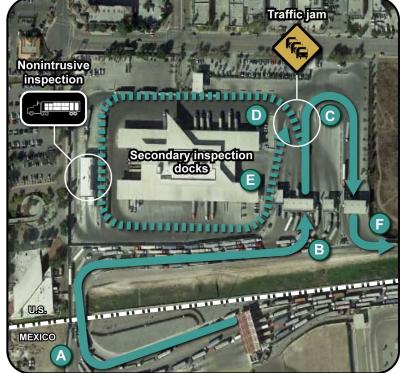
- Inbound commercial trucks from Mexico make a 180 degree turn as they enter the United States.
 Commercial trucks make a 90 degree turn to enter primary inspection.
 Commercial trucks not referred to secondary take a second 180 degree turn after primary inspection to the exit lanes/booths where officers verify they are cleared to enter the United States.
 Trucks referred to secondary inspection make a 90
 - degree turn toward the non-intrusive inspection technology and inspection docks in the secondary inspection area.
- After secondary inspection, trucks re-join the queue and make a 180 degree turn to proceed toward exit booths.
- After passing through the exit booths, trucks make a final 90 degree turn to exit the facility.

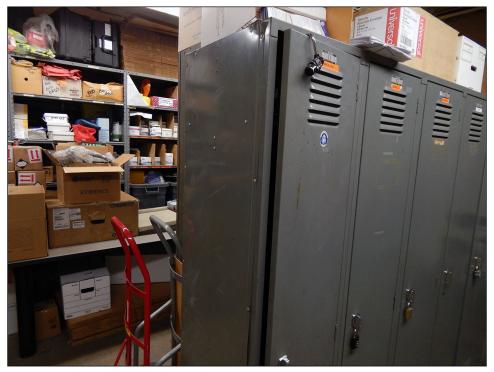
Figure 14: Officer Lockers Located in the Contraband Seizure Room at a Northern Land Border Crossing

- Insufficient capacity to accommodate the volume of traffic. CBP officers stated that the number of travelers can exceed the capacity of the facility. For example, CBP officers stated that insufficient number of inspection lanes can result in lengthy wait times for travelers.
- Limited administrative space. CBP officers stated that insufficient administrative office space can be a challenge at land border crossings. For example, one land border crossing we visited did not have sufficient space for officer lockers and as a result placed some lockers in the contraband seizure room.

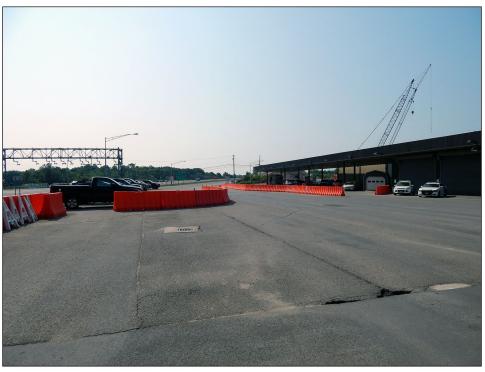
• **Port security limitations.** CBP officers also described challenges with land border crossing security. For example, officers stated the lack of measures to prevent travelers from exiting the crossing without authorization, such as vehicle barriers and security gates, impedes CBP's ability to stop drivers from fleeing the land border crossing and entering the United States without inspection.

According to officers at a land border crossing on the northern border, the land border crossing lacks measures to prevent vehicles from speeding through the crossing without authorization. This photo shows exit lanes constructed with temporary barriers to control the flow of traffic as it leaves the land border crossing.
