# Problems In Constructing Segments Of Interstate Route 71 In Ohio B-118653

Federal Highway Administration  
Department of Transportation

BY THE COMPTROLLER GENERAL  
OF THE UNITED STATES

MARCH 16, 1972

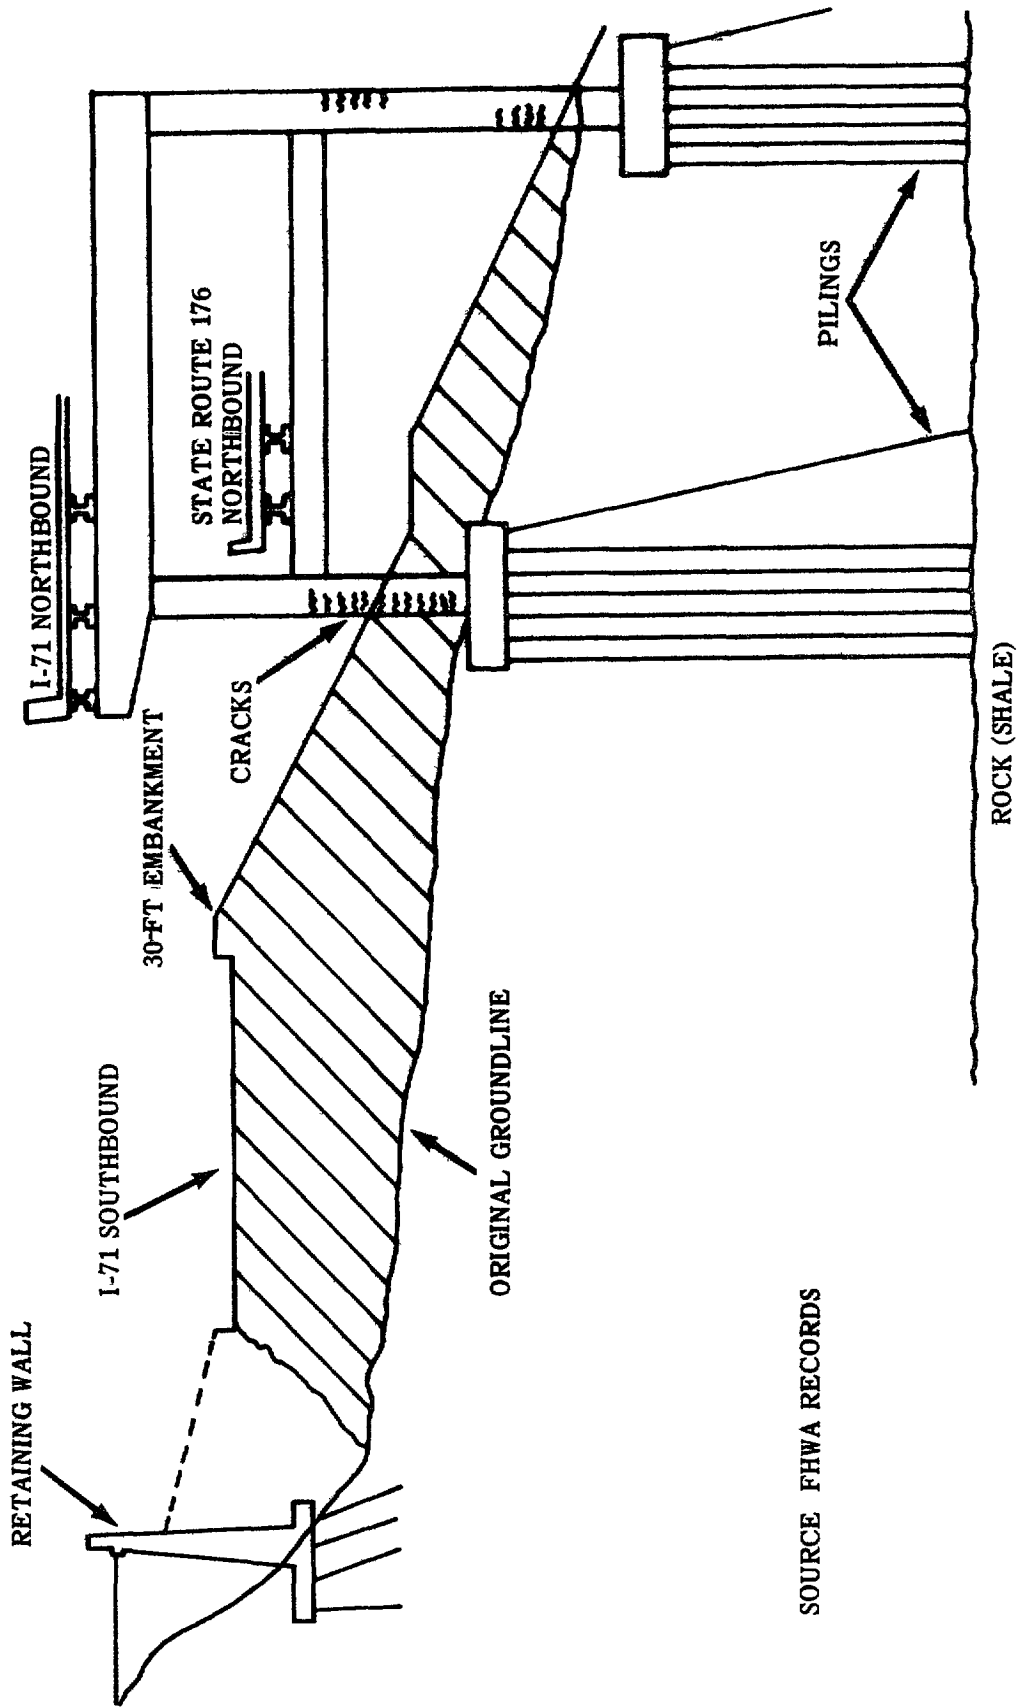
CROSS-SECTIONAL SKETCH  
SHOWING PROXIMITY OF PIERS AND EMBANKMENT (AT PIER 16)

In May and June 1966, cracks and/or movements were detected on piers 13 through 19 which support the bridge. Shortly after the damage was detected, the State requested its consulting engineers for the project to determine the extent of damage and the probable cause and to recommend appropriate corrective measures. The consulting engineers, in a report dated July 1, 1966, stated that the probable

cause of the damage was the consolidation of the underlying subsoils of the 30-foot embankment that produced an underground lateral movement which acted against the piles supporting the piers. (See sketch on p 16 )

The damaged piers subsequently were repaired, and the State requested Federal participation in the repair costs. FHWA agreed to participate in these costs, except those associated with pier 19, the cost of which had not been allocated. The total cost to stabilize the embankment and repair the piers amounted to about \$1.4 million.

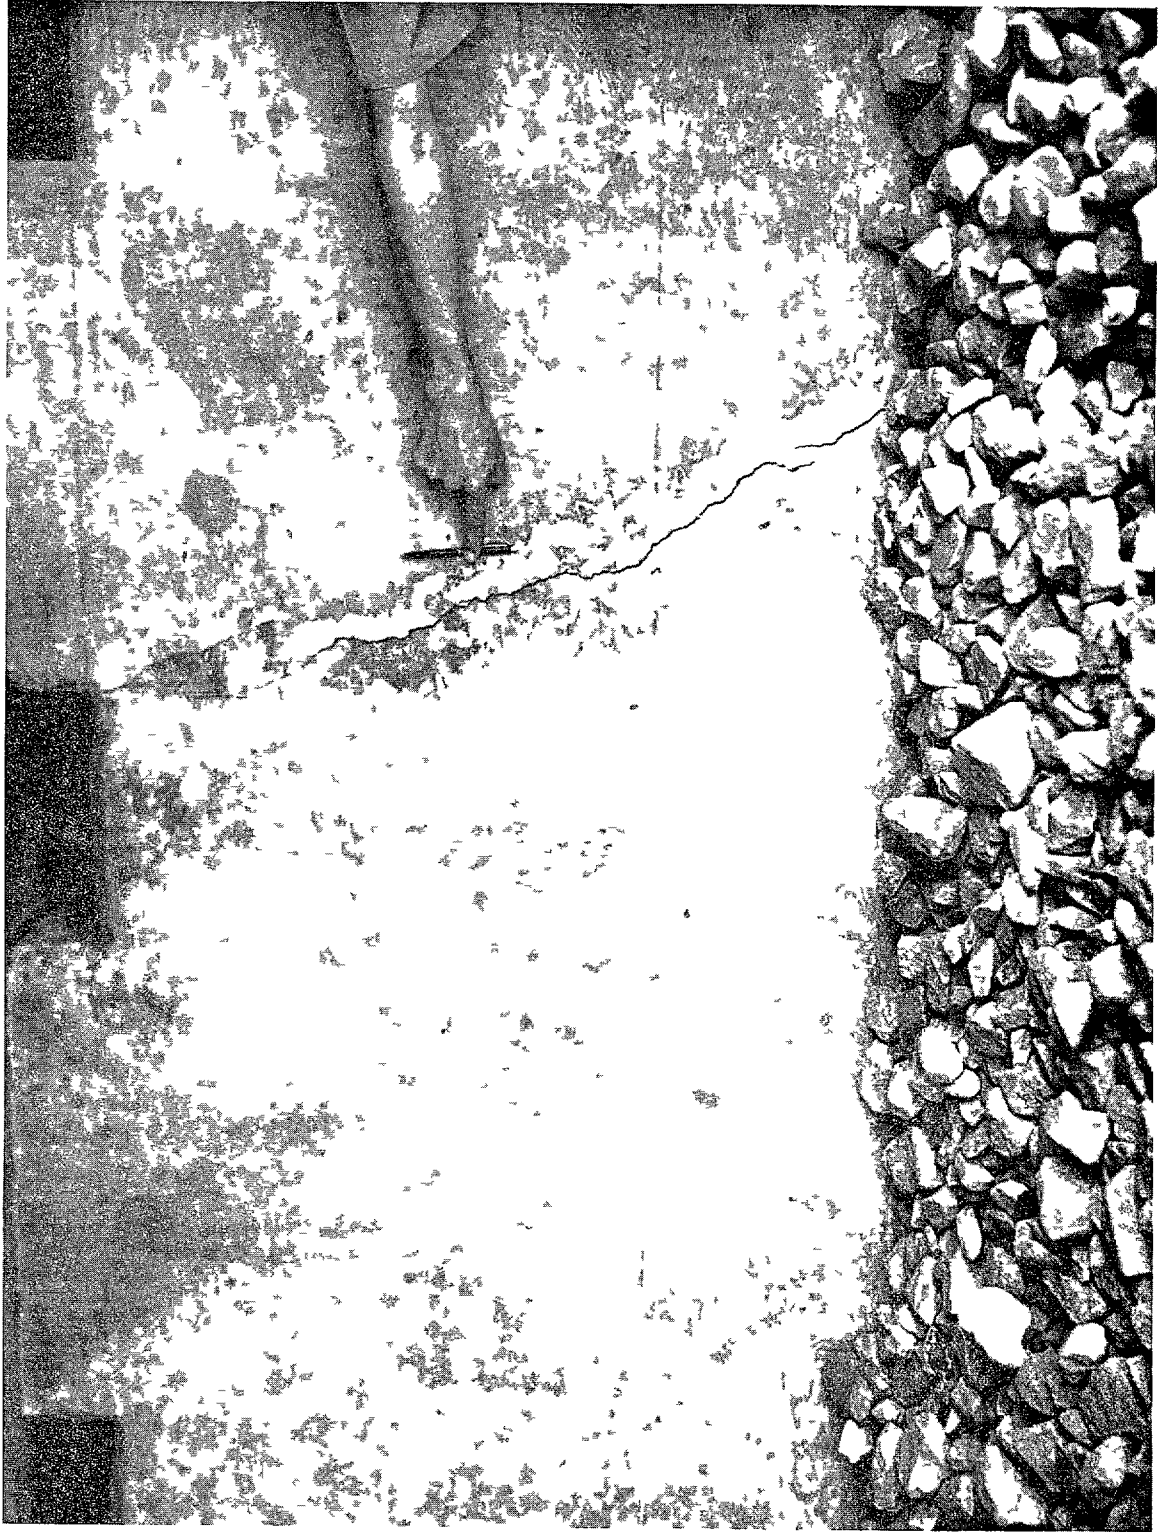
layers of asphalt (overlays) on the road. At the time of our review, three overlays had been placed on the roadway. The embankment, however, has continued to sink, causing damage to the roadway leading to the bridge, a retaining wall, guardrails and lighting fixtures of the roadway, and the abutments to the bridge. (See photographs on pp 24 to 26.)

**Separation of roadway and bridge abutment**
