Case Studies Prepared In Conjunction  
With A Report To The  
Government Activities Subcommittee,  
Committee On Government Operations,  
House Of Representatives, On Need  
For Improved Controls For Identifying  
And Correcting Safety Defects  
On Light Aircraft B-164497(1)

Federal Aviation Administration  
Department of Transportation

**BY THE COMPTROLLER GENERAL  
OF THE UNITED STATES**

JUNE 15, 1973

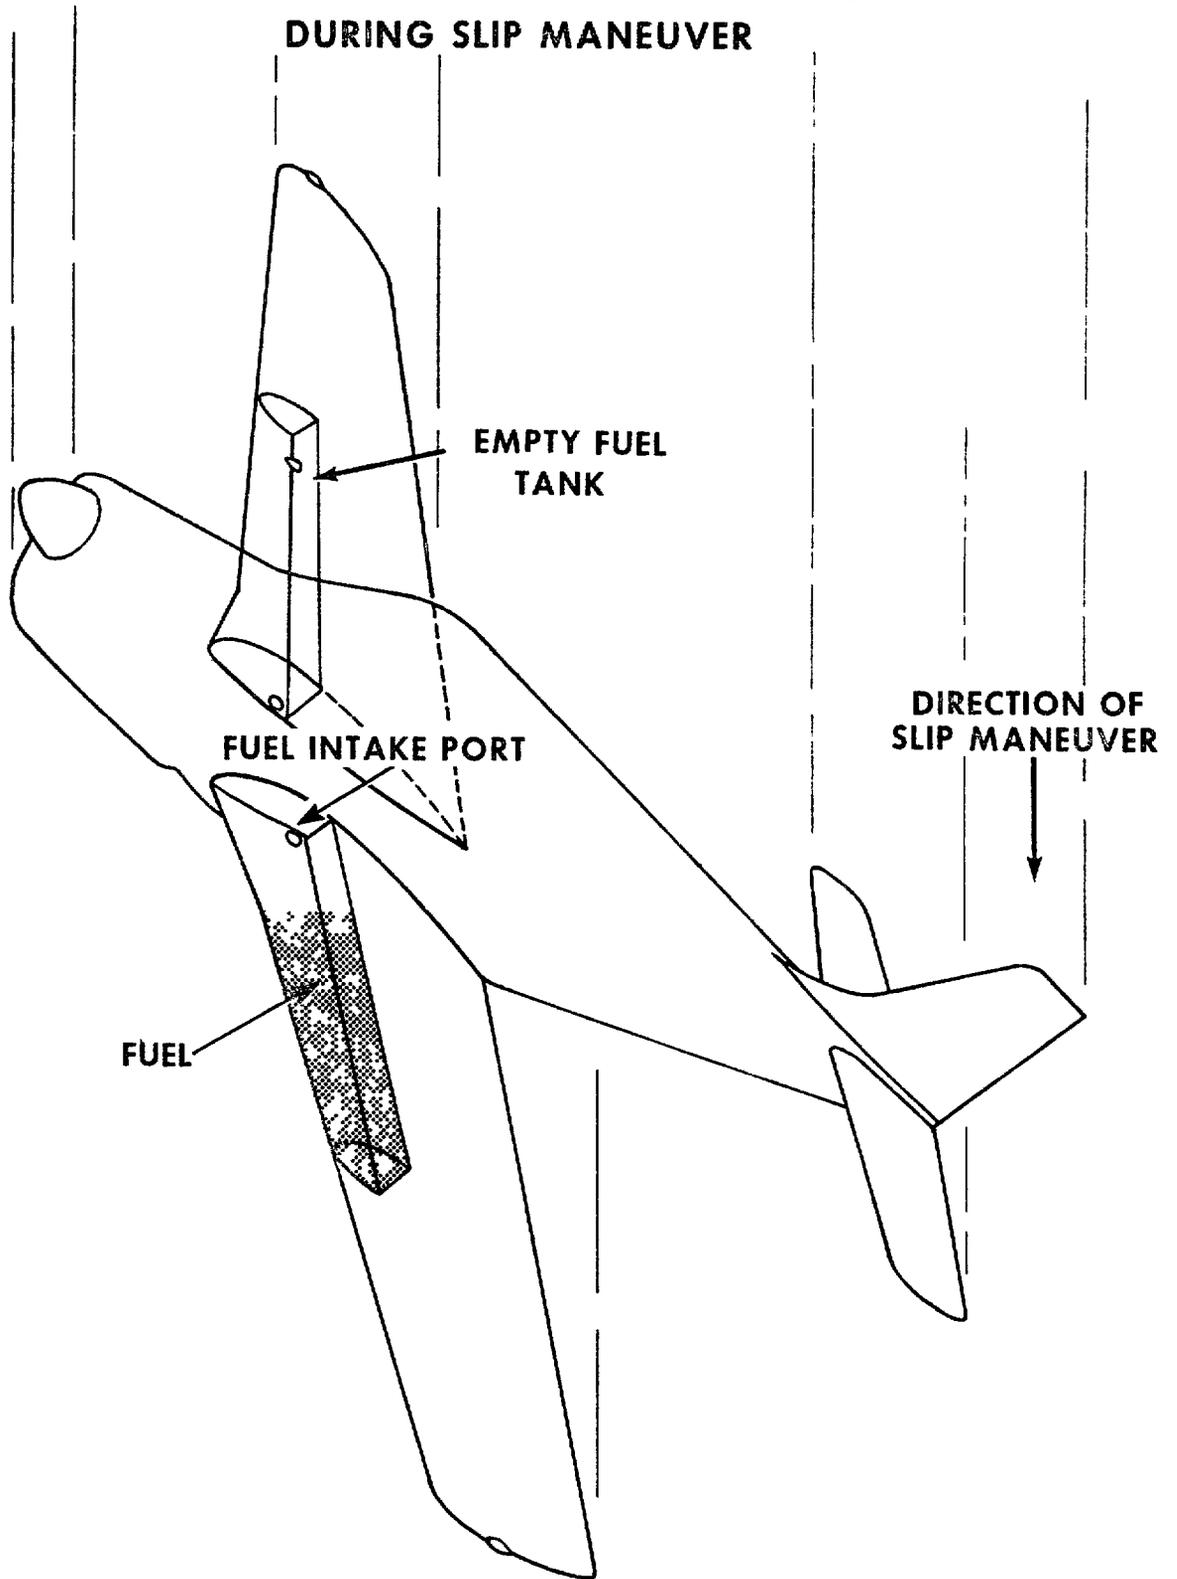
"When making a rolling takeoff when the tanks register half full, the centrifugal force throws the gas to the outside of the tanks and the engine quits dead after the airplane is airborne  
\* \* \* [a sales representative] tried this several times and found it to happen each and every time that he experimented with the rolling takeoff "

**ILLUSTRATION OF FUEL INTERRUPTION  
DURING SLIP MANEUVER**

In October 1965 a fatal accident occurred near Salinas, California, in which the pilot of a Baron aircraft lost control of the aircraft after experiencing a power loss. FAA and CAB investigators flight-tested the same model aircraft, simulating flight maneuvers and fuel conditions that might have been experienced by the pilot. In reporting these tests in February 1966, the investigators stated that they considered it significant that a slight skid in a turn or a slip in straight flight had caused fuel interruption and engine failure.

Between 1958 and 1969 Beech produced approximately 7,800 aircraft with the apparent defect in the fuel system. Beginning in 1969, at FAA's direction, Beech placed placards in aircraft in service or under construction that warned against maneuvers that critically affected fuel flow. Late in 1969 Beech began incorporating on all new aircraft a

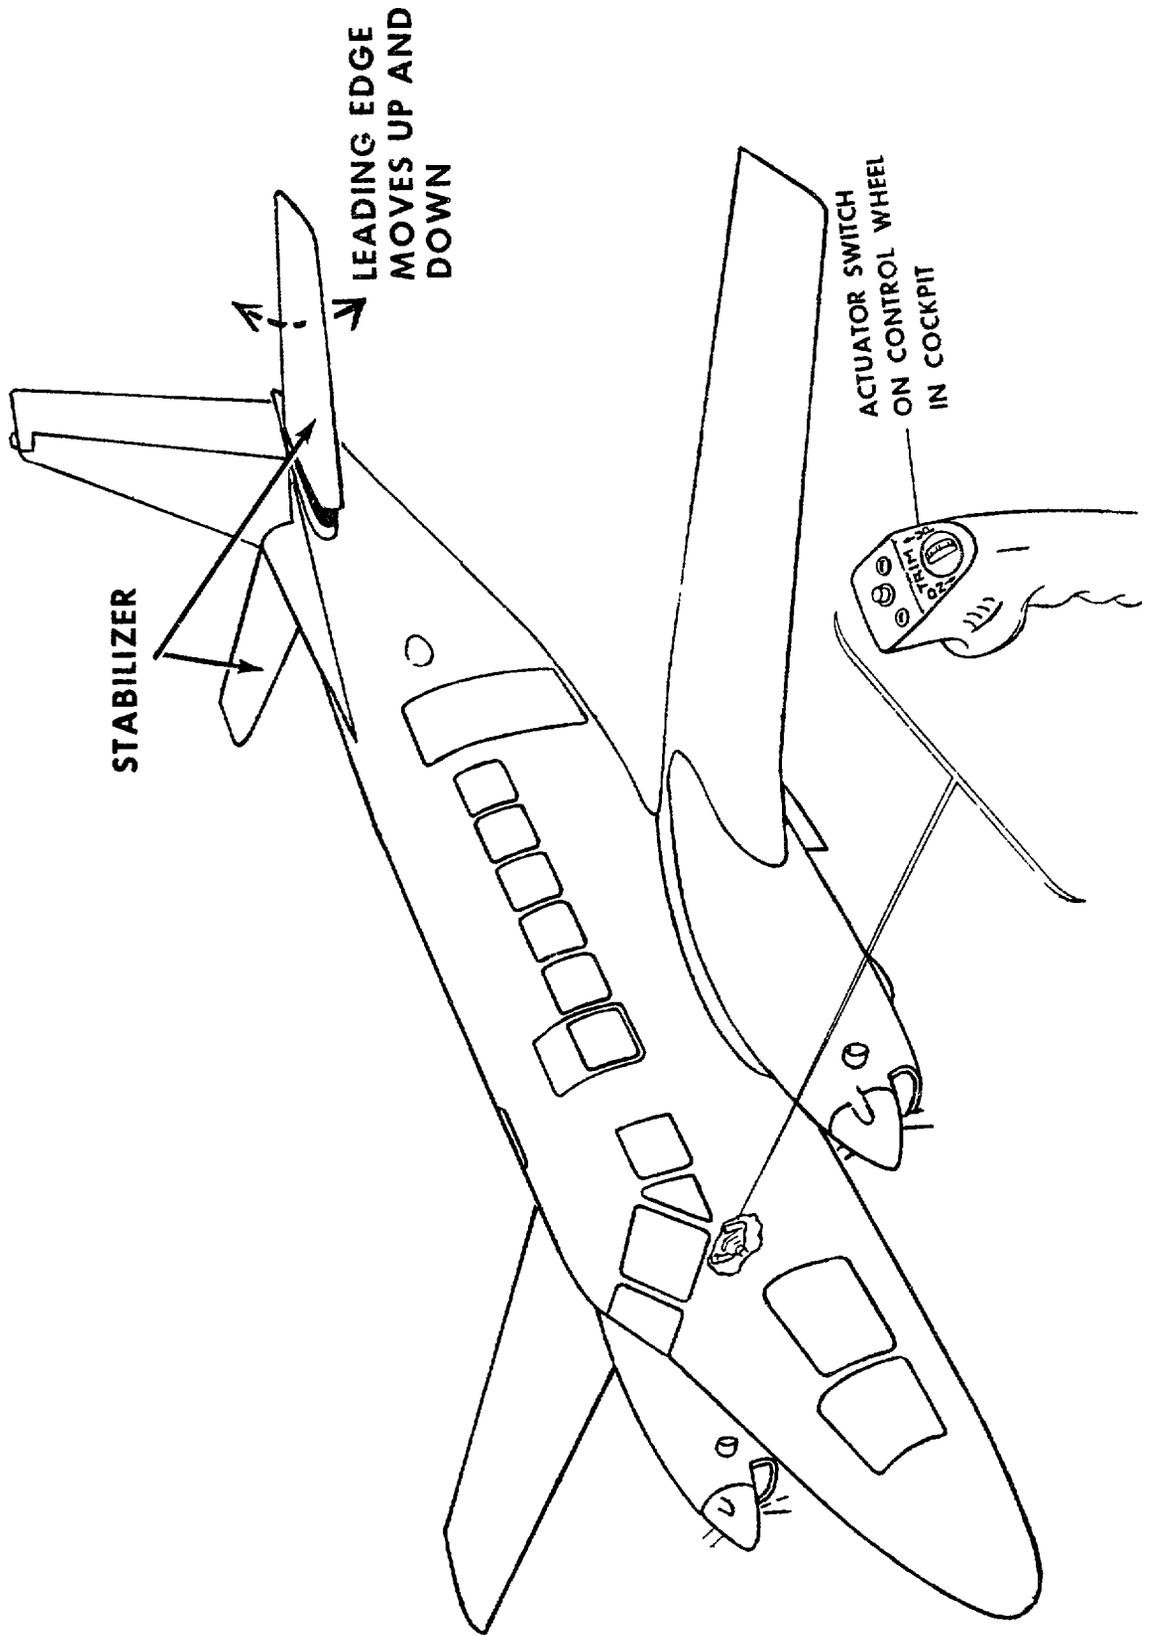
Model 99 experienced hazardous operating difficulties associated with the movable stabilizer, a new design feature incorporated into the aircraft's trim system. Between January and March 1969, difficulties in aircraft handling attributable to the trim system were reported to Beech by a commuter airline operator. FAA conducted flight tests and reported to Beech in May 1969 that the aircraft's trim system was unsafe. During June and July 1969, 2 aircraft accidents occurred involving 16 fatalities and NTSB determined that the trim system was the probable cause of one accident and a possible cause of the other. Subsequently, the aircraft were modified to correct the problem. NTSB reported that FAA had not participated in flight-testing the stabilizer, even though it was a new design feature, and recommended that in the future FAA participate directly in certifying all new design features.

**ILLUSTRATION OF MOVABLE HORIZONTAL STABILIZER**

On July 6, 1969, another model 99 had an accident The carrier involved was Air South, Inc This accident near Monroe, Georgia, caused 14 fatalities NTSB concluded that the probable cause of the accident was an unwanted change in longitudinal trim which resulted in a nosedown, high-speed flight condition that the pilots were not physically capable of overcoming Although NTSB could not specifically determine the initiating element in the accident sequence, it considered the design of the aircraft flight control system conducive to malfunctions which, if undetected by the crew, could lead to a loss of control

The evaluation team made 17 recommendations generally consistent with the expert team's recommendations and suggested that Beech undertake a long-range design program to improve the trim system. Between July 1969 and November 1970, FAA issued several airworthiness directives requiring Beech to install sounding devices to warn pilots of faulty trim conditions and to make some alterations to correct the trim system.

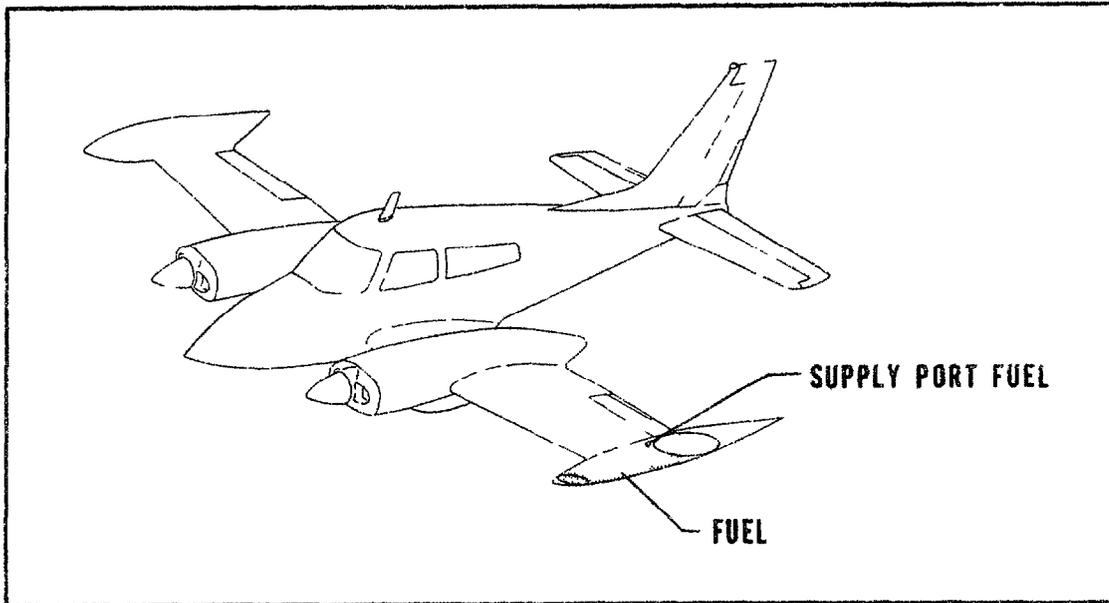
**ILLUSTRATION OF FUEL INTERRUPTION DURING DEEP DESCENTS**

fuel difficulties were of an inconsistent nature and occurred in aircraft operations, such as prolonged power off steep descents, which Cessna considered abnormal

After further tests and discussions, FAA issued an airworthiness directive dated June 4, 1969, requiring that owners of post-1962 models of Cessna 300 and 400 aircraft (most of the operating fleet) install placards reading "Operation with less than 10 gallons of fuel in each main tank is prohibited "

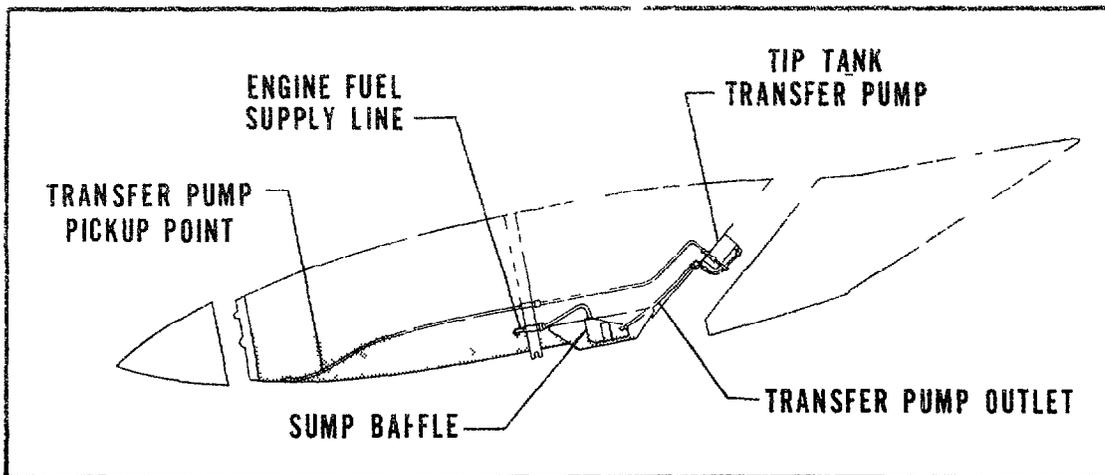
**SUBSEQUENT MODIFICATION OF FUEL SUPPLY TANK**

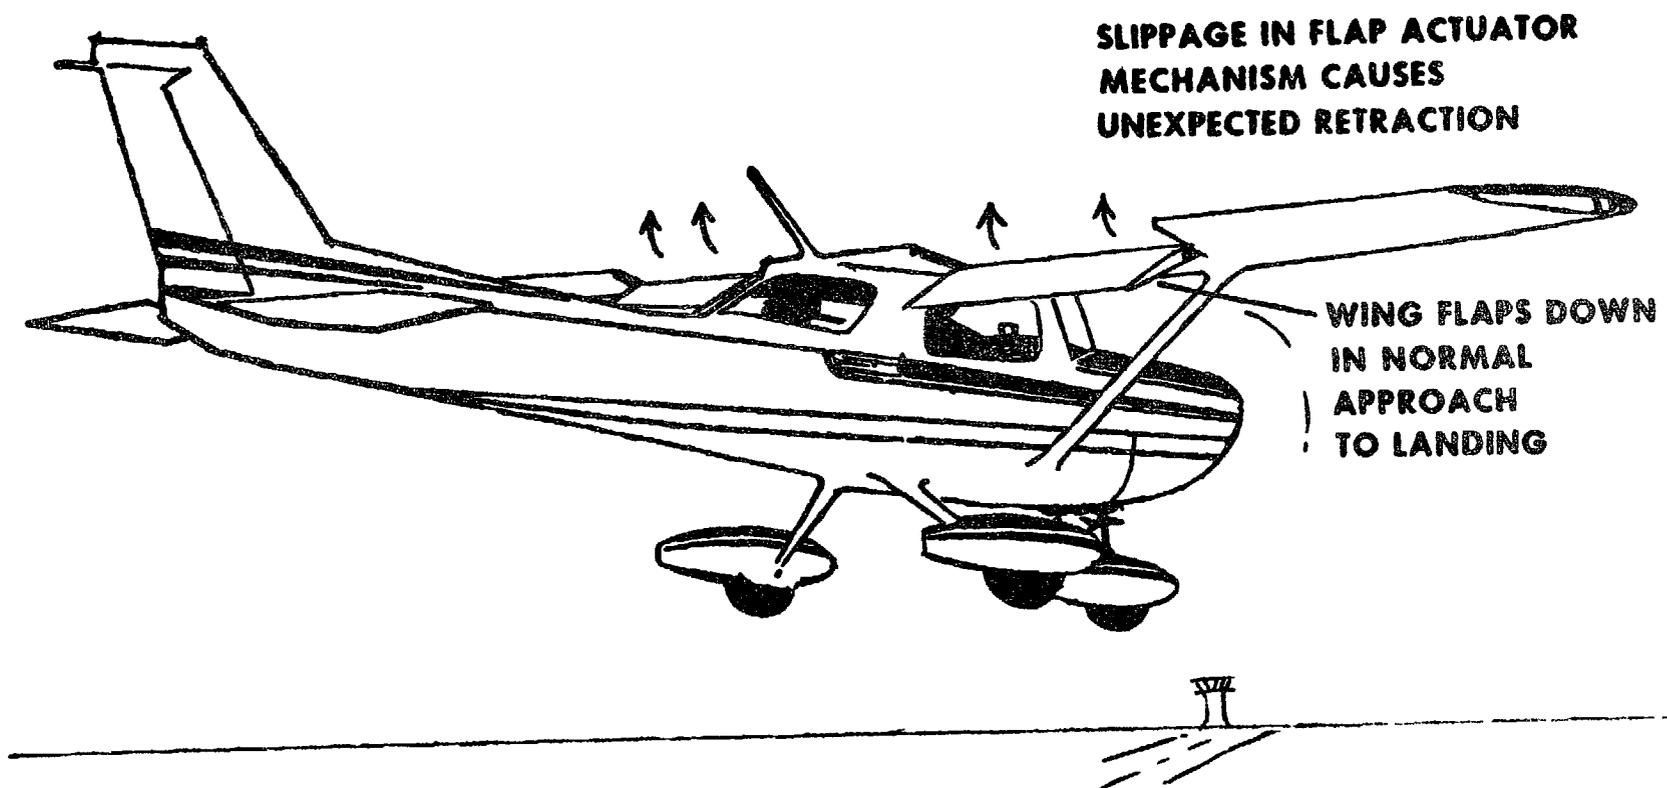
**ILLUSTRATION OF UNCONTROLLED WING FLAP RETRACTION  
ON APPROACH TO LANDING**

In December 1966 FAA notified Cessna that two instances of unexpected flap retractions had occurred in less than a month. Cessna tested the malfunctioning parts and stated that it was unable to duplicate the slippage and advised FAA on February 24, 1967, that the parts had withstood design load tests, and that the flaps may have been used when the aircraft were being operated above manufacturer-recommended speeds. In 1967 Cessna received a number of flap retraction reports and, as a result, issued two service letters during 1968 notifying aircraft owners that experience had shown that the extension devices on all Cessna single-engine aircraft with electric flap actuators should be cleaned and lubricated to increase operational reliability.

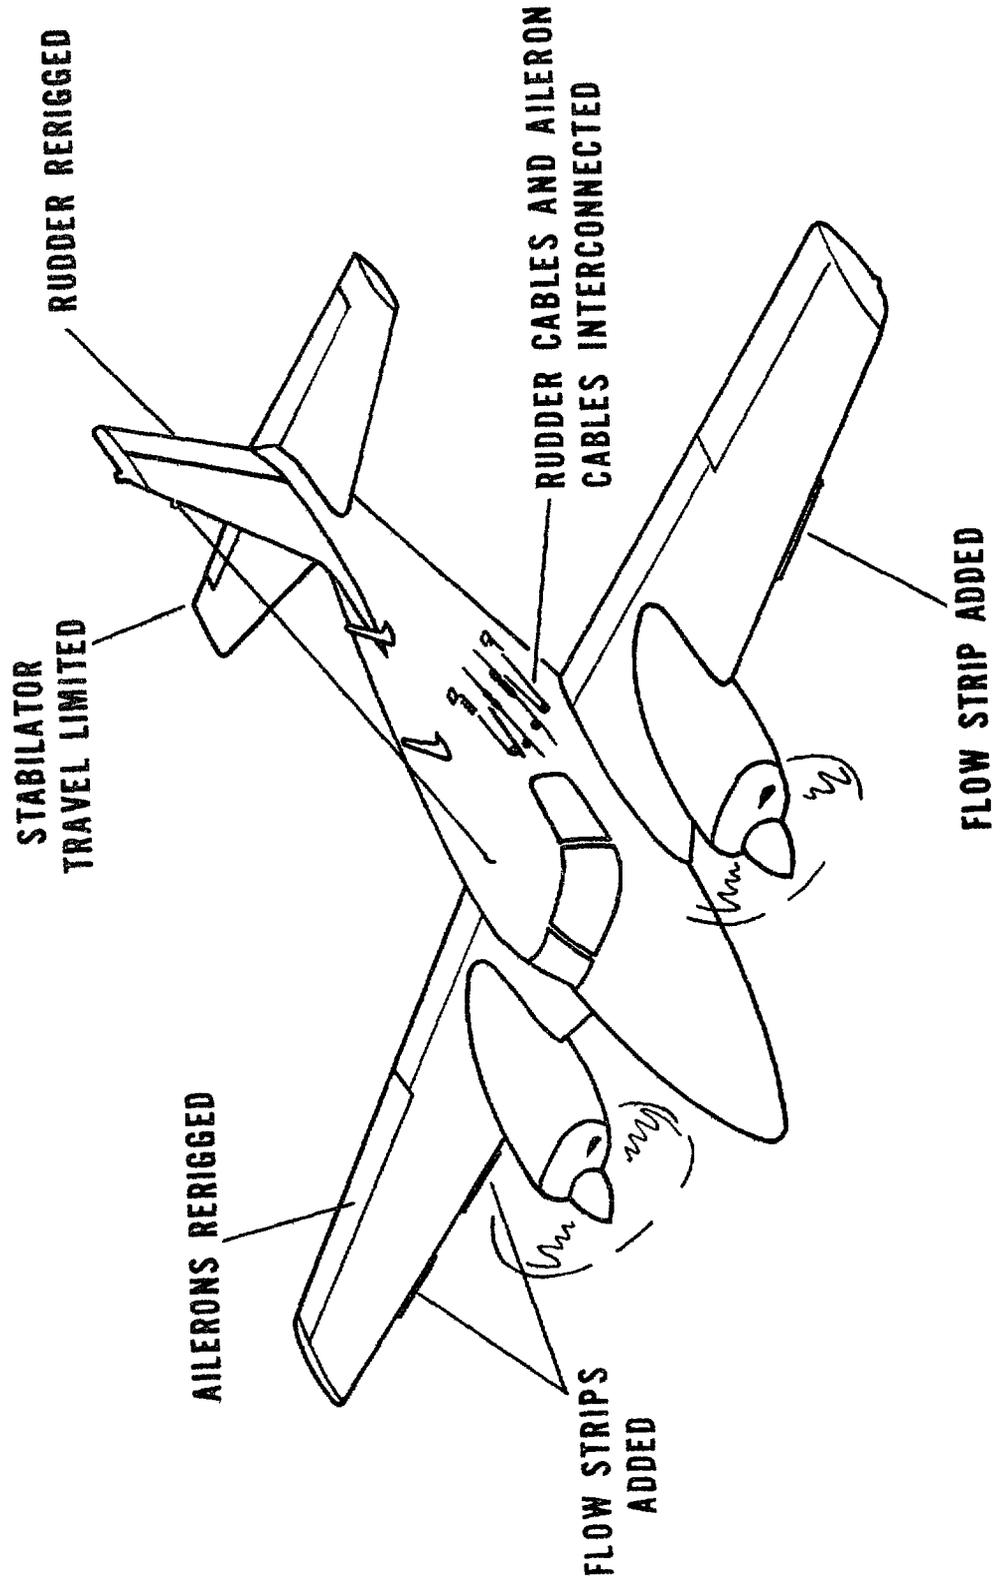
According to Piper officials, there were a number of factors that contributed to the accident record experienced by this aircraft. Piper believes that many of the stall-spin accidents occurred through aircraft overloading or mishandling near the ground when recovery is difficult if not impossible. Piper officials also indicated that the British have had an excellent safety record with the Piper 30 and that more closely controlled British training programs and the discouragement of stall maneuvers near the ground contributed to this record. Piper indicated that FAA, in contrast, has required new pilots to demonstrate slow-speed, single-engine control competence at low altitudes.

**ILLUSTRATION OF AIR FLOW MODIFICATION KIT  
INSTALLED TO IMPROVE HANDLING CHARACTERISTICS**

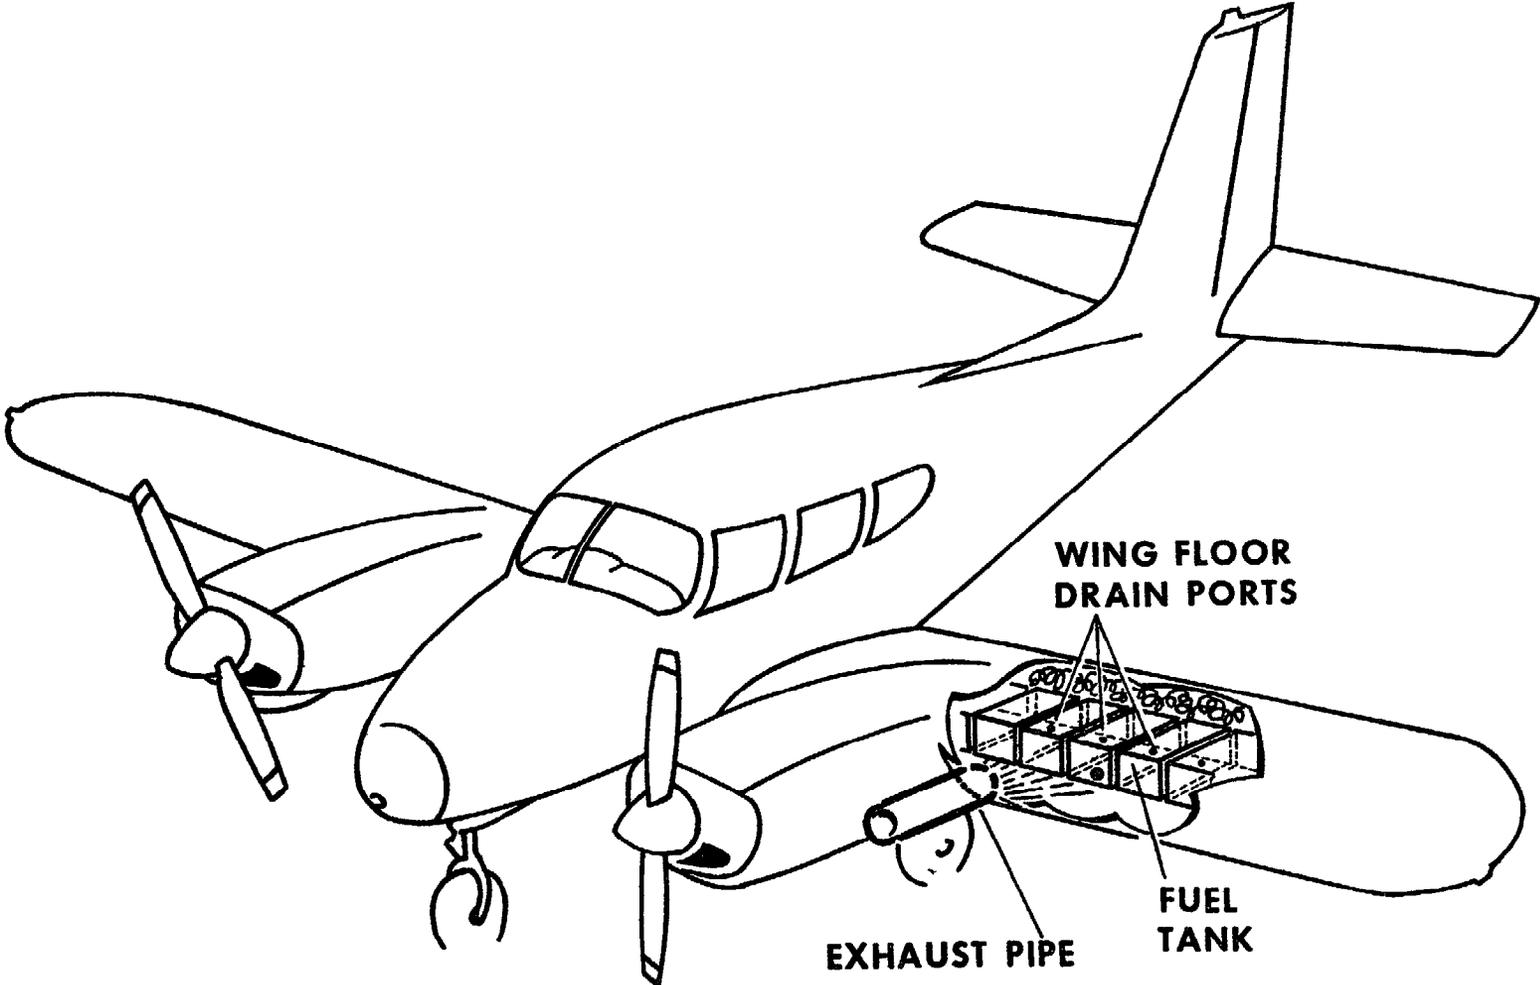
**ILLUSTRATION OF FIRE-EXPLOSION  
HAZARD FROM FUEL CELL LEAKAGE**

In March 1968 FAA forwarded data to Piper on two Piper 23-250 aircraft explosions and fire incidents caused by fuel leakage. FAA stated that the leakage was a distinct hazard which apparently could not be effectively controlled or eliminated by conducting preflight inspections or by keeping the fuel tanks full when the aircraft was not in use. FAA requested Piper to investigate and propose corrective measures. Piper replied in May that it recognized fuel leakage could be a hazard but that (1) the fuel tanks could not be expected to last forever, (2) proper maintenance and good preflight inspections should avoid similar incidents, and (3) the drainage provided should normally allow leaking fuel to escape.

FAA issued General Aviation Inspection Aids<sup>1</sup> which cited the fuel leakage problem and which recommended that fuel tanks be kept full when the aircraft were not in operation.

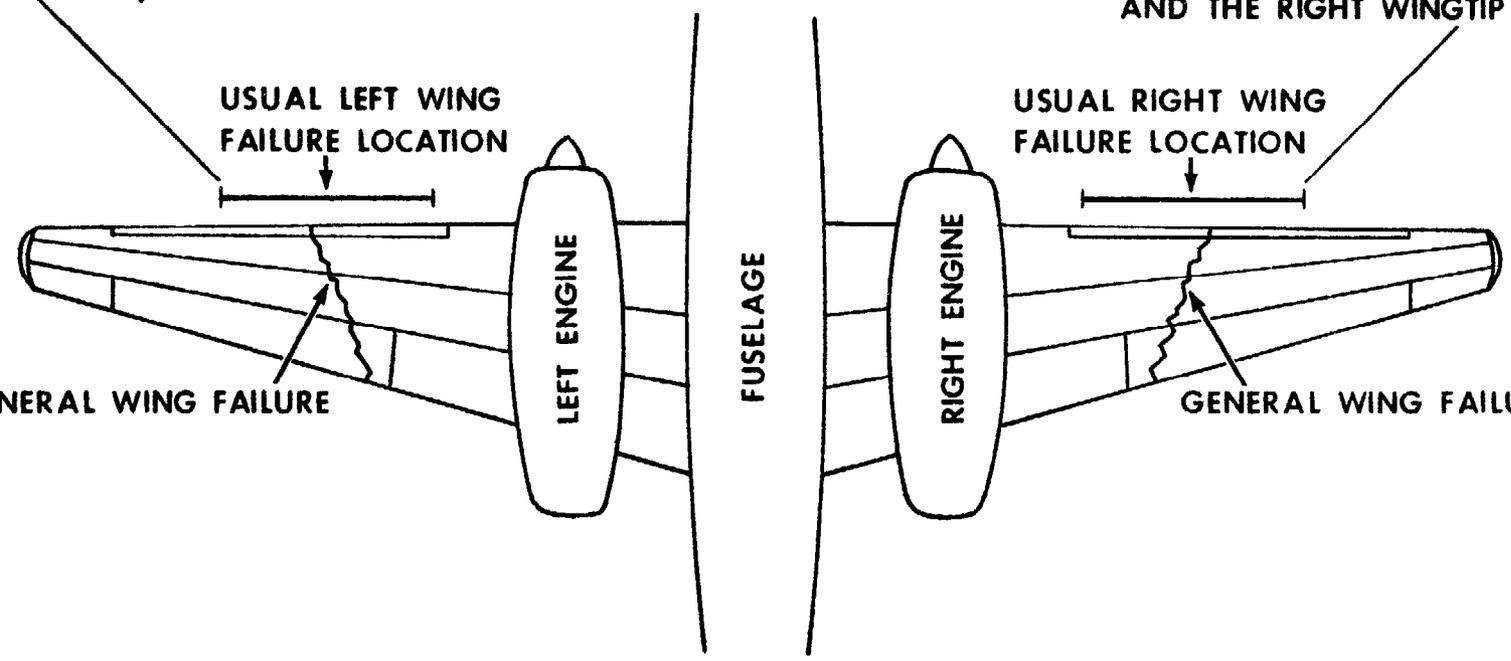
GENERAL WING FAILURE

These accidents generally occurred during flight under turbulent conditions or during abrupt maneuvers

In 1963 the Chairman of CAB advised the Administrator of FAA of a trend in Aero Commander wing failure accidents and suggested that the effects of turbulence may not have been considered in original manufacturer tests for type certification. FAA advised CAB that the aircraft met or exceeded FAA requirements. However, since 1963 the manufacturer has been conducting a series of tests to establish the cause of the problem. Bethany Division officials stated that the costs of their testing programs have been substantial and that they included analyses outside the scope of Federal regulations. FAA has monitored Division efforts in this area but has not independently attempted to identify the cause of the failures. The tests have repeatedly shown that the aircraft complied with applicable Federal regulations.
