CED-77-66

Poor Design Reviews And
Construction Inspections Of
Apartment Project In Rhode Island

Department of Housing and Urban Development

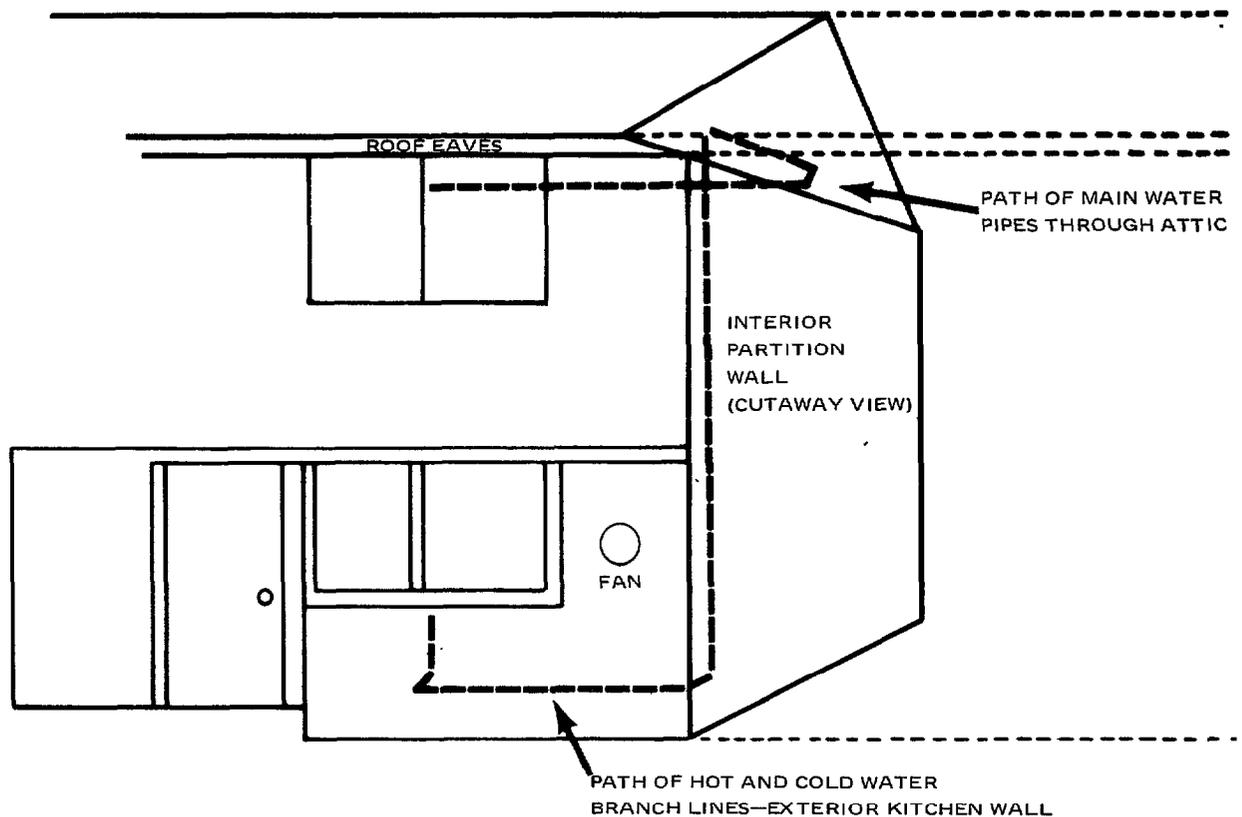
kitchen wall. The pipes then extend into the exterior wall, run horizontally inside the partition and enter at the kitchen sink cabinets. The following diagram shows the configuration.

Deficiencies in construction were the primary causes for frozen and burst pipes in the two- and three-bedroom, upstairs and downstairs apartments. Pipes froze and/or burst because they were installed in the attics and exterior kitchen wall partitions and were subject to freezing temperatures without adequate protection--the conclusion reached by both our consultant and one hired by project management. In the attics, hot water pipes were not insulated, although this is required

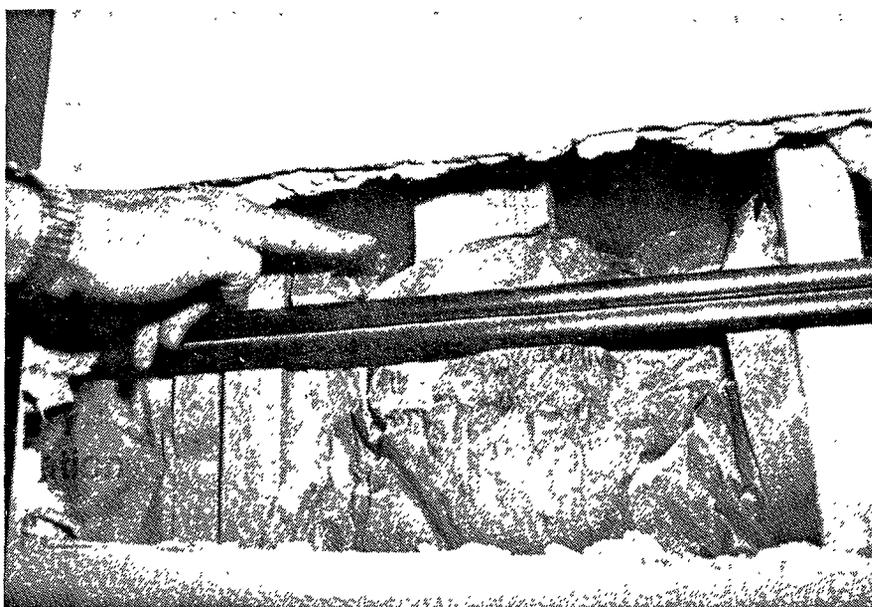
3. Inadequate installation of insulating material--The contractor, after consulting with the design engineer, chose to rely on blanket insulation installed in exterior walls for protection of kitchen pipes. The professional engineer assisting us said this provided inadequate insulation against cold infiltrating from above (exhaust fans) and below (foundation slabs) the pipes. In addition, deficient installation of insulating material resulted in inadequate protection.

**GAPS IN BLANKET INSULATION OF EXTERIOR KITCHEN WALL
IN APARTMENT 217F--MARCH 1976**

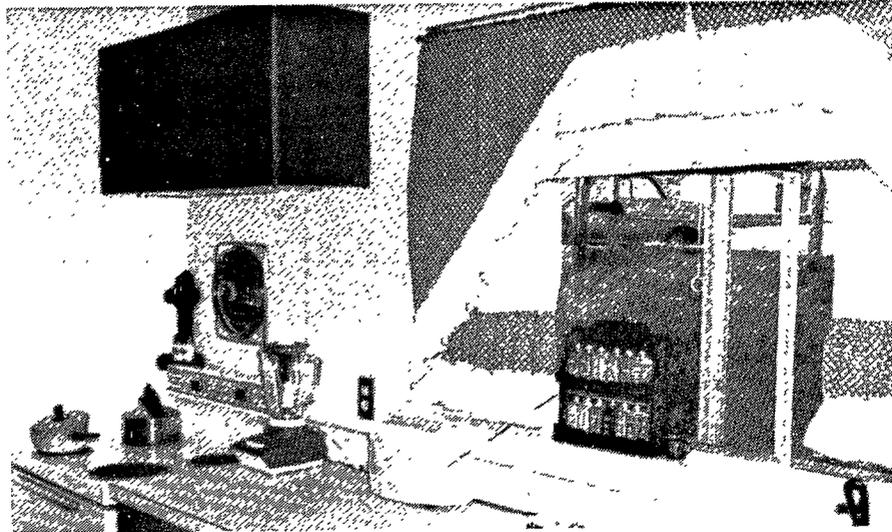
4. Sinks and stoves located against exterior walls--According to our consultant, locating the pipes at a level which resulted in sinks and stoves keeping warm room air from reaching the wall adjacent to the pipes was another factor contributing to the frozen and burst pipes in the kitchens. In addition, the above-mentioned subcommittee official stated that contractors in practice relied primarily on heat loss through walls to prevent freezing of pipes, but he felt that this was not good practice.

LOCATION OF WATER SUPPLY PIPES IN WALLS BEHIND SINK AND STOVE IN TYPICAL APARTMENT--OCTOBER 1976

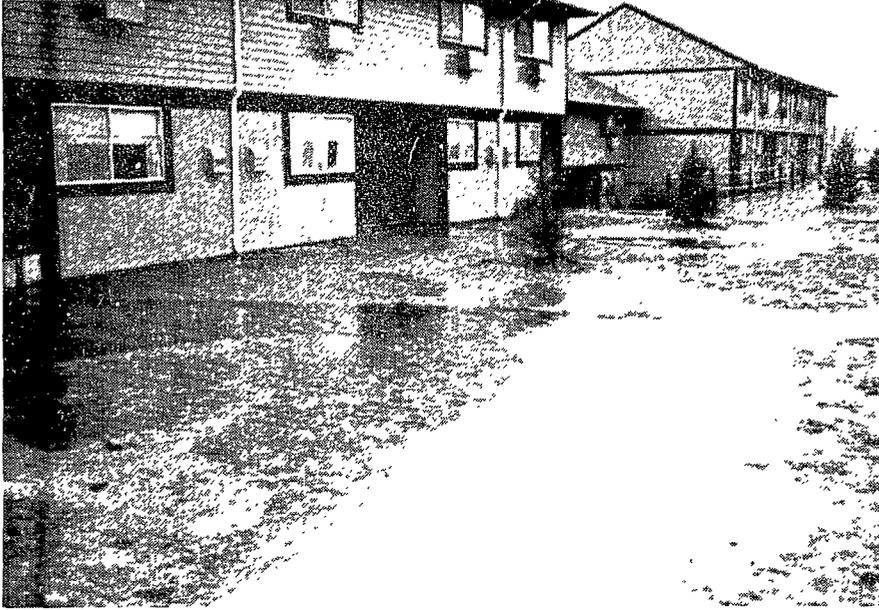
BUILDING D1 DURING HEAVY RAIN IN APRIL 1976

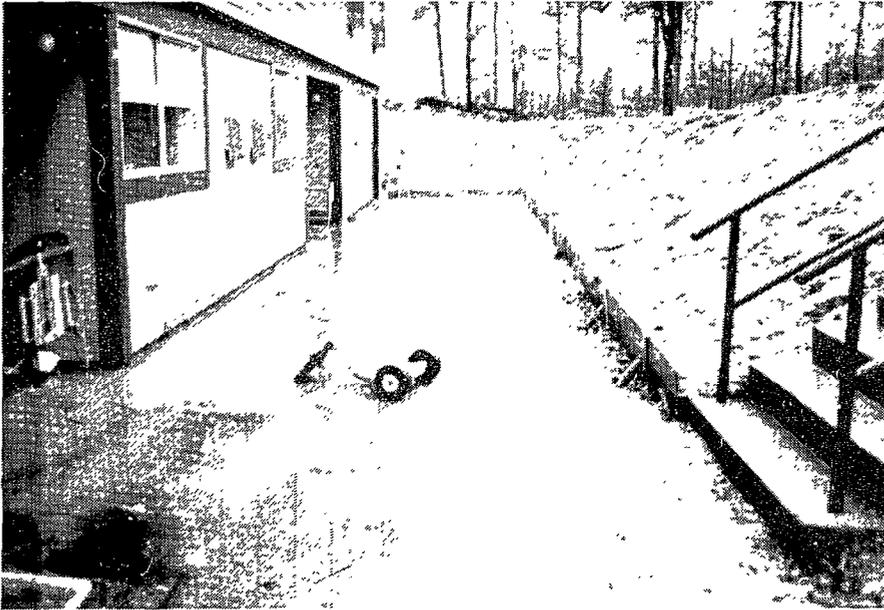
WEST END OF BUILDING D2 AFTER RAIN IN APRIL 1976

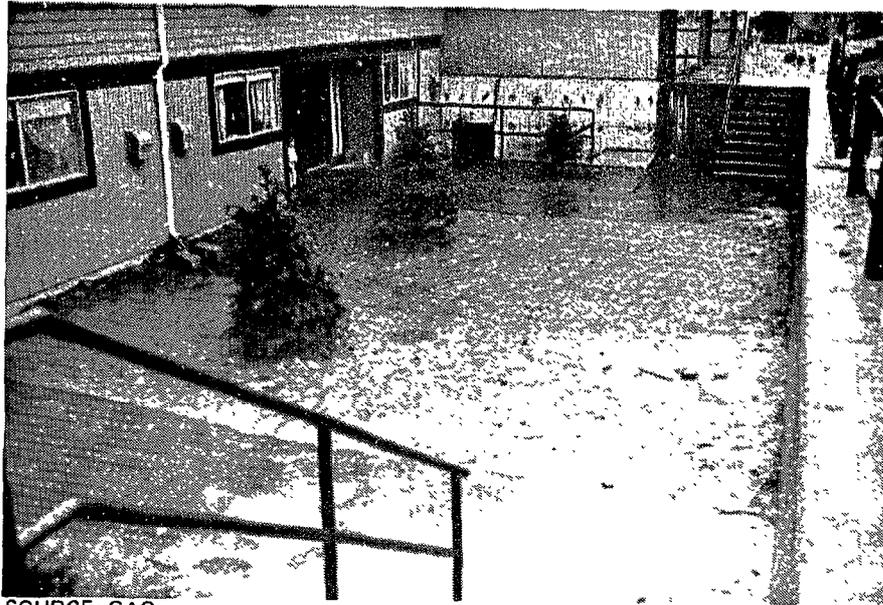
SUNKEN LAWN AT BUILDING D2--APRIL 1976

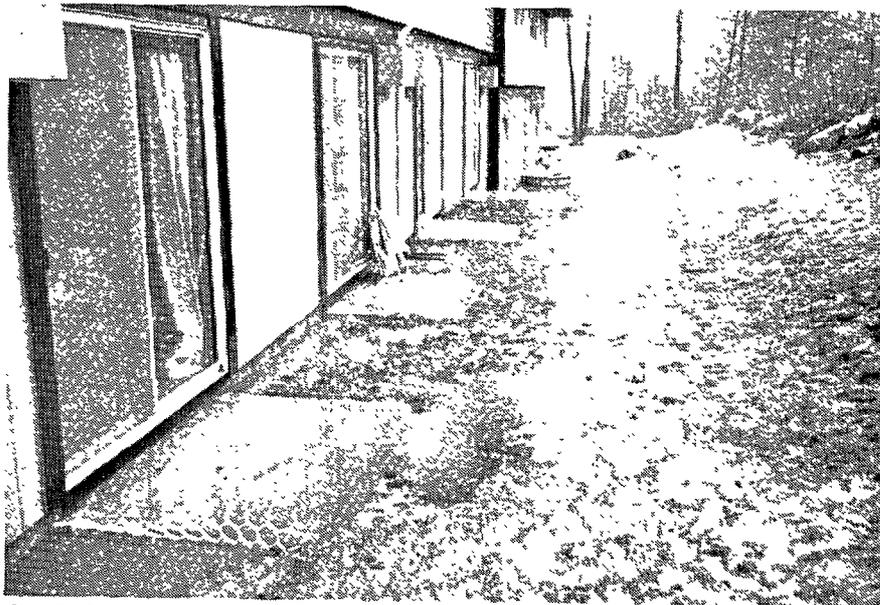
REAR OF BUILDING E1 DURING RAIN SHOWING LACK OF DRAINAGE AND CLOSENESS OF ENTRANCE TO FINISHED GRADE--APRIL 1976

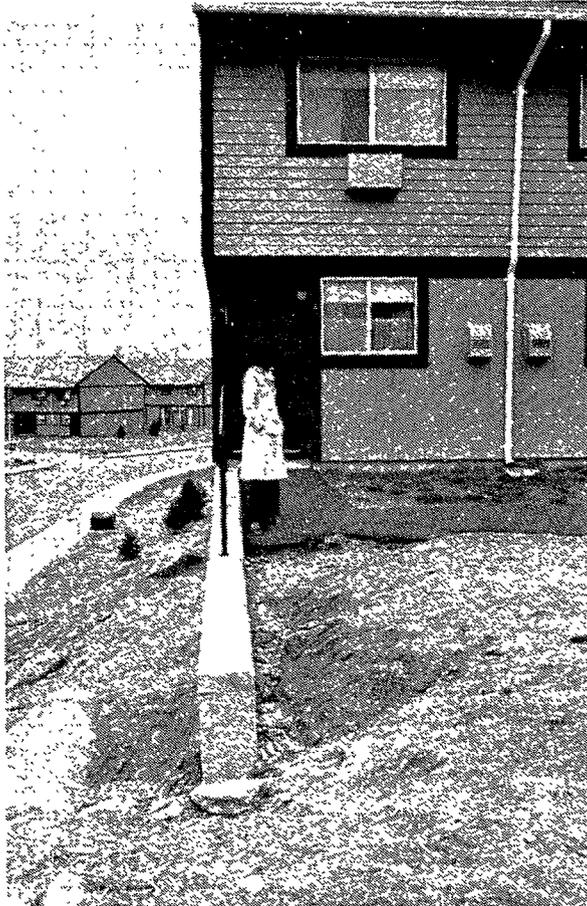
As cited earlier, the grade slope at the eroded area does not comply with plans and MPS in that it is too steep. Our consultant stated that the slope was used as a travel walk by tenants. He pointed out that the contract drawings called for a stairway between the walkway and the sidewalk at the bottom of the slope which, if constructed, probably would have allowed vegetation to grow.

**TOO STEEP SLOPE AND SOIL EROSION
AT BUILDING B5--MARCH 1976**

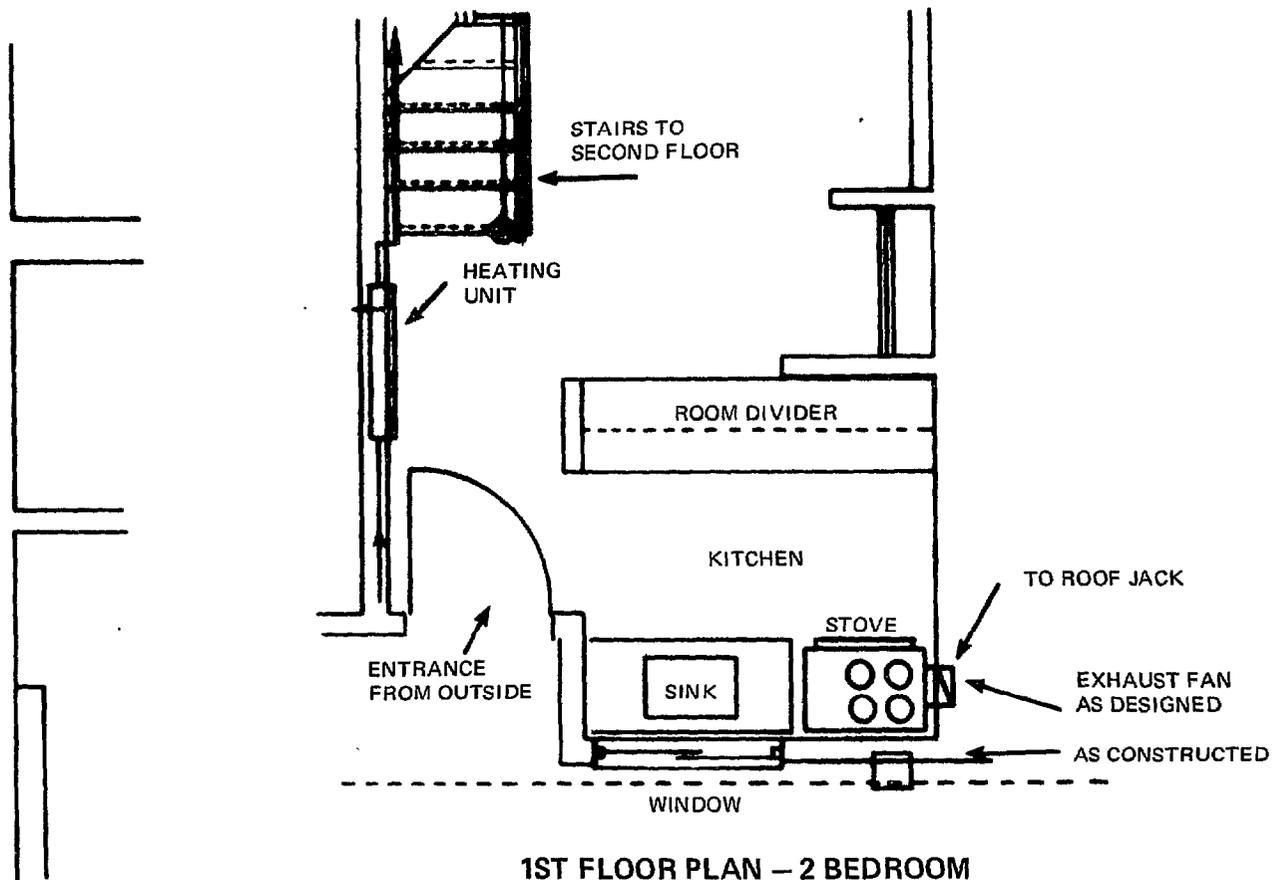
Most two- and three-bedroom apartments, according to a project management consultant's report, experience cold temperatures in the kitchens during cold weather months. Apartments having an upstairs and downstairs total 116 and are located in 12 of the 14 project buildings. Faulty design, coupled with a construction deficiency, appears to have led to the condition. The following diagram shows the kitchen area and the location of the stairway and heating element in a typical apartment.

The design of the kitchen areas for the two- and three-bedroom apartments having upstairs and downstairs rooms did not provide for a heating unit in the kitchens. The nearest heating element is at the bottom of the stairway leading to the second-floor bedrooms. According to management's consultant, the unit was intended to provide heat to both the kitchen and the foyer but was rendered ineffective

primarily because of the stairway's location. The stairway acted as a flue for heat from the first floor to be drawn to the second floor.
