**Actions Needed To Increase
The Safety Of Dams Built By
The Bureau Of Reclamation And
The Corps Of Engineers**

CED-77-85

JUNE 3, 1977

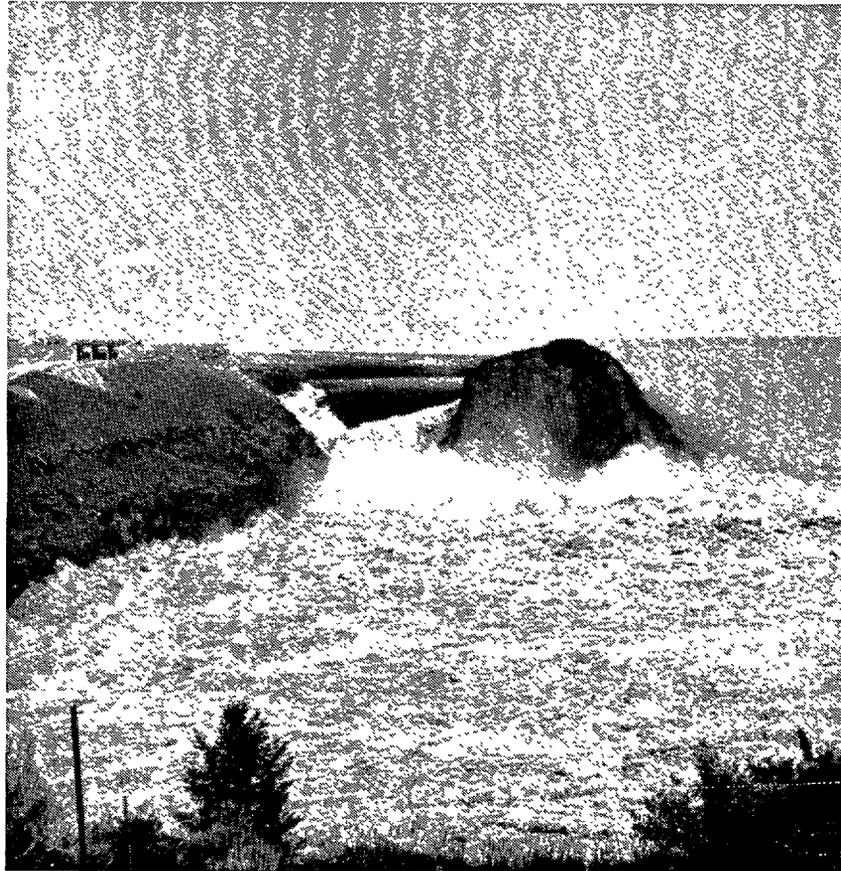
WATER GUSHING THROUGH THE RIGHT SIDE OF THE 305-FOOT
TETON DAM IN THE EARLY AFTERNOON ON JUNE 5, 1976

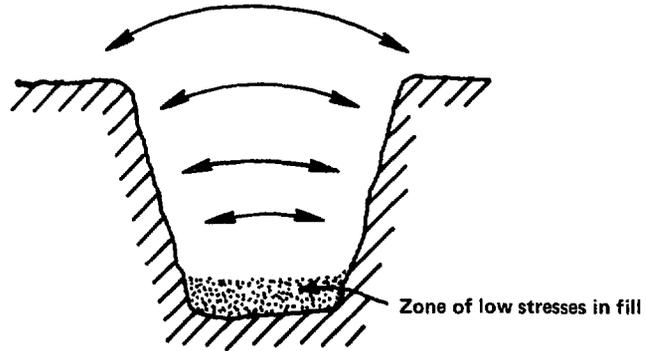
The Panel said that in the bottom of the key trench in the vicinity of the failure, there was a concentration of steps and overhanging rocks which made proper compaction of soil in the trench difficult and was conducive to arching as

First order arching in fill over and between walls of key trench

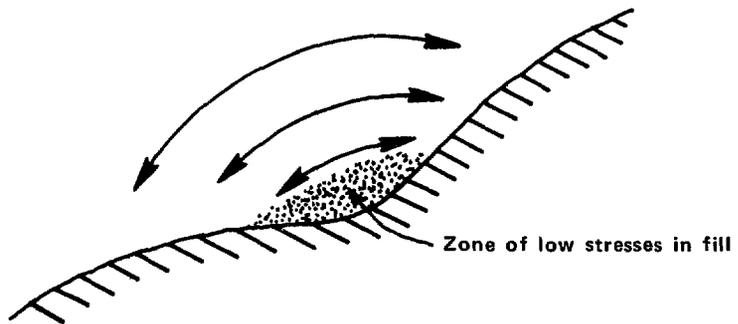
Second order arching produced by longitudinal topography of rock surface in key trench

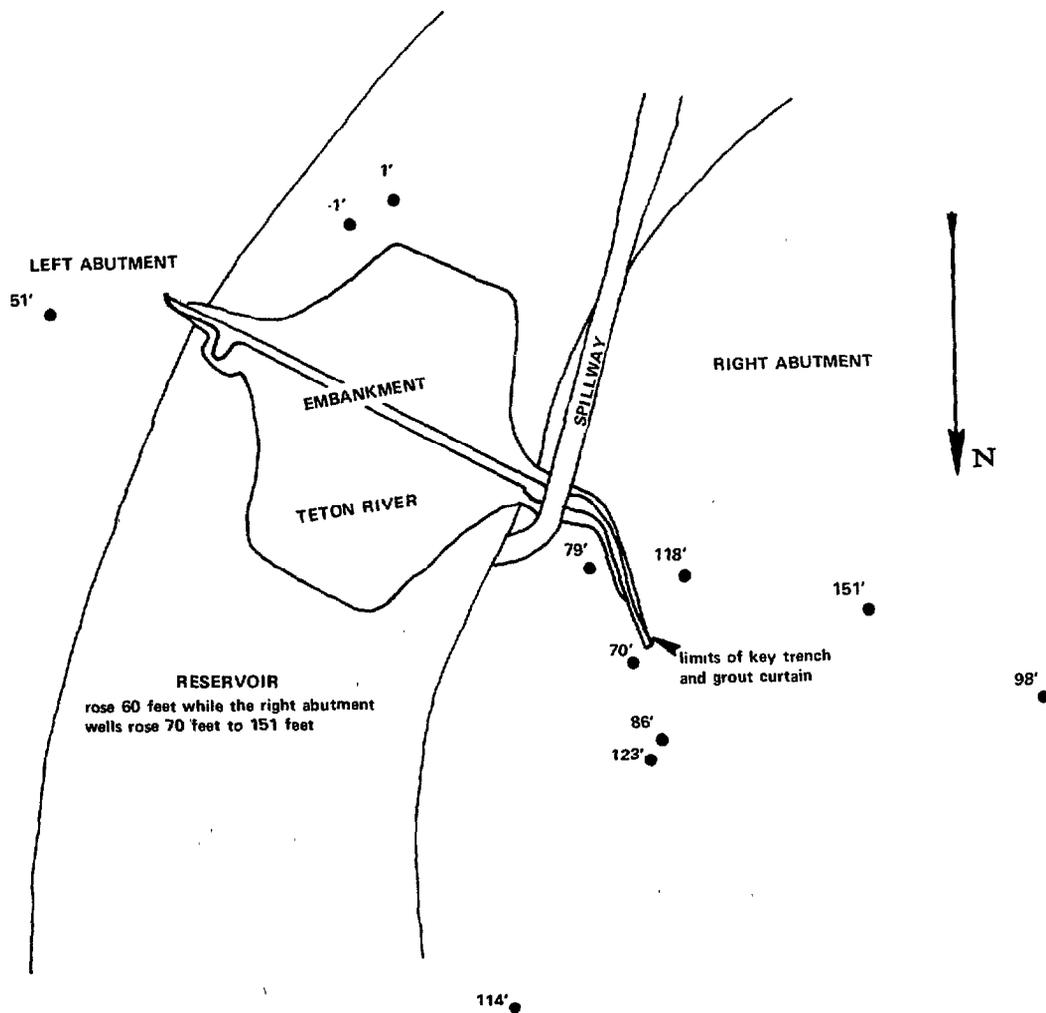
Bureau designers told us that had they seen such information earlier, they probably would have initiated action to check the accuracy of the data and to evaluate the effects of the seepage, if any, on dam safety. They told us that this could have led to opening the main river outlet to drain a portion of the reservoir.

Location of observation wells(●) and rises in feet for the wells and reservoir from May 13, 1976 to June 1, 1976

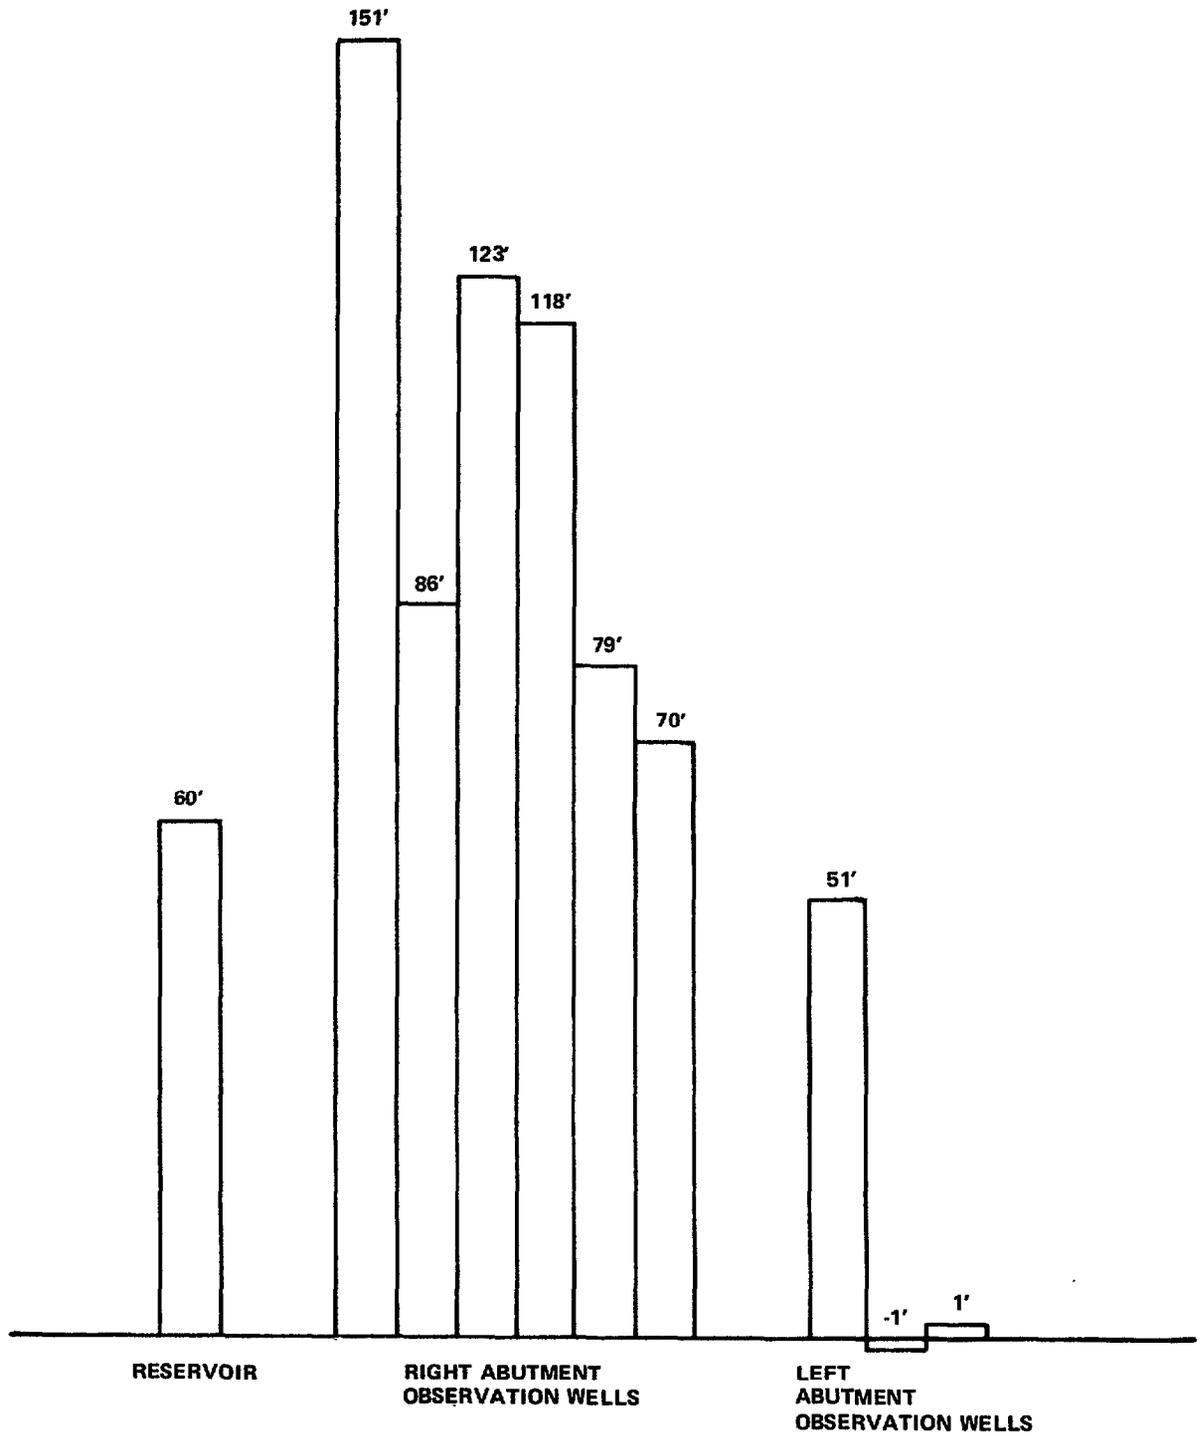
RELATIONSHIP OF THE WATER RISE IN THE TETON DAM RESERVOIR TO THE WATER RISE IN THE SURROUNDING GROUND WATER OBSERVATION WELLS

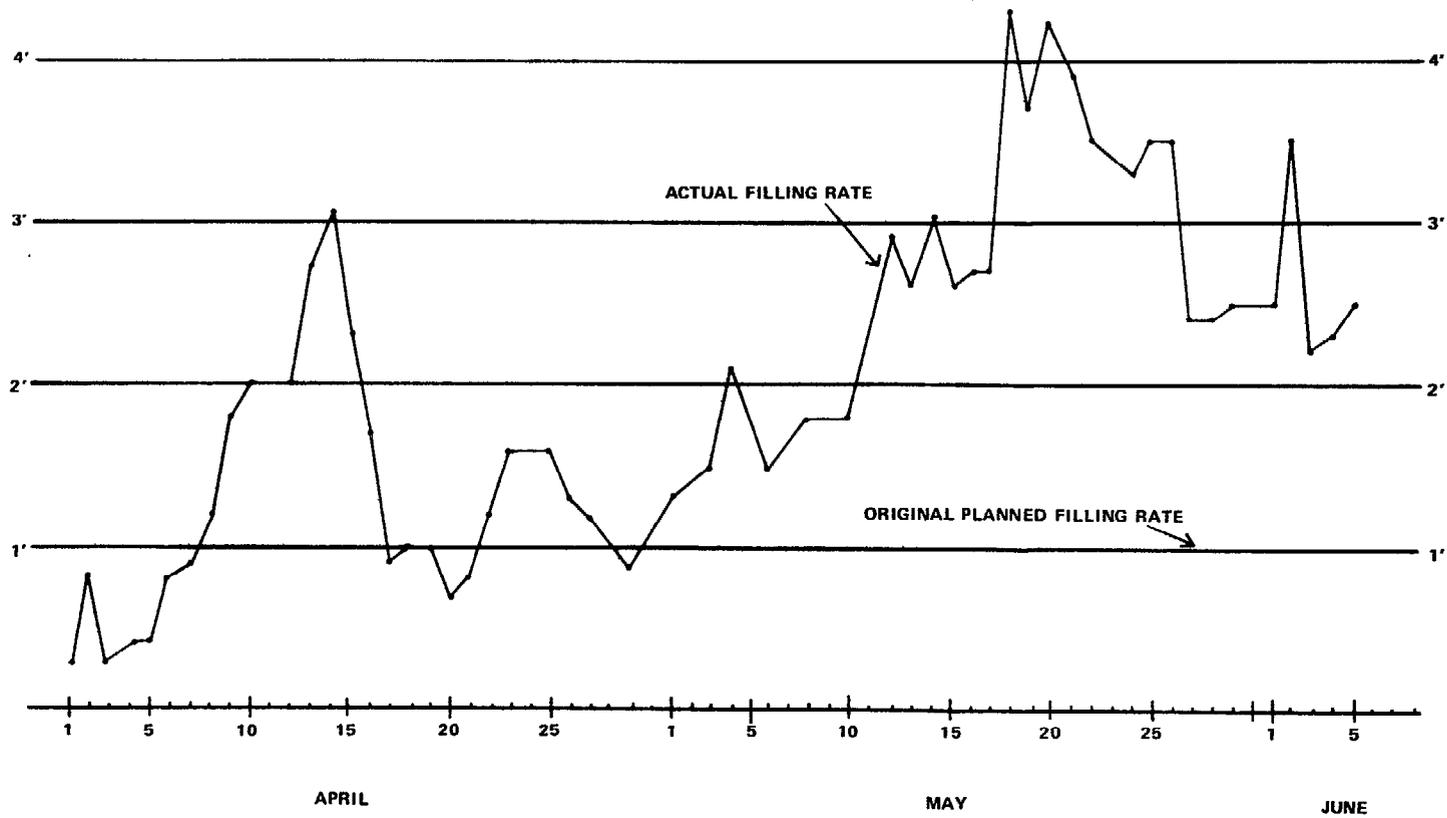
TETON DAM
DAILY INCREASE OF RESERVOIR HEIGHT IN FEET
FROM APRIL 1, 1976 TO JUNE 5, 1976

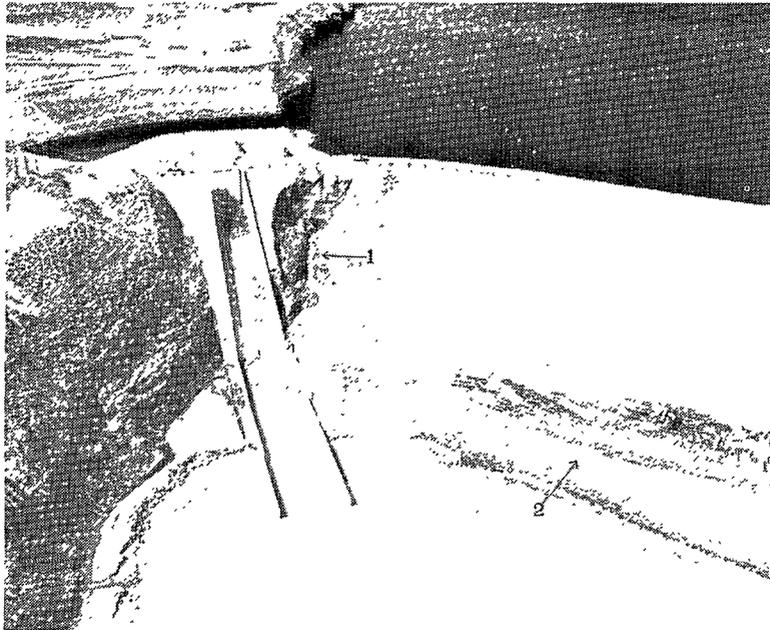
FONTENELLE DAM— LEAKAGE AND THE RESULTING EROSION OF THE RIGHT SIDE OF THE DAM (see arrow 1) AND EROSION ON THE FACE OF THE DAM (see arrow 2)

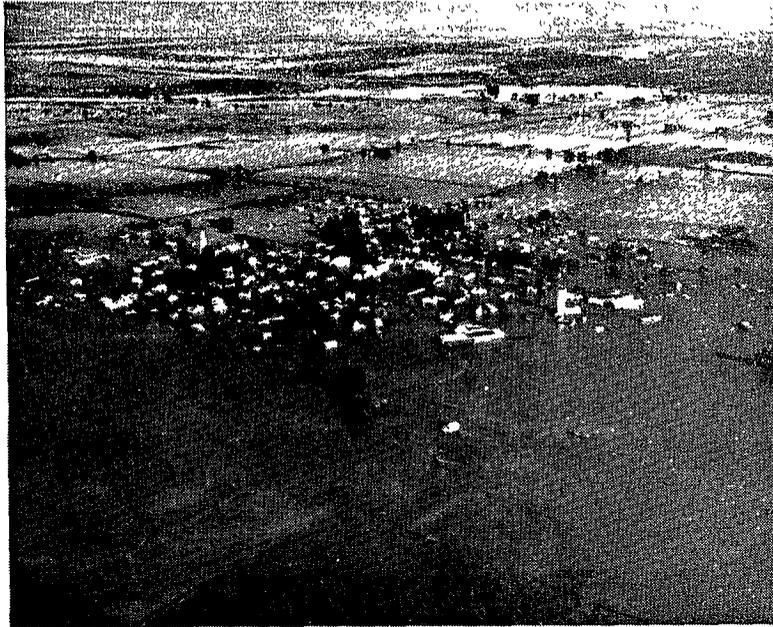
SUGAR CITY, IDAHO— FLOODING ON JUNE 5, 1976, CAUSED BY THE FAILURE OF THE TETON DAM EARLIER THAT MORNING

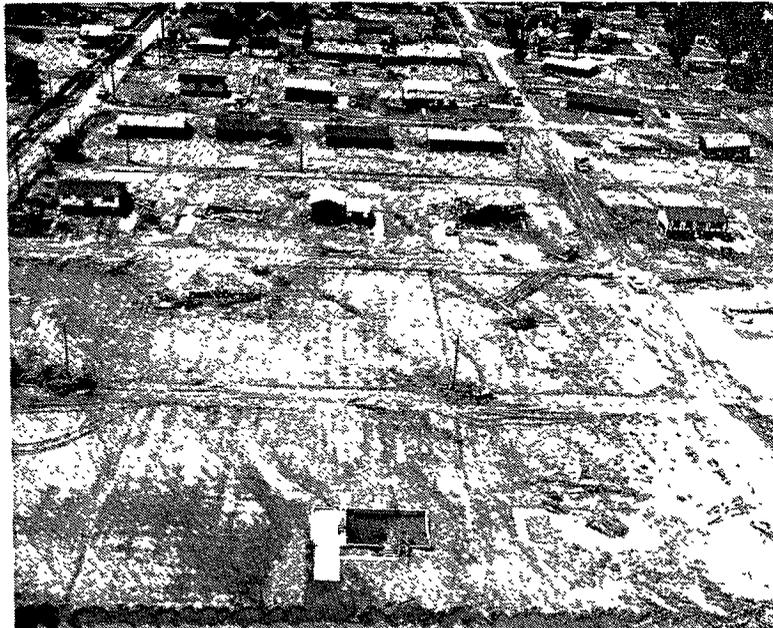
SUGAR CITY, IDAHO—VACANT FOUNDATIONS WHERE HOUSES WERE WASHED AWAY AS A RESULT OF THE TETON DAM FAILURE

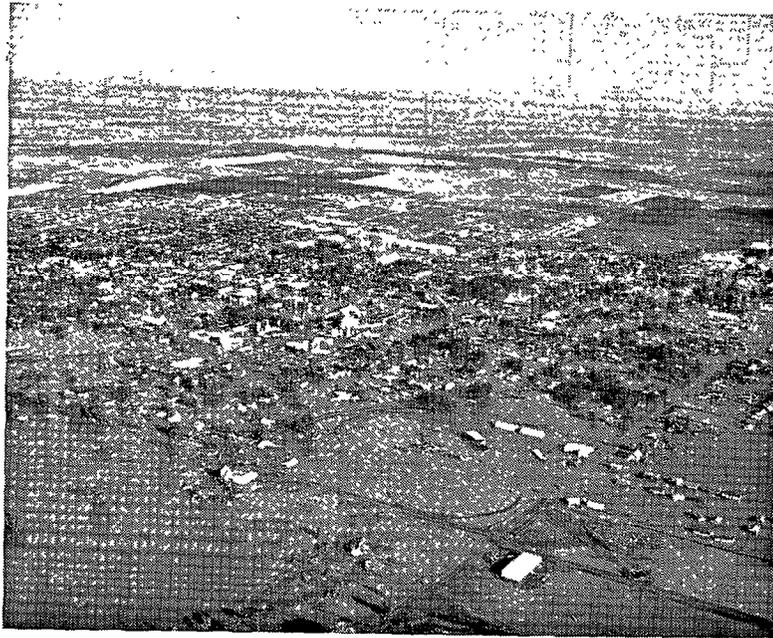
REXBURG, IDAHO—FLOODING ON JUNE 5, 1976, CAUSED BY THE FAILURE OF THE TETON DAM THAT MORNING

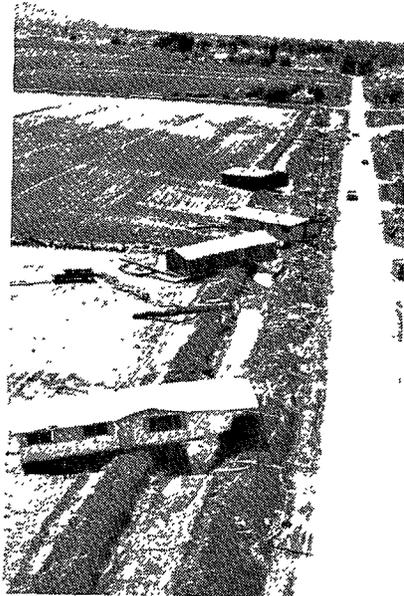
REXBURG, IDAHO—HOUSES MOVED FROM THEIR FOUNDATIONS AS A RESULT OF THE TETON DAM FAILURE
