Highlights of [GAO-10-119](#), a report to congressional requesters

WARFIGHTER SUPPORT

Independent Expert Assessment of Army Body Armor Test Results and Procedures Needed Before Fielding

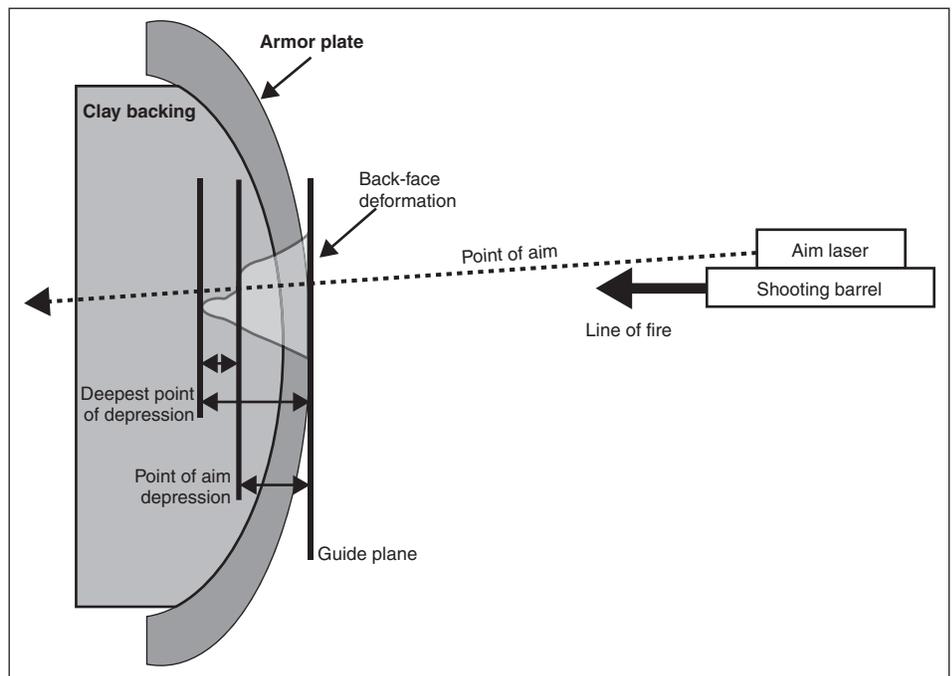
During Preliminary Design Model testing the Army took significant steps to run a controlled test and maintain consistency throughout the process, but the Army did not always follow established testing protocols and, as a result, did not achieve its intended test objective of determining as a basis for awarding contracts which designs met performance requirements. In the most consequential of the Army's deviations from testing protocols, the Army testers incorrectly measured the amount of force absorbed by the plate designs by measuring back-face deformation in the clay backing at the point of aim rather than at the deepest point of depression. The graphic below depicts the difference between the point of aim and the deepest point.

Source: GAO analysis.

Army testers recognized the error after completing about a third of the test and then changed the test plan to call for measuring at the point of aim and likewise issued a modification to the contract solicitation. At least two of the eight designs that passed Preliminary Design Model testing and were awarded contracts would have failed if measurements had been made to the deepest point of depression. The deviations from the testing protocols were the result of Aberdeen Test Center's incorrectly interpreting the testing protocols. In all these cases of deviations from the testing protocols, the Aberdeen Test Center's implemented procedures were not reviewed or approved by the Army and Department of Defense officials responsible for approving the testing protocols. After concerns were raised regarding the Preliminary Design Model testing, the decision was made not to field any of the plate designs awarded contracts until after First Article Testing was conducted.
