November 1985

RADIATION ACCIDENT

Incident at Clear Air Force Station, Alaska

B-217674

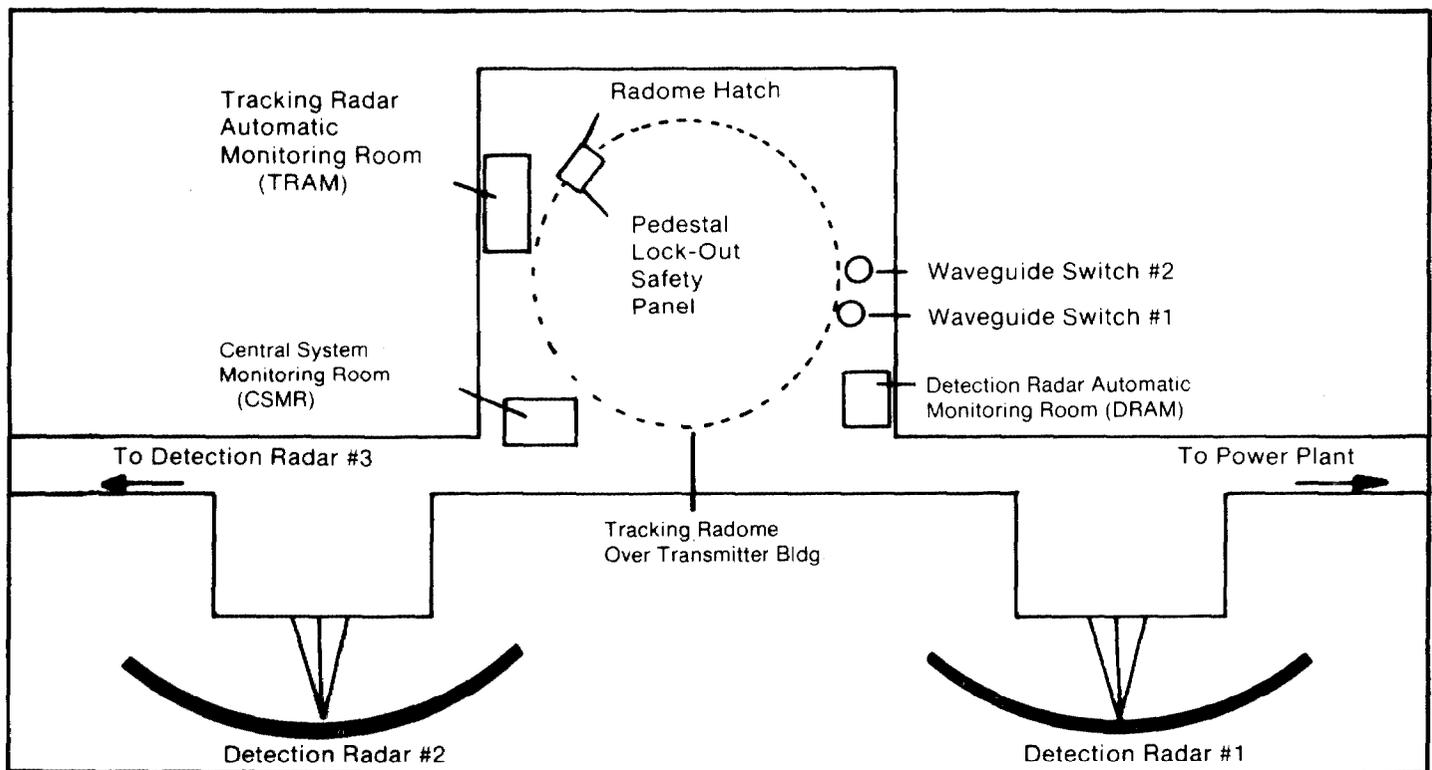
Figure 2.1: Technical Building Layout

The control facility at Clear houses rooms used to operate and oversee the tracker and detection radars. In conjunction with the Tracking Radar Automatic Monitoring (TRAM) room and the Detection Radar Automatic Monitoring (DRAM) room, there is also a Central System Monitoring Room (CSMR). (See fig. 2.1.) From these rooms, technicians routinely direct megawatts of power from a series of transmitters, through metal ducts called waveguides to energize the radars. As part of the

technical design of the radar facility, a key interlock system is incorporated as a safety measure. The interlock system allows technicians to close the waveguide switches while carrying out preventive maintenance procedures, in order to protect personnel in the radome from hazards due to transmitter radiation.

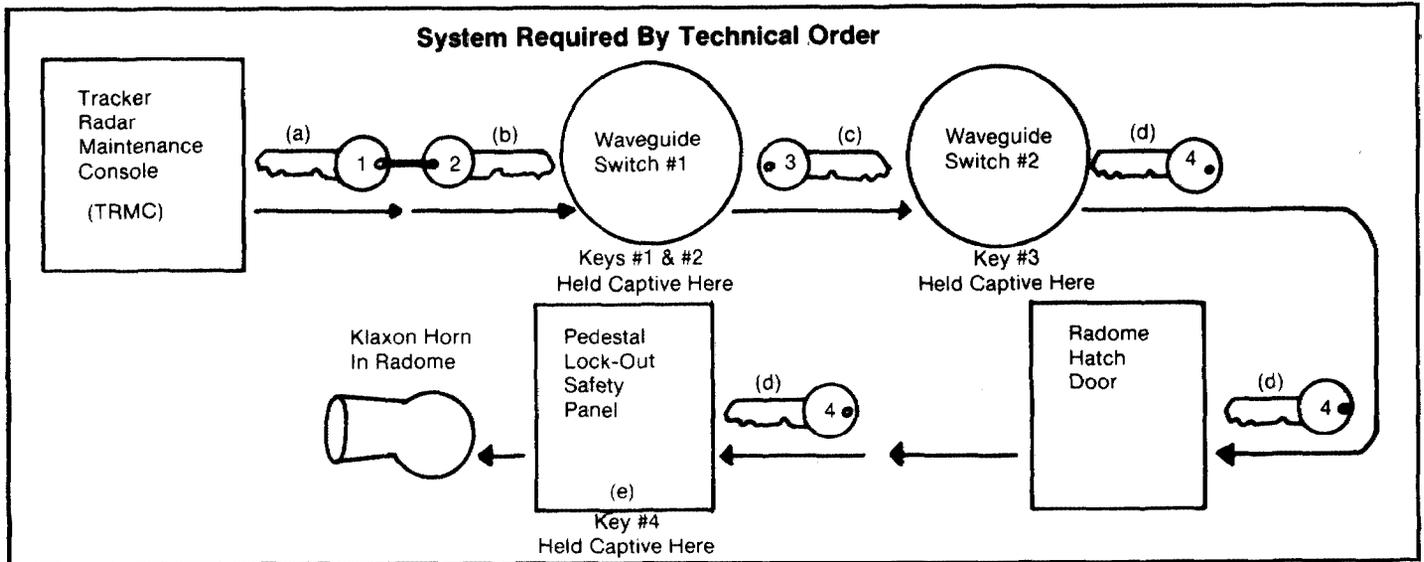
Figure 2.3: Key Lock-Out System Design Specifications Versus FSI Procedures

Even though the contract and related technical orders provide clear and extensive guidance on operation and use of the tracking radar safety system interlock, FSI instructions to employees, covering radome access procedures, omit significant elements of the system. FSI site instructions do not treat key #1 as a part of the interlock system. Consequently, on the day of the accident, this key was left in the console while the team leader performed the preventive maintenance routine, leaving the antenna operable and capable of emitting radiation. Key #2, which is the first waveguide switch key, and normally hung by the Tracking Radar Automatic Monitoring (TRAM) room door, along with the radome hatch door key (#5), had been separated from key #1.

^a Rotation and removal disables transmitter radiation and antenna movement.

^b Attached to key #1. Unlocks waveguide switch, rotation of handle physically blocks transmitter radiation and exposes key #3.

^e Removal of key #4 turns out maintenance lights and sounds klaxon horn in radome for 30 seconds.

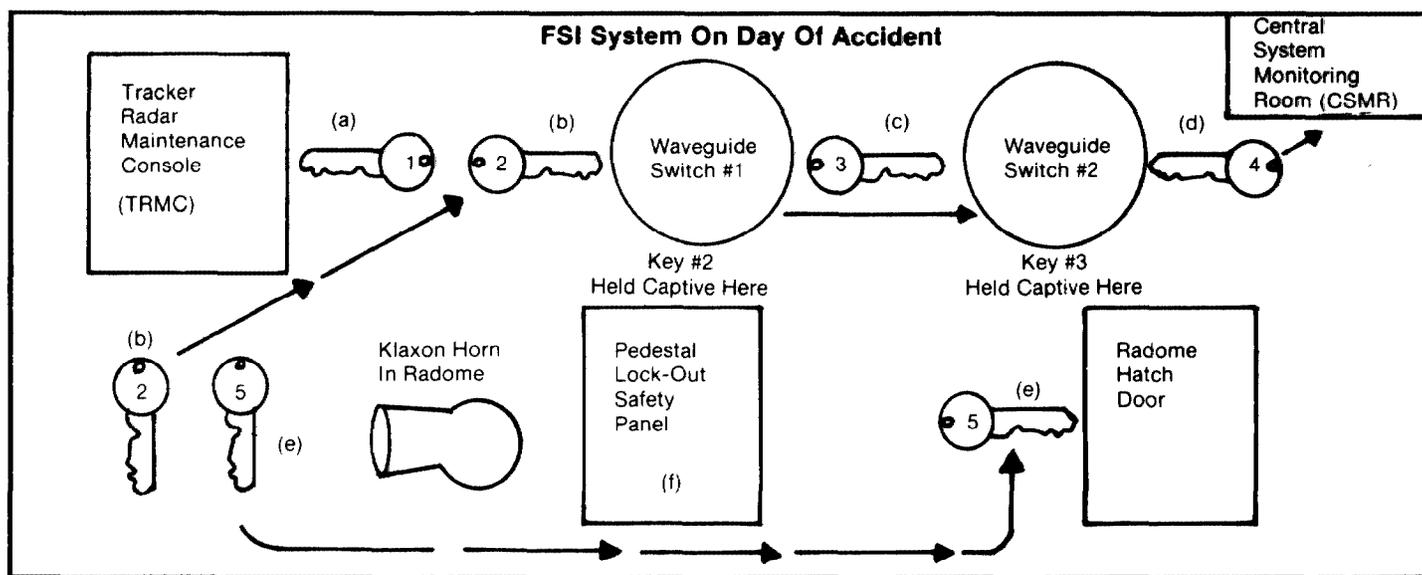
^a FSI procedures did not consider this key as a part of the safety interlock system. It had been separated from key #2 and remained in the console.

^b Hangs on wall in Tracker Radar Automatic Monitoring (TRAM) room until needed to open waveguide switch #1. See (b) on page 20.
