Report to the Chairman, Subcommittee on National Parks, Historic Preservation, and Recreation, Committee on Energy and Natural Resources, U.S. Senate

August 1998

NATIONAL PARK SERVICE

The Condition of Lodging Facilities Varies Among Selected Parks

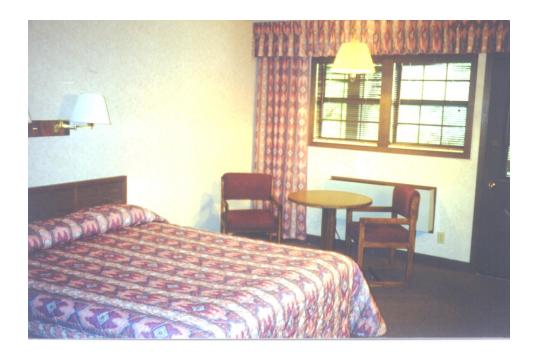
Figure II.2: Motel Room in Very Good Condition at Bryce Canyon National Park

There were no repair and maintenance problems in any of the rooms we inspected. Figure II.2 shows the condition of a typical motel room at Bryce Canyon National Park.

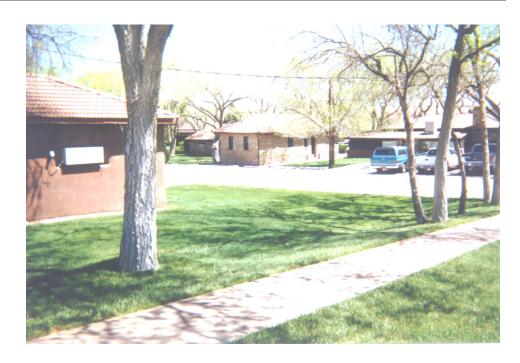
Figure II.3: Well-Maintained Lodge Buildings and Grounds at Canyon de Chelly National Monument

The structures at Thunderbird Lodge consist of a motel office, a cafeteria, a gift shop, and seven lodging buildings. These buildings were generally very clean and in good repair. We did note some minor paint chipping around the exterior of some room windows and minor stains/marks where water had run down exterior walls. Figure II.3 shows the landscaping and some of the lodging structures at Thunderbird Lodge.

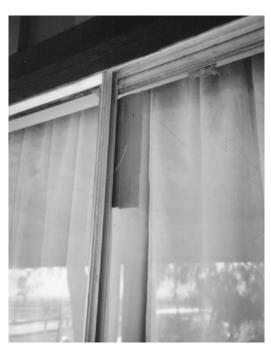
Figure II.4: Needed Exterior Repairs at a Lodging Structure at Stovepipe Wells in Death Valley National Park

Some of the lodging structures at Stovepipe Wells need work. For example, at least two of the facilities needed exterior paint. In addition, some of the sidewalks were cracked and sunk and needed to be repaired or replaced. At one facility, the front doors on two rooms had about a 1-inch gap between the bottom of the door and the doorsill. Furthermore, as illustrated by figure II.4, the exteriors of several other rooms needed to be repaired as evidenced by a broken window temporarily repaired by duct tape and a broken back door handle and screen in another room.

Broken handle and screen on back door

An NPS representative who oversees the concessioner operations at Stovepipe Wells as a collateral duty and a representative of the concessioner agreed that the exterior of these facilities needed repairs. They noted that the damaged sidewalks were scheduled for replacement this summer and that the 10-room facility, which included the room with the broken window, was scheduled for a major \$200,000 renovation. Subsequently, the NPS representative informed us that the renovation of these rooms is under way and should be completed by mid-July. The NPS representative also noted that other needed repairs would be made to the facility's exteriors as soon as money was available and that discussions with the concessioner on these issues would take place this winter season.

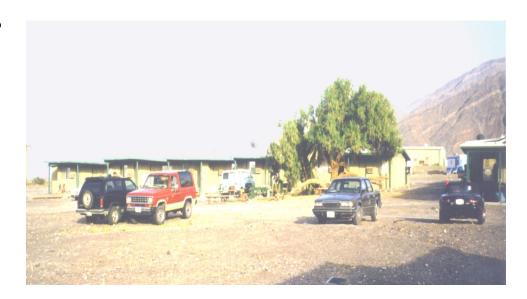
Figure II.5: View of Employee Housing at Stovepipe Wells From the Rear Patio of Guest Rooms

shown in figure II.5, a barrier is needed to block the view of employee housing from guest rooms. According to the NPS representative, an aesthetic barrier between the visitor and employee facilities is planned.

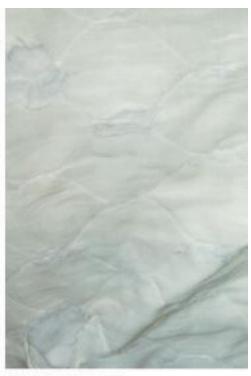
Figure II.6: Repair and Maintenance Problems in Rooms Located at Stovepipe Wells

Corroded drinking water facility and damaged wall

Plastic bag holding broken shower facility

Holes in bedspread

The NPS and concessioner representatives agreed that all four of these rooms need to be renovated. However, they noted that the concessioner was also having difficulty hiring and retaining an adequate number of quality maintenance personnel, given the location of the park. In addition, the NPS representative stated that it is not easy to get parts to make repairs in a timely manner, given the distance of the park to a community with needed supplies. For example, Las Vegas—the nearest large city—is over 125 miles away.

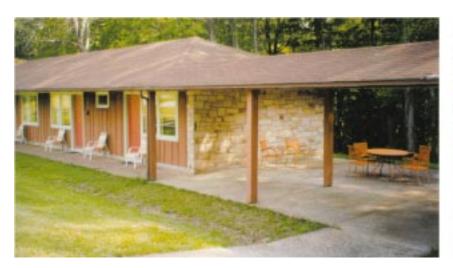
Figure II.7: Needed Exterior Repairs at Mammoth Cave Lodge

The exterior of the hotel was generally in good repair; however, the hotel lobby's furnishings were old, and some were torn and stained. The exterior of the lodge, shown in figure II.7, needs to have the roof repaired, and the wooden overhang of the roof had peeling paint that needs to be repaired. In addition, much of the paint on the roof's walkway at the lodge was mildewed. The concessioner agreed that these problems needed to be fixed and stated that the repairs would be made this summer. Subsequently, an NPS representative told us that the contract to repaint Sunset Point Lodge has been awarded and that the roof is scheduled for replacement this year. We found that the cabins recently had an extensive rehabilitation of the electrical and plumbing systems. However, we also noted that some of the hotel cottages' storm windows were left half open and that debris had collected between the storm windows and regular windows.

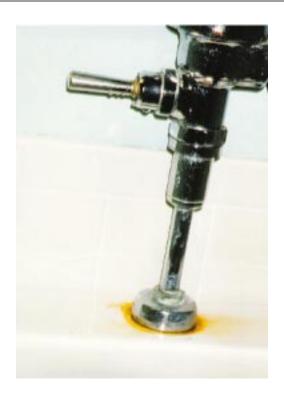
Figure II.8: Leaking and Stained Urinal in Public Rest Room at Shenandoah National Park

The registration building at the lodge had no public rest room, but there were two rest rooms in the adjoining restaurant for use by the public. The upstairs rest room was clean and well maintained. However, the downstairs rest room needed repairs. Specifically, we found rust on the porcelain of one urinal, which appeared to be caused by a valve that had been leaking for a long period of time. (See fig. II.8.) Furthermore, the sink counter was poorly maintained as evidenced by grout problems and numerous stains and burns. The concessioner told us that these problems would be fixed. The NPS concessions management specialist noted that these rest-room deficiencies had just been identified on the latest NPS inspection report and that the concessioner had been given a correction date for this project. The official stated that under NPS standards, deficiencies identified during a periodic evaluation are generally to be corrected within 15 days of the inspection. This period can be reduced or extended, depending on the type of deficiency and its impact on visitors and/or employees and the resource. NPS officials noted that this process agrees with industry standards for corrective action.

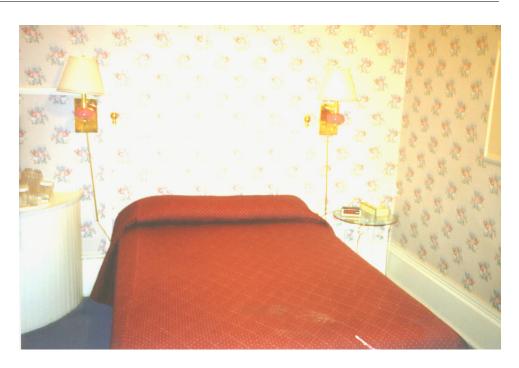
Figure II.10: Typical Room in Good Condition at the Wawona Hotel

housekeeping, and the repair and maintenance of these facilities. Specifically, we inspected 12 rooms in Yosemite Lodge, 10 rooms in Curry Village, and 10 rooms at the Wawona Hotel. As illustrated in figure II.10, the overall condition of the rooms at Yosemite was good. We found a few safety and security concerns in Curry Village and Yosemite Lodge but none at the Wawona Hotel. Some furnishings required by industry's standards, such as a television and air conditioner in every room, were not available because the park's policy states that such items are not needed. However, most of the rooms at Curry Village did not have additional furnishings, such as a telephone, ice bucket, alarm clock/radio, notepads, and pen/pencils, available to guests. The quality of housekeeping varied among the lodges; Yosemite Lodge had the most problems. We found very few room repair and maintenance problems at any of the lodging facilities that we inspected.

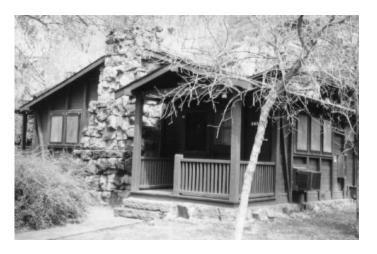
Figure II.11: Well-Maintained Cabins and Motel at Zion National Park

As shown in figure II.11, the exterior of the cabins and motel was in very good condition. All the facilities were painted this year. The lodge and motel were clean and in good repair. The cabins had just been remodeled and were in excellent condition.

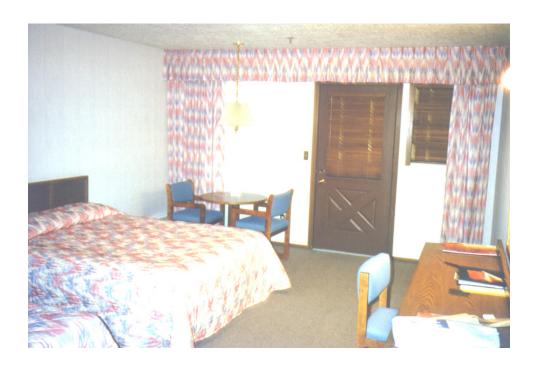
Figure II.12: Typical Motel Room in Very Good Condition at Zion National Park

We found only one maintenance problem in the 10 rooms that we inspected; one room had a sagging mattress. The NPS concessioner specialist noted that this mattress was scheduled to be replaced this year.
