# BORDER INFRASTRUCTURE

## Actions Needed to Improve Information on Facilities and Capital Planning at Land Border Crossings

Highlights of [GAO-19-534](#), a report to congressional requesters

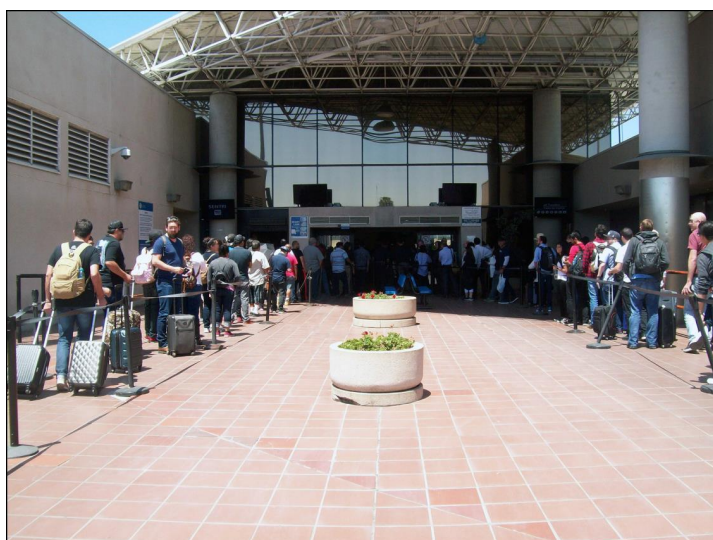
**Figure 1: Examples of Preprimary Inspection Infrastructure at U.S. Land Border Crossings**

Pedestrian travelers queue in preprimary prior to entering the main building at the Otay Mesa land border crossing in San Diego, California.

traffic by directing travelers to different lanes according to the type of travel documents they have. For example, CBP may use signs to designate specific lanes for travelers with Radio Frequency Identification (RFID) or other machine readable documents (“Ready lanes”) or for trusted travelers.<sup>10</sup> Infrastructure in the pedestrian preprimary area often includes a space for travelers to queue prior to entering primary inspection. Infrastructure in the preprimary area for passenger vehicle and commercial traffic includes lanes for traffic to queue and radiation portal monitors that are designed to detect radiation and help prevent the smuggling of nuclear material into the United States.<sup>11</sup> The passenger vehicle preprimary area also often includes screening technologies, including license plate readers and RFID readers to capture information on vehicles and RFID-ready travel documents such as passport cards and border crossing cards.<sup>12</sup> At some land border crossings, CBP may use RFID readers in the commercial preprimary inspection area to electronically transmit identification, manifest, and other information to CBP officers prior to entering primary inspection. See figure 1 for examples of preprimary infrastructure.

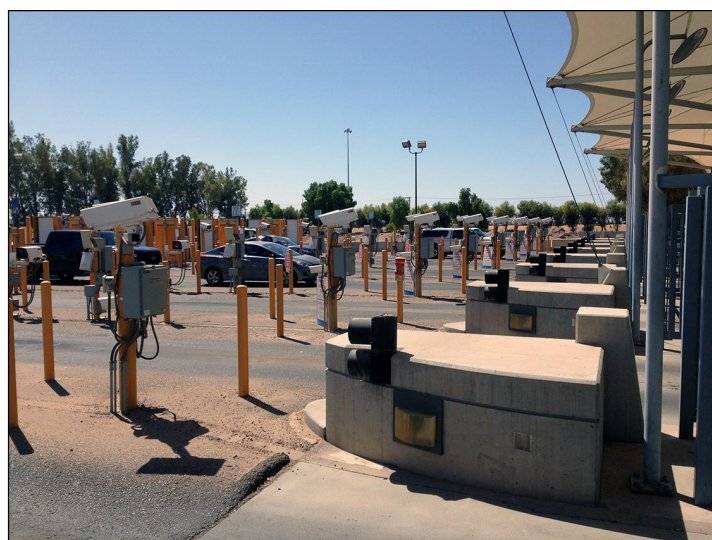
Technologies, including radiation portal monitors and license plate readers, scan inbound vehicles in the preprimary area at the Calexico East land border crossing in Calexico, California.

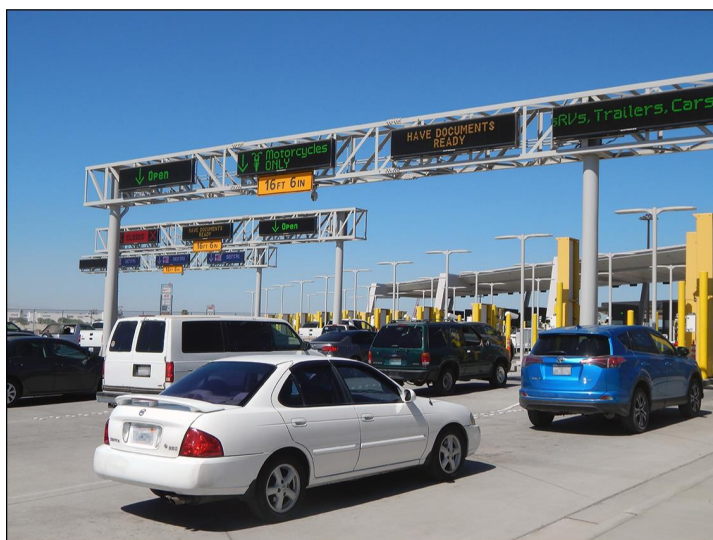
Vehicles queue in preprimary at the Calexico West land border crossing in Calexico, California. Overhead signs indicate which lanes are reserved for travelers enrolled in one of U.S. Customs and Border Protection's trusted traveler programs and which are for the general traveling public.<sup>a</sup>

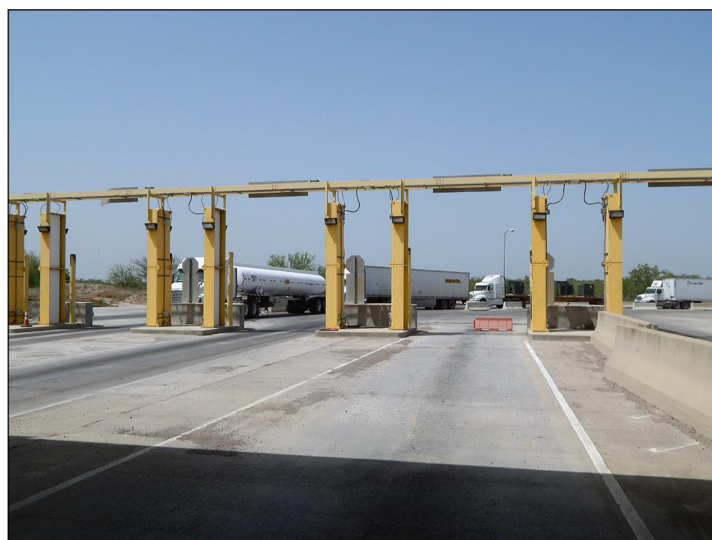
Commercial trucks queue in the preprimary inspection area equipped with radiation portal monitors prior to entering the Colombia Solidarity Bridge land border crossing in Laredo, Texas.

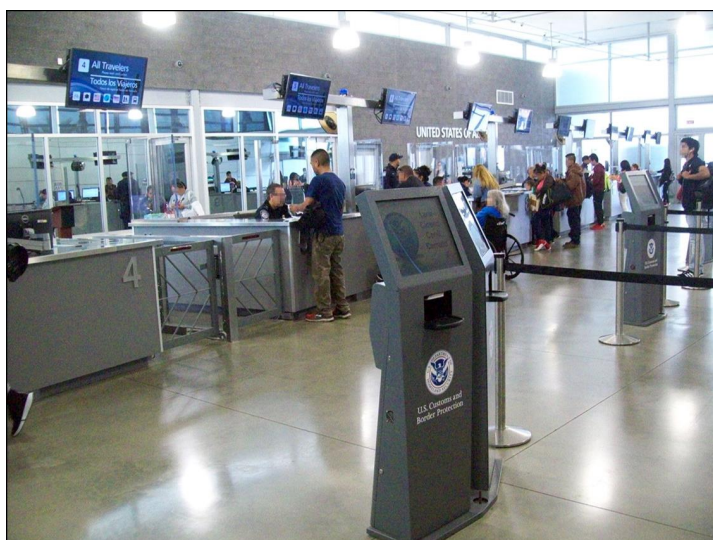
**Figure 2: Examples of Primary Inspection Infrastructure at U.S. Land Border Crossings**

Pedestrians undergo primary inspection at the pedestrian processing facility at the San Ysidro land border crossing in San Diego, California.

Infrastructure for pedestrian primary inspection may include one or more lanes and officer booths where CBP officers review traveler information. Passenger vehicles and commercial traffic enter a primary inspection area where CBP officers verify passenger identification and perform an initial inspection of the vehicle, which may include a visual inspection of vehicles' exterior and interior. Infrastructure supporting vehicular primary inspection includes one or more lanes and officer booths. Each booth may be equipped with an HVAC system to keep dangerous vehicle emissions and other fumes from entering the workspace and maintain a safe work environment during extreme heat and cold. Primary inspection booths are designed to be bullet and blast resistant to ensure officer safety. See figure 2 for examples of primary inspection infrastructure.

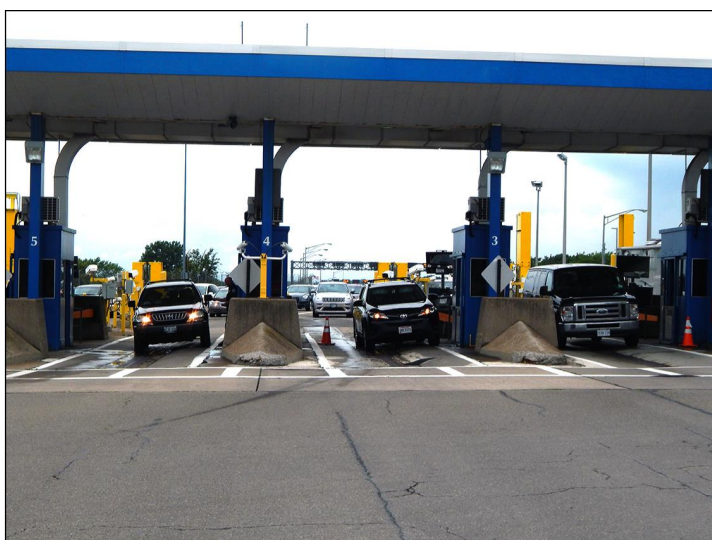
Passenger vehicles undergo primary inspection at the Lewiston-Queenston Bridge in Lewiston, New York.

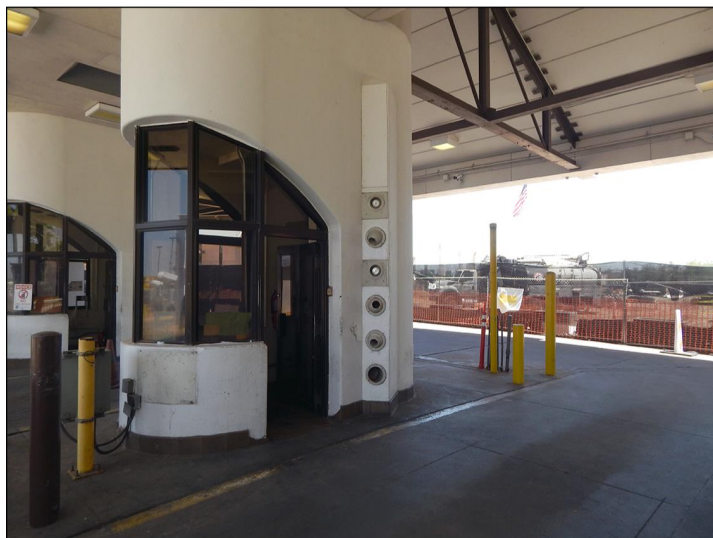
CBP officer booth in the passenger vehicle primary inspection area at the Lincoln-Juarez Bridge land border crossing in Laredo, Texas.

- **Officer inspection booths in the primary inspection area in need of repair.** CBP officers stated that officer inspection booths may be inadequately cooled or heated resulting in officers more frequently rotating out of the booths for health and safety reasons. At one land border crossing, officers stated that the booth windows provide limited visibility since the old bullet resistant glazing has deteriorated and clouds officers' view. At another land border crossing we visited, we observed that the doors on the primary inspection booths do not have working locks. Officers stated that as a result, when the land border crossing closes overnight they are unable to secure the booths or the computer equipment inside.

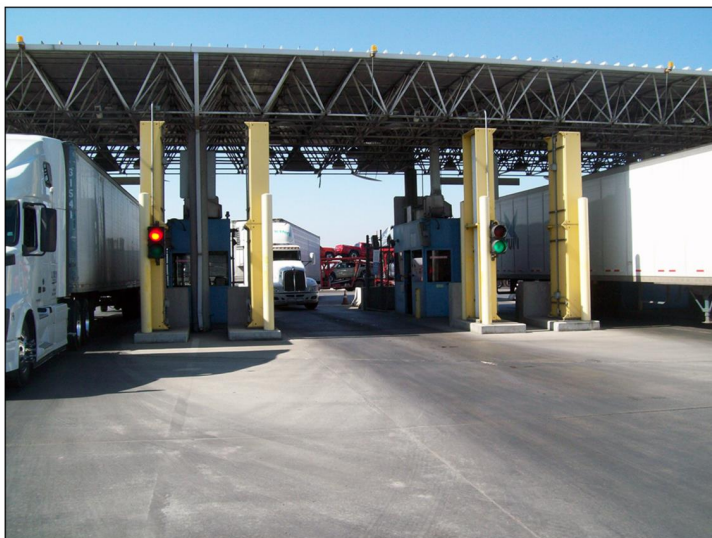
Commercial trucks undergo primary inspection at the Otay Mesa land border crossing in San Diego, California.

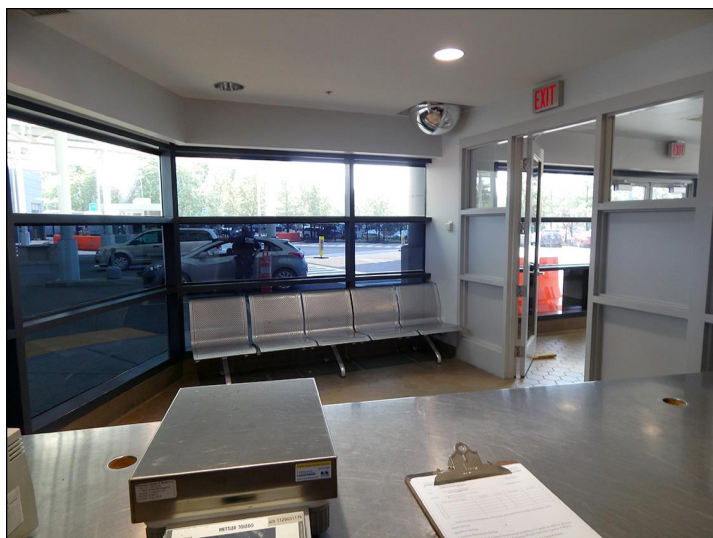
**Figure 3: Examples of Secondary Inspection Infrastructure at U.S. Land Border Crossings**

Secondary inspection area at the Rainbow Bridge land border crossing in Niagara Falls, New York.

to secondary inspection.<sup>13</sup> Infrastructure in the pedestrian secondary inspection area is typically located within the main building and may include a processing area and a separate secure room where CBP officers can perform more thorough inspections for travelers suspected of criminal activity. Infrastructure in the passenger vehicle secondary inspection area may include work areas where CBP officers can search vehicles, vehicle lifts, and non-intrusive inspection x-ray technologies to identify contraband hidden in concealed compartments. Passengers may wait in the pedestrian secondary inspection area while CBP officers inspect vehicles. Infrastructure in the commercial secondary inspection area may include a loading dock where CBP officers can manually examine cargo and use x-ray technologies to identify hidden contraband. In addition, CBP uses canines at some land border crossings to conduct secondary inspections in the pedestrian, passenger, and commercial environments. See figure 3 for examples of secondary inspection infrastructure.

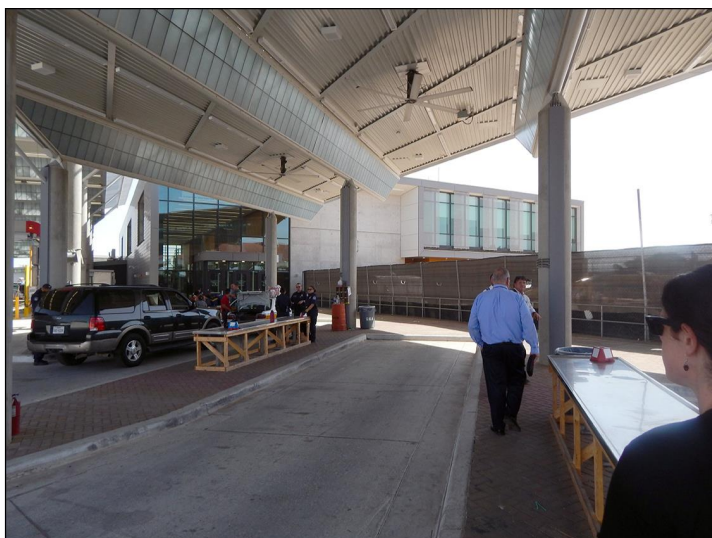
Passenger vehicle secondary inspection area at the Lincoln-Juarez Bridge land border crossing in Laredo, Texas.

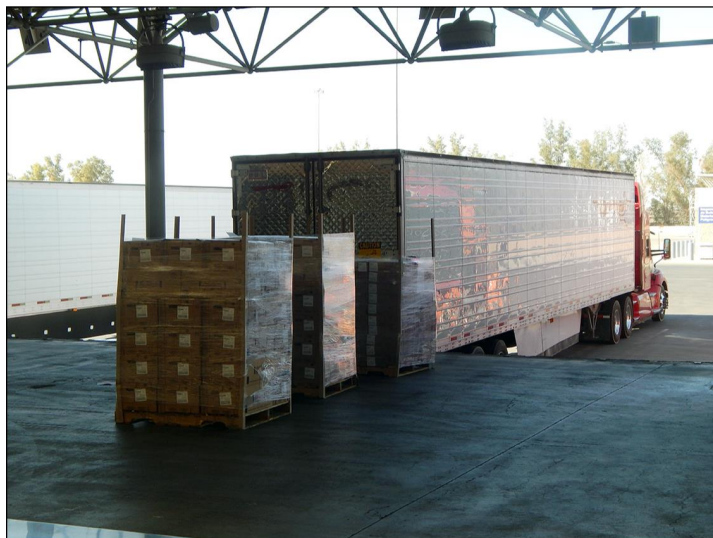
Commercial truck parked at the secondary inspection dock at the Calexico East land border crossing in Calexico, California. CBP officers may offload and inspect contents for contraband.

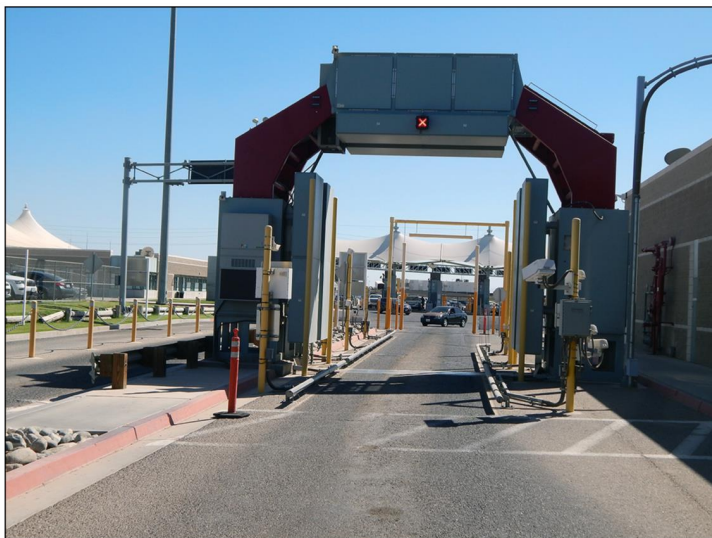
Non-intrusive inspection x-ray technology used to scan vehicles for concealed contraband at the Calexico East land border crossing in Calexico, California.

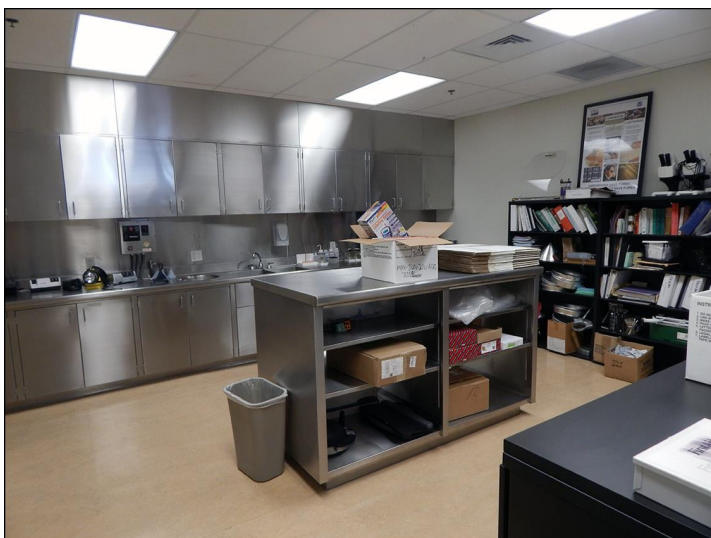
**Figure 4: Examples of Main Building Infrastructure at U.S. Land Border Crossings**

Agricultural lab at the San Luis II land border crossing in San Luis, Arizona.

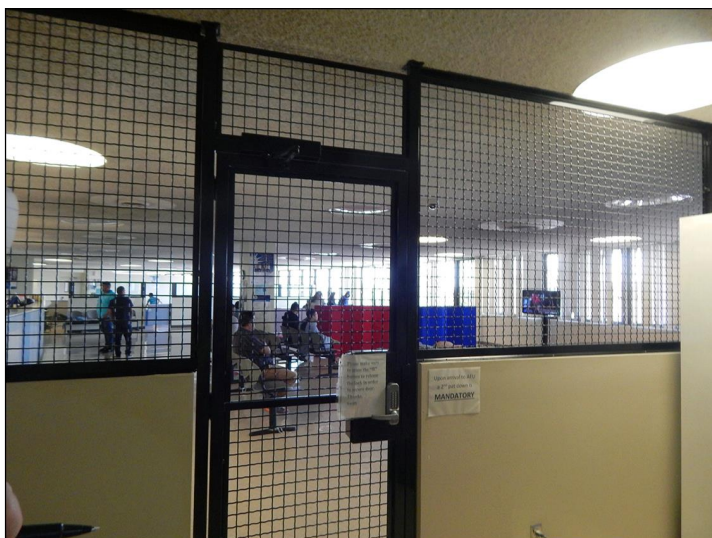
Holding area at the Calexico West land border crossing in Calexico, California.

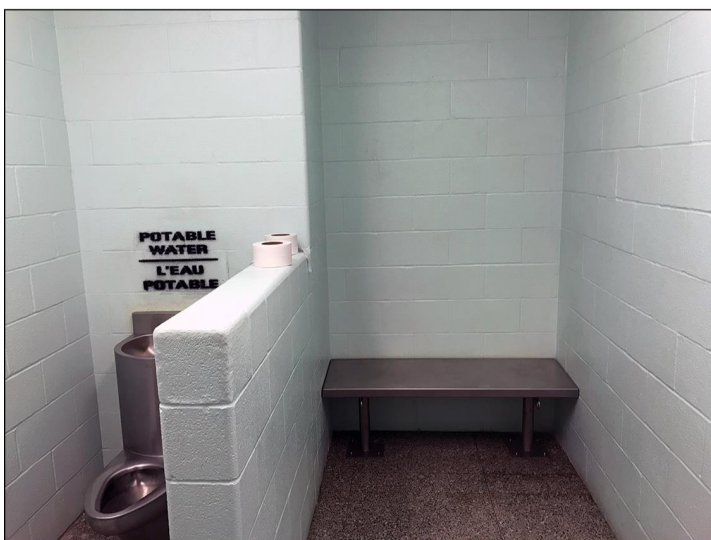
Holding room at the Peace Bridge land border crossing in Buffalo, New York.

- **Inadequate holding facilities in the secondary inspection area.** Holding facilities at several land border crossings we visited had holding rooms that did not meet current CBP safety requirements, according to CBP officers. Officers at two land border crossings stated that safety concerns included inadequate ventilation. Officers at another land border crossing identified exposed wiring in a holding

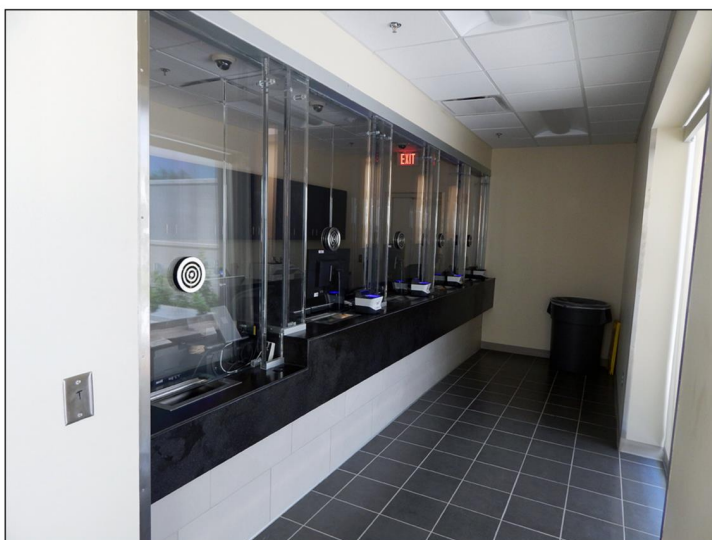
Traveler processing area at the Convent Street Bridge in land border crossing in Laredo, Texas.

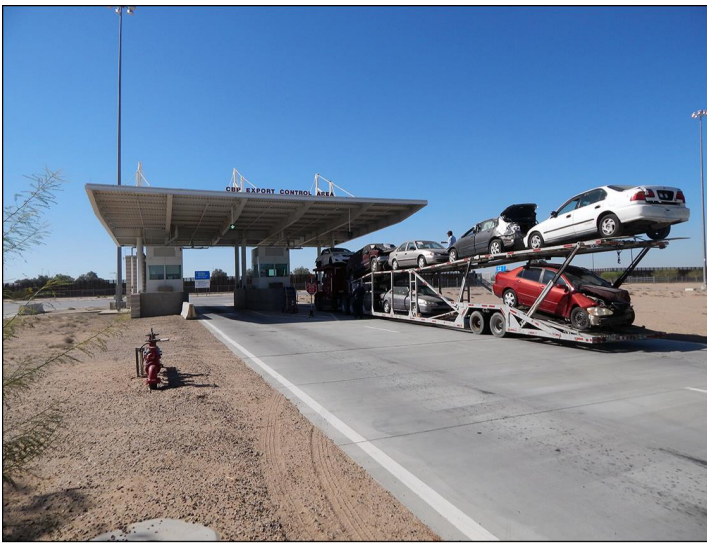
**Figure 5: Examples of Outbound Infrastructure at U.S. Land Border Crossings**

Outbound cargo inspection booth at the San Luis II land border crossing in San Luis, Arizona.

infrastructure in the passenger vehicle, bus, commercial, and pedestrian area typically consists of one or more exit lanes and may also include inspection booths, inspection technologies, a secondary inspection area and support facilities, among others, to process traffic leaving the United States. See figure 5 for examples of outbound infrastructure.

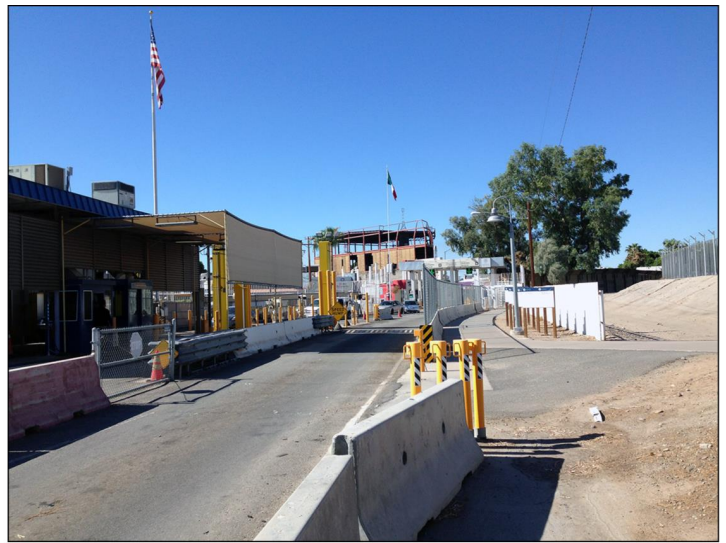
Outbound passenger vehicle and pedestrian lanes at the Andrade land border crossing in Andrade, California.

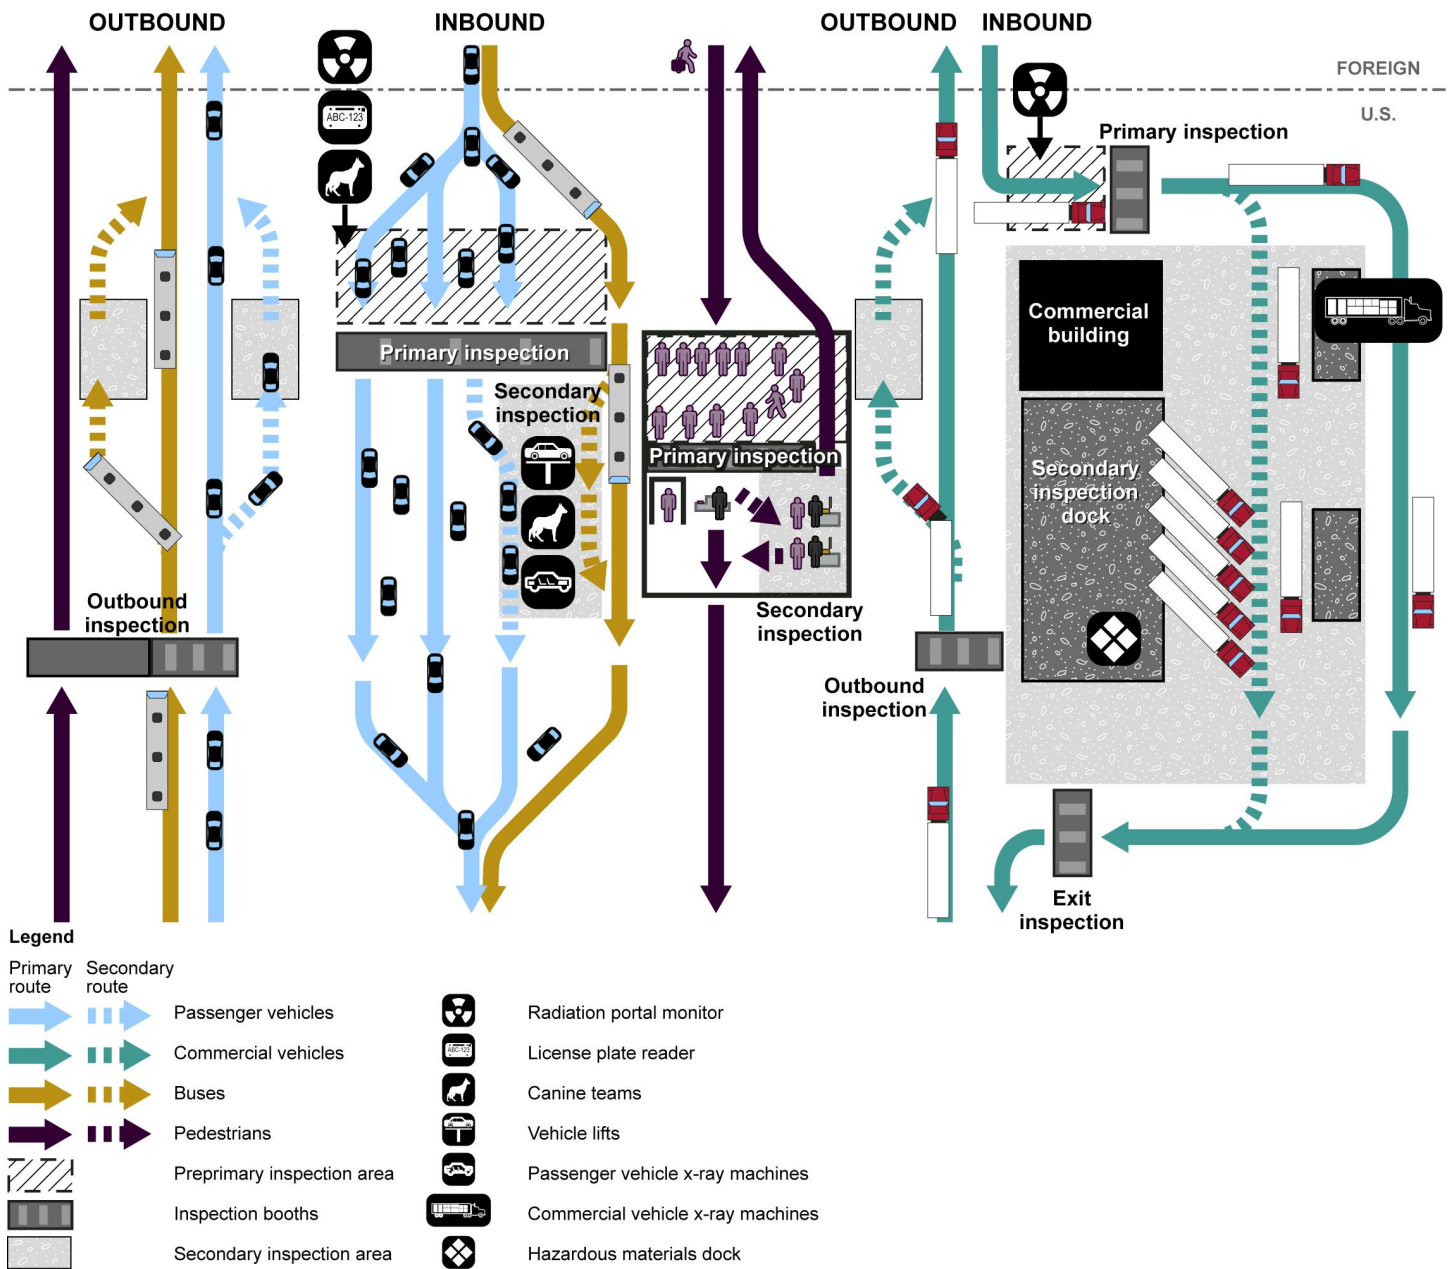
Figure 6: General Layout of a Land Border Crossing

Figure 6 depicts a generic layout of a land border crossing with all modes of traffic.

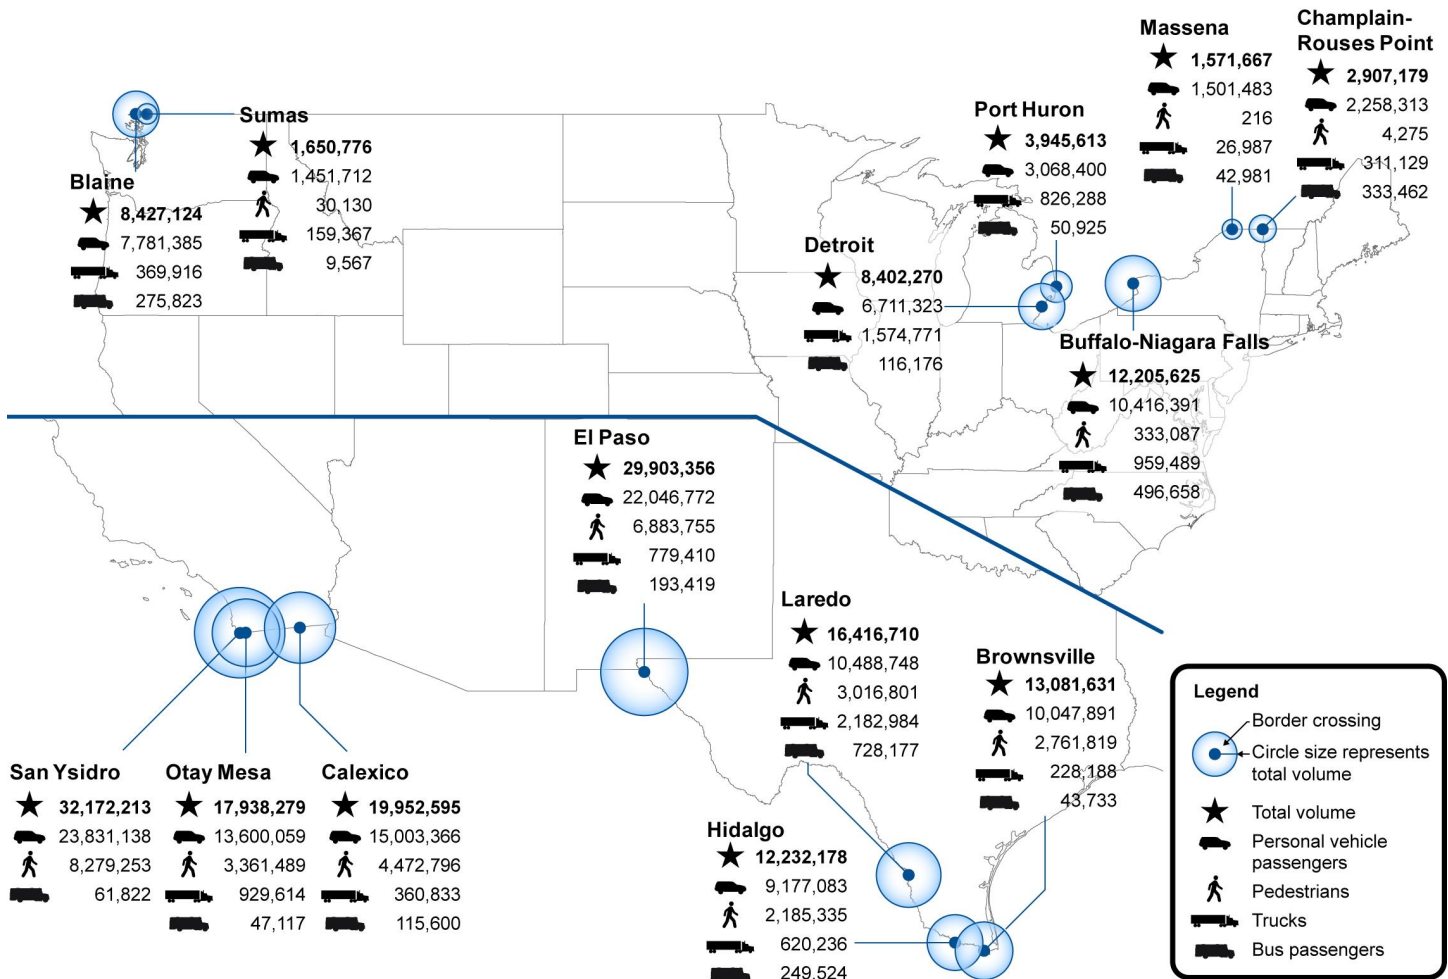
Figure 7: Largest Northern and Southern Land Ports of Entry by Volume of Entries into the United States in 2017

Note: U.S. Customs and Border Protection and the Bureau of Transportation Statistics compile crossing data at ports of entry, which may include one or more land border crossings. The Bureau of Transportation Statistics does not report the number of passengers in U.S.-bound commercial trucks. Therefore, "Trucks" represent the number of commercial trucks entering through a U.S. land port of entry.

**Travel:** The volume of traffic at land border crossings varies across the northern and southern borders. At the nation's busiest land border crossing—San Ysidro in California—CBP processed over 32 million entries in 2017. Conversely, at the Whitlash land border crossing in Montana—one of the smaller land border crossings—CBP processed 1,339 entries that same year. In total, CBP processed over 252 million entries in 2017 including 43 million pedestrian entries, 209 million passengers traveling to the United States in over 104 million passenger vehicle entries, 256,000 buses, and nearly 12 million commercial truck crossings.<sup>14</sup> Figure 7 shows the largest northern and southern border U.S. land ports of entry by volume in 2017.

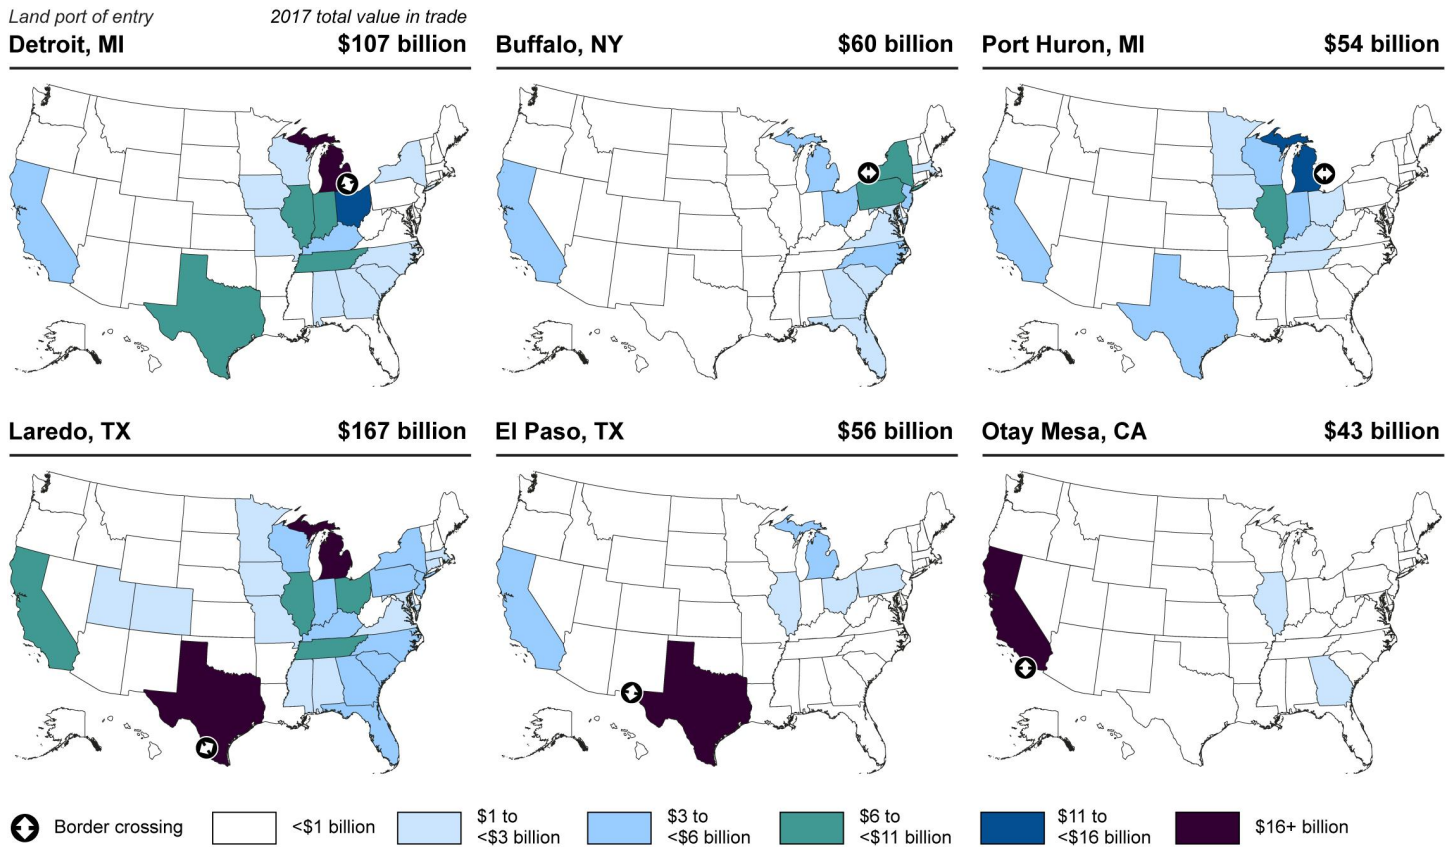
**Figure 8: Distribution of Trade in Goods across U.S. States Facilitated by the Largest Northern and Southern Land Ports of Entry by Total Value of Trade in 2017**

Note: The dollar values identify the total nominal value of trade in goods transported by commercial trucks through land ports of entry. A land port of entry may consist of one or more land border

**Trade:** In 2017, CBP processed and inspected nearly \$721 billion in traded goods (imports and exports) through U.S. land ports of entry.<sup>15</sup> As shown in figure 8, trade in goods transported via commercial truck through the largest northern and southern border land ports of entry impacted states across the country.

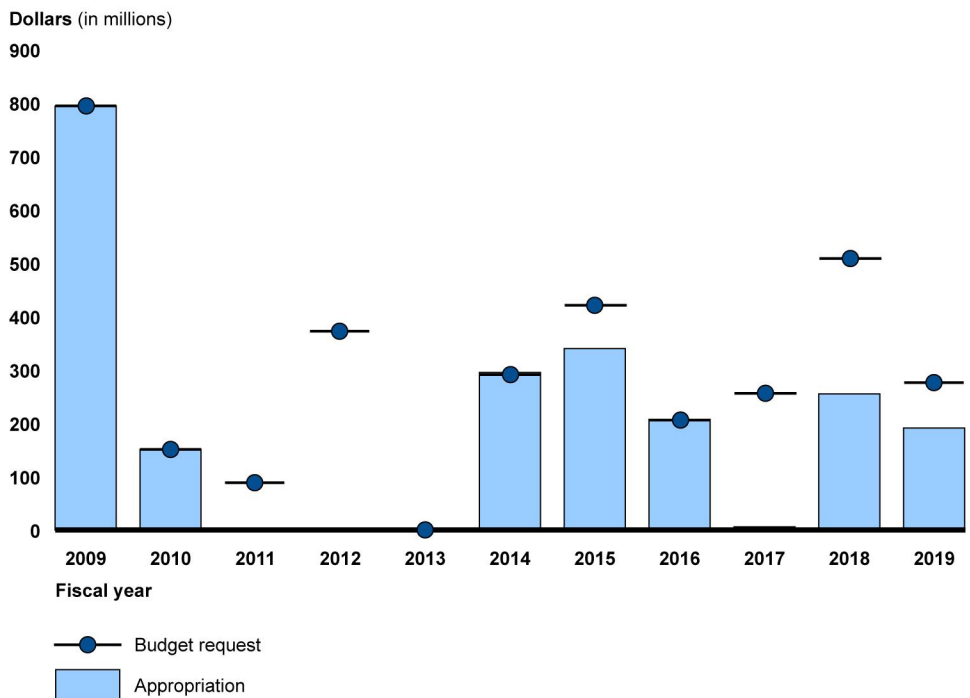
**Figure 9: Budget Requests and Appropriations for Land Border Crossing Capital Projects in Fiscal Years 2009 through 2019**

Note: Appropriations include appropriated funds, as reported by U.S. Customs and Border Protection (CBP), for fiscal years 2009 through 2019, for the General Services Administration's (GSA) Federal Buildings Fund, and for GSA and CBP through the American Recovery and Reinvestment Act of 2009 (Pub. L. No. 111-5, 123 Stat. 115), as well as reprogrammed funds and project transfers. CBP reported not receiving funds for land border crossing capital projects in fiscal years 2011 and 2012. CBP reported that GSA and CBP did not request or receive funds for any land border crossing capital projects in fiscal year 2013. Appropriation totals for each year are in nominal dollars.

Figure 9 identifies funding for CBP and GSA-owned land border crossings in fiscal years 2009 through 2019.

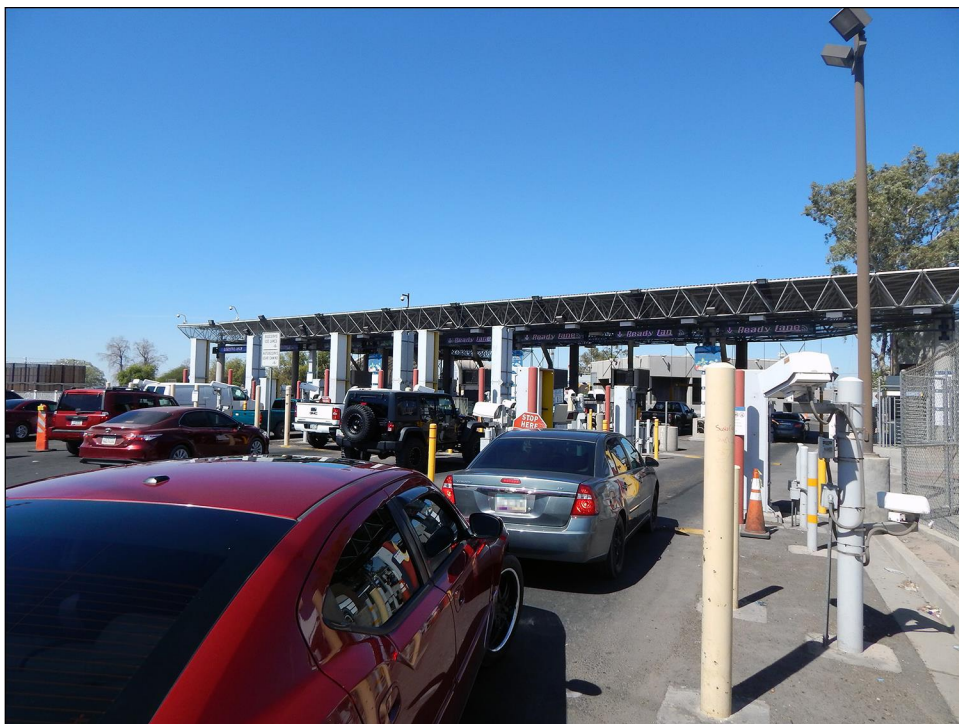
**Figure 10: Example of a U.S. Land Border Crossing With Limited Space in the Preprimary Area**

Photo of the primary inspection area at a land border crossing on the southern border taken from the international border line showing limited space in the preprimary area—approximately two car lengths.

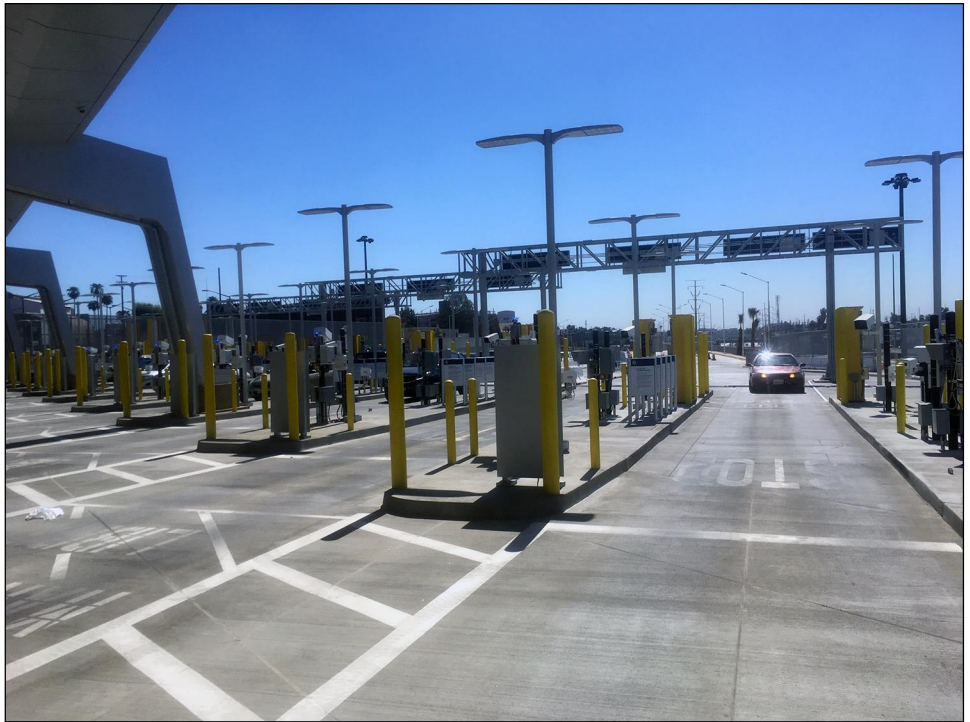
**Figure 11: License Plate Readers and Radiation Portal Monitors on the Southern Border**

Technology in the preprimary area that CBP officers identified as experiencing periods of inoperability due to high temperatures and exposure to sunlight.

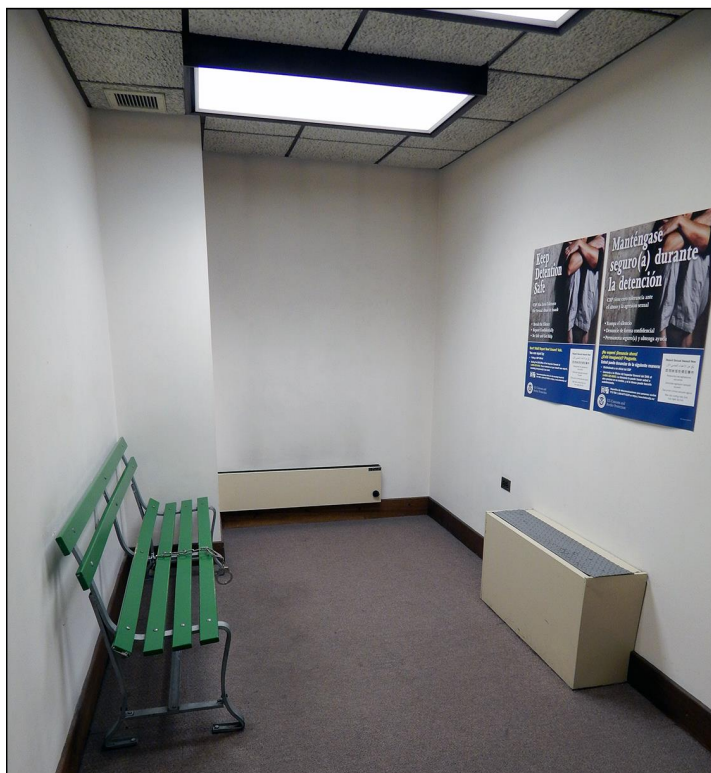
**Figure 12: Examples of Holding Facility Constraints at U.S. Land Border Crossings**

Park bench bolted to the floor with attached handcuffs located in the waiting area at a land border crossing on the northern border that CBP uses in place of a holding room.

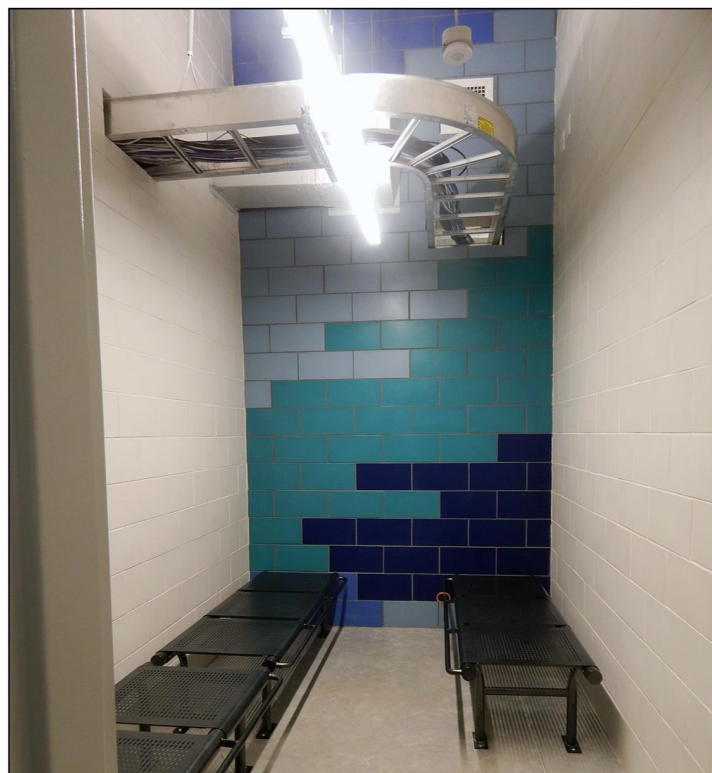
CBP officers identified that exposed cabling accessible to detainees as seen in this photo is a safety hazard at a land border crossing on the southern border.

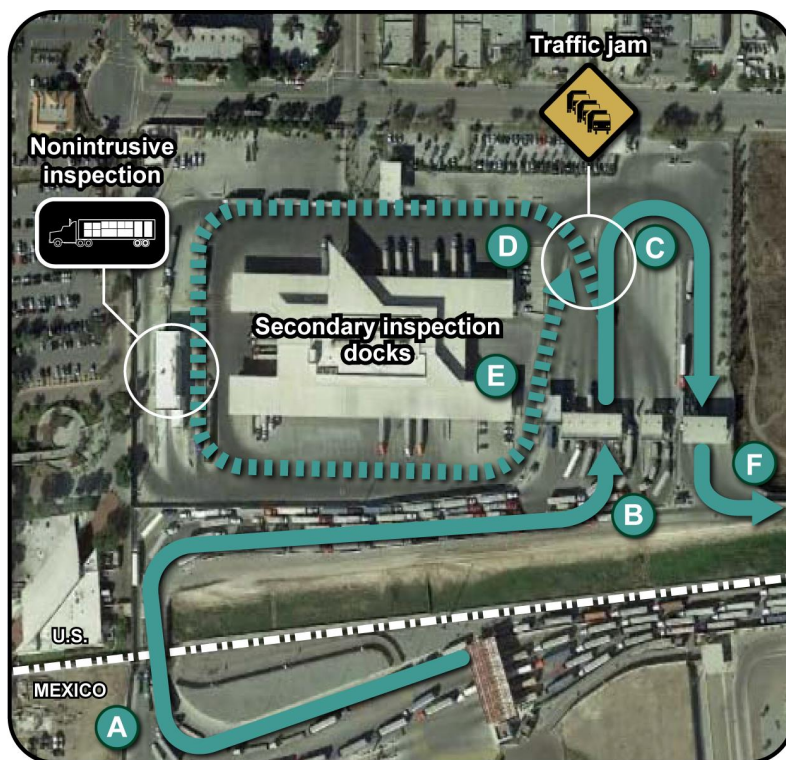
- A** Inbound commercial trucks from Mexico make a 180 degree turn as they enter the United States.
- B** Commercial trucks make a 90 degree turn to enter primary inspection.
- C** Commercial trucks not referred to secondary take a second 180 degree turn after primary inspection to the exit lanes/booths where officers verify they are cleared to enter the United States.
- D** Trucks referred to secondary inspection make a 90 degree turn toward the non-intrusive inspection technology and inspection docks in the secondary inspection area.
- E** After secondary inspection, trucks re-join the queue and make a 180 degree turn to proceed toward exit booths.
- F** After passing through the exit booths, trucks make a final 90 degree turn to exit the facility.

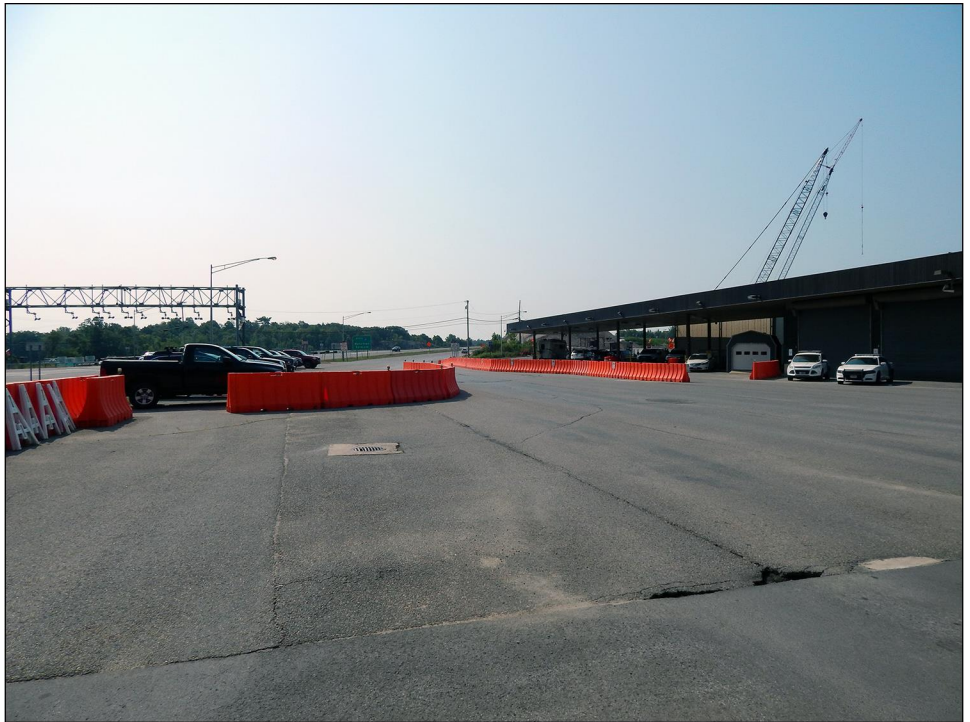
**Figure 15: Constructed Exit Lanes to Control Traffic Leaving the Land Border Crossing**

According to officers at a land border crossing on the northern border, the land border crossing lacks measures to prevent vehicles from speeding through the crossing without authorization. This photo shows exit lanes constructed with temporary barriers to control the flow of traffic as it leaves the land border crossing.

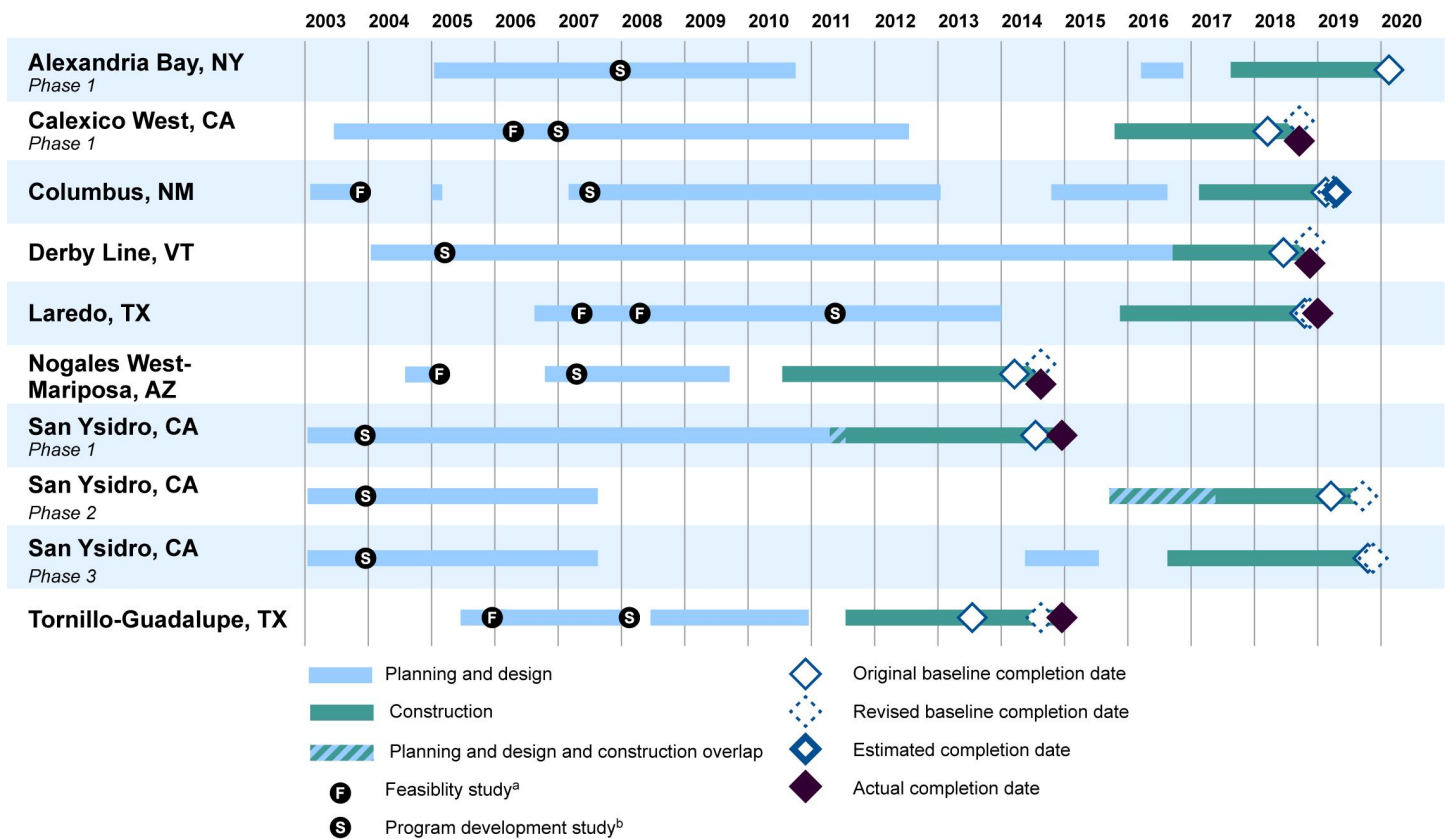
**Figure 16: General Services Administration (GSA) Land Border Crossing Project Development Timelines as of January 2019**

<sup>a</sup>GSA conducts feasibility studies at U.S. Customs and Border Protection's (CBP) request to determine the technical and economic viability of a project, identify what infrastructure improvements may be necessary, and determine the project's estimated cost.

the potential for funding lags to occur.<sup>46</sup> According to CBP and GSA officials, the process from requesting an infrastructure project to completing the project lasts approximately 7 years. However, GSA experienced funding lags of up to 10 years between design and construction. Figure 16 identifies development timelines from initial planning through construction for our 10 selected land border crossing capital projects.
