August 1995

MIDWEST FLOOD

Information on the Performance, Effects, and Control of Levees

GAO/RCED-95-125

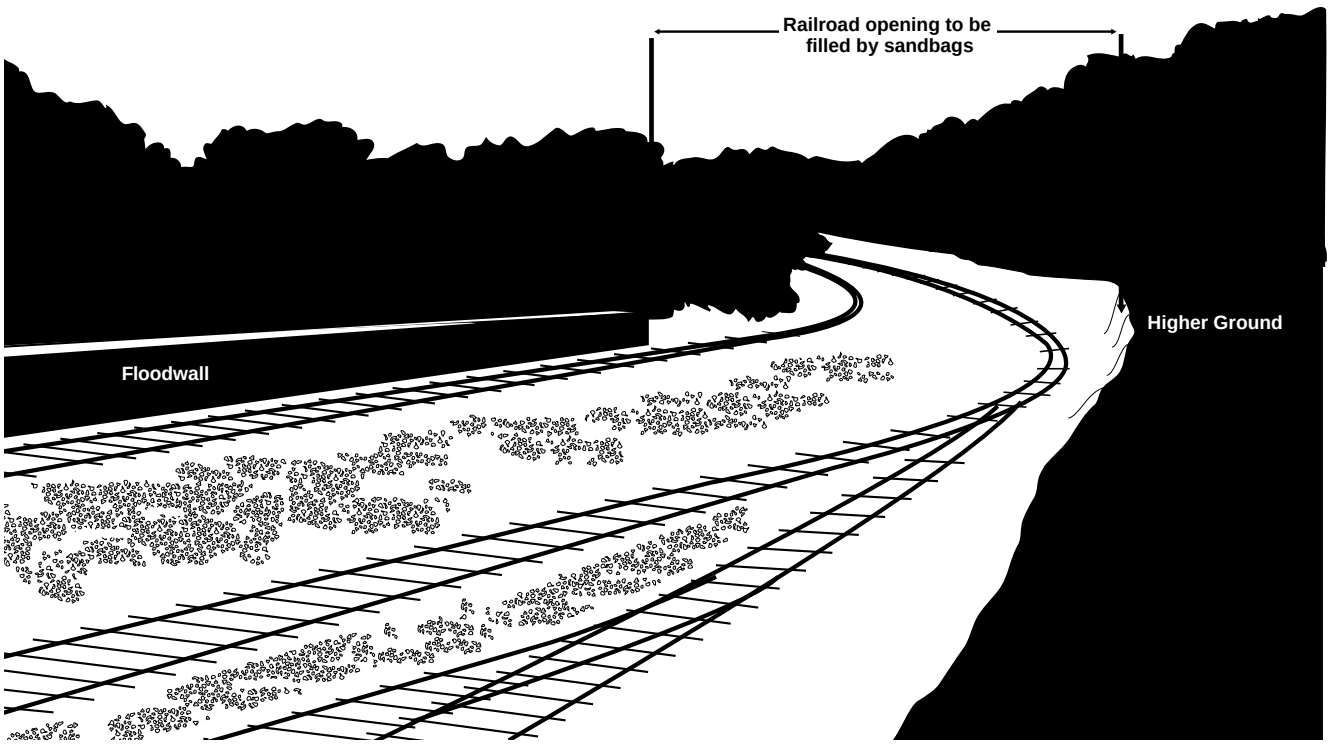
Figure V.3: Railroad Opening at the City of Des Moines, Iowa, Local Flood Protection Project Along the Raccoon River

According to Corps district staff, the breach in the third levee, Missouri River Levee Unit L-550, was caused by the use in the construction of the levee of a material that allowed underseepage. Corps staff told us that the fourth levee failed to prevent flooding because a railroad opening in the floodwall protecting the city of Des Moines was not closed in time. Each of these situations is described in appendix V.

at the railroad track opening after the 1993 flood to permit the more efficient closure of the levee.
