United States General Accounting Office

BORDER PATROL

Procurement of MD 600N Helicopters Should Be Reassessed

GAO/GGD-00-201

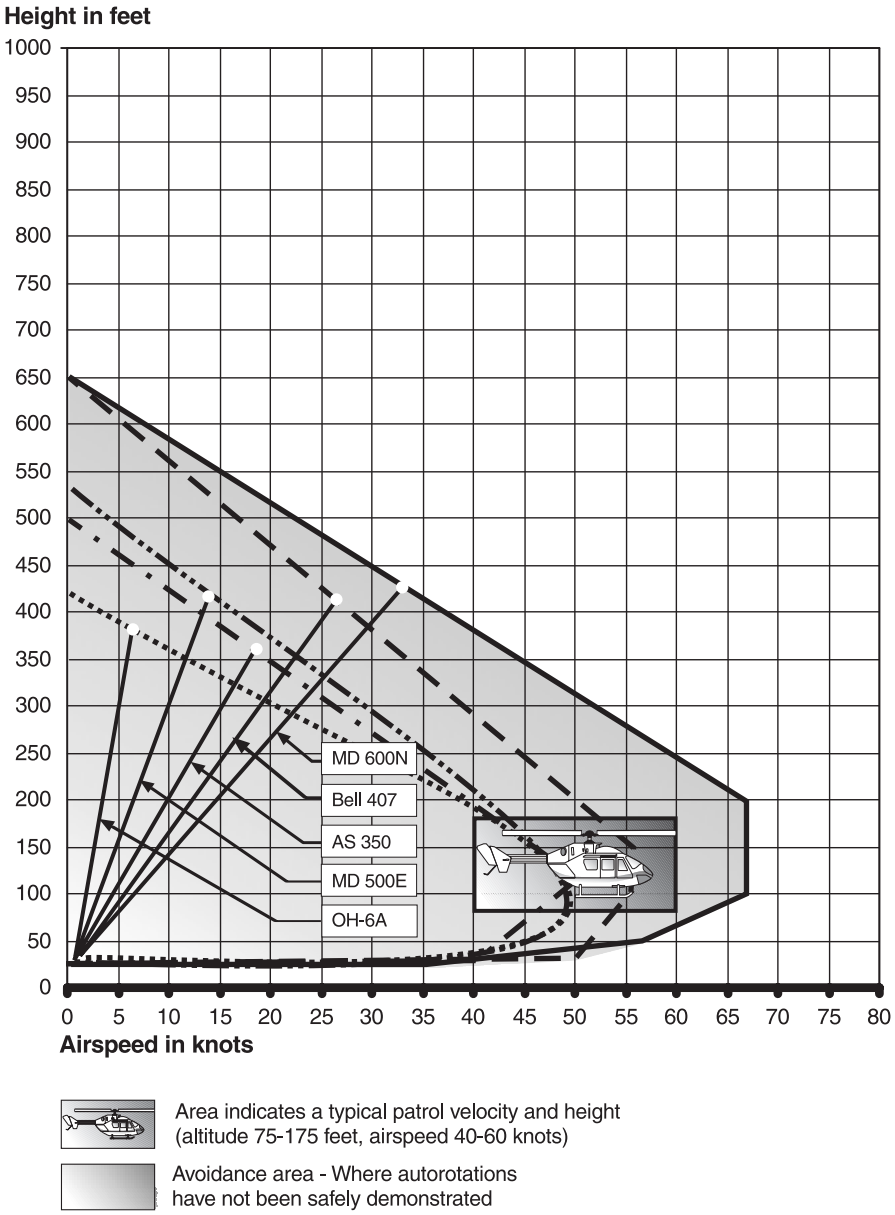
Figure 3: Height/Velocity Curves for MD 500E, MD 600N, Bell 407, American Eurocopter AS 350, and Hughes OH-6A

Most of the pilots we interviewed agreed that a significant amount of their sectors' work involved flying at low speeds and altitudes performing patrol missions and that the MD 600N was not conducive to that type of flying. To effectively accomplish their mission, the pilots in one sector explained that they must fly low and slow to detect and apprehend illegal aliens hiding in canyons, bushes, and trees. These maneuvers cannot be performed as effectively and safely in the MD 600N, according to these pilots, because the MD 600N should be flown higher and faster than other aircraft to avoid the FAA-certified altitude and speed combinations (avoidance area). This area is where recovery from an engine failure might not be successful. All aircraft have an area of avoidance; however, the area is larger for the MD 600N than for the OH-6A and MD 500E helicopters (see fig. 3).

MDH officials stated that the pilots based their concerns on a misunderstanding of the height/velocity curve rather than on the helicopter's operational characteristics. According to MDH, the MD 600N's height/velocity curve appears to cover more area because of more stringent testing conditions used for establishing the curve.[9] However, we examined the height/velocity curves for several helicopters that were tested at or estimated for sea level. The MD 600N height/velocity curve had a larger area to avoid (see fig. 3). A senior FAA certification official said that this is a valid means for showing how different aircraft height/velocity curves relate to the height and airspeed of a typical Border Patrol mission.

[9] The MD 600N was certified under part 27 of the Federal Aviation Regulations (14 C.F.R. p. 27). An MDH official stated FAR 27 requires testing to be done at 7,000 feet, while the MD 500E model was tested under an earlier regulation, that allows testing to be done at sea level, where more of the helicopter's weight is supported by denser air.

Regarding safety, most of INS' comments related to a comparison of the height-velocity curves of the MD 600N and those of other aircraft (see fig. 3). INS stated that the figure portrays the MD 600N as less safe because of its larger height-velocity avoidance area (the combination of altitude and airspeed where an autorotative landing might not be safely made). Our portrayal was meant to show where a typical mission falls in relation to the avoidance areas of the different aircraft. According to INS' Air Operations Manual, operations in this area should be avoided or limited to the minimal amount necessary to complete operational maneuvers. Figure 3 shows that a typical patrol mission falls entirely within the MD 600N's avoidance area, but only partially within this area for the other aircraft. This is a valid means for comparison, according to a senior FAA official, as is noted in our report.

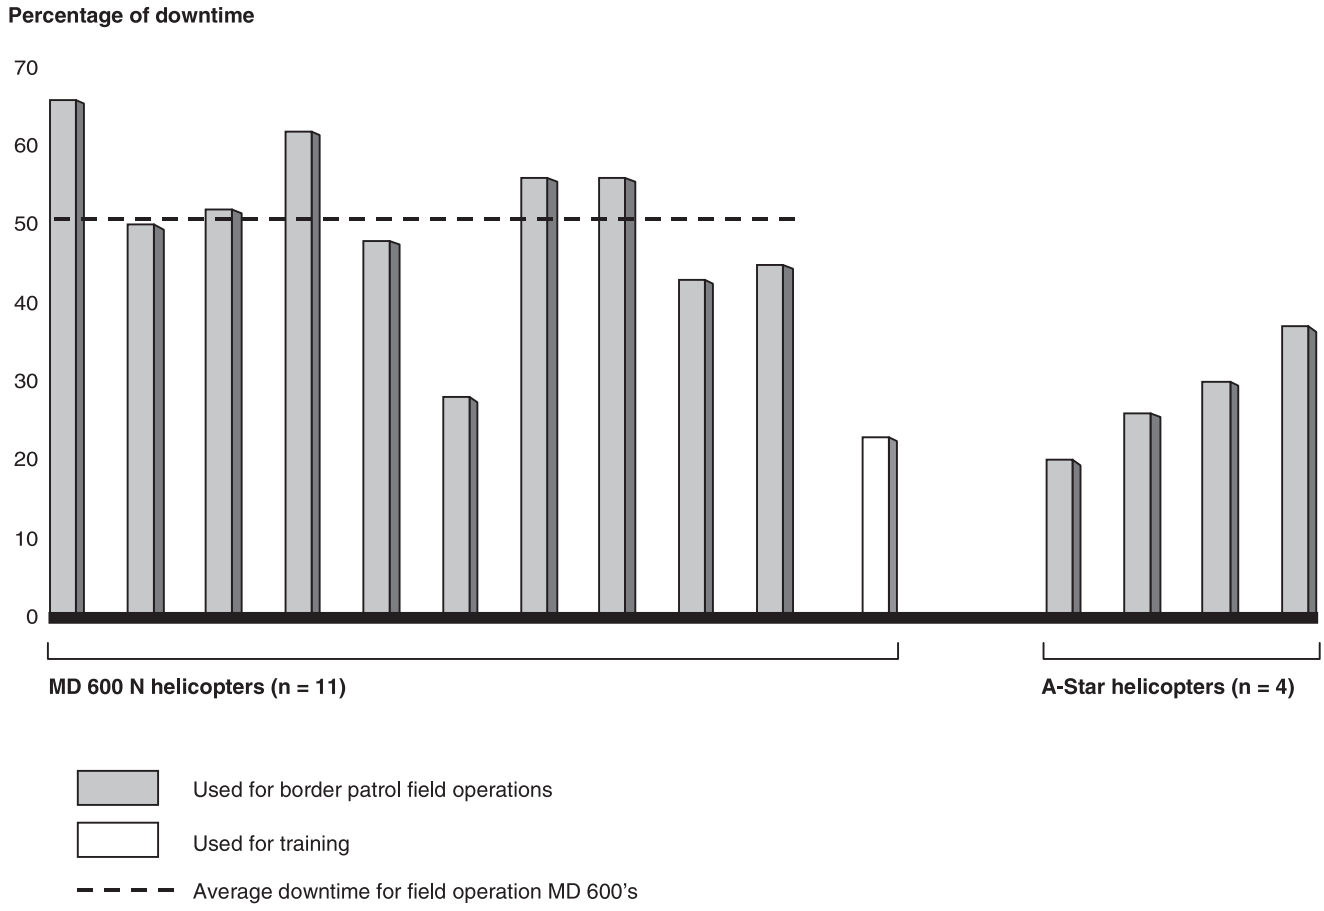
Figure 5: Downtime for Border Patrol 600N Helicopters

[18] The eleventh Border Patrol MD 600N is assigned to Air Operations and is used mainly as a training vehicle by instructor pilots. It does not fly sector missions on a regular basis and has flown fewer hours than the field helicopters. It was unavailable about 25 percent of the time.

The consequences of the MD 600N helicopters not being available were greater in sectors without other helicopters in their inventory. For example, during our visits to two sectors, all six of the MD 600Ns were unavailable. One of the sectors had OH-6A helicopters for backup, but the other sector's single backup OH-6A was awaiting an engine, leaving the sector without any helicopters. The patrol agent in charge said that with no working helicopters, ground agents' requests for assistance could not be supported, including an incident where an agent was being fired on by armed drug smugglers.

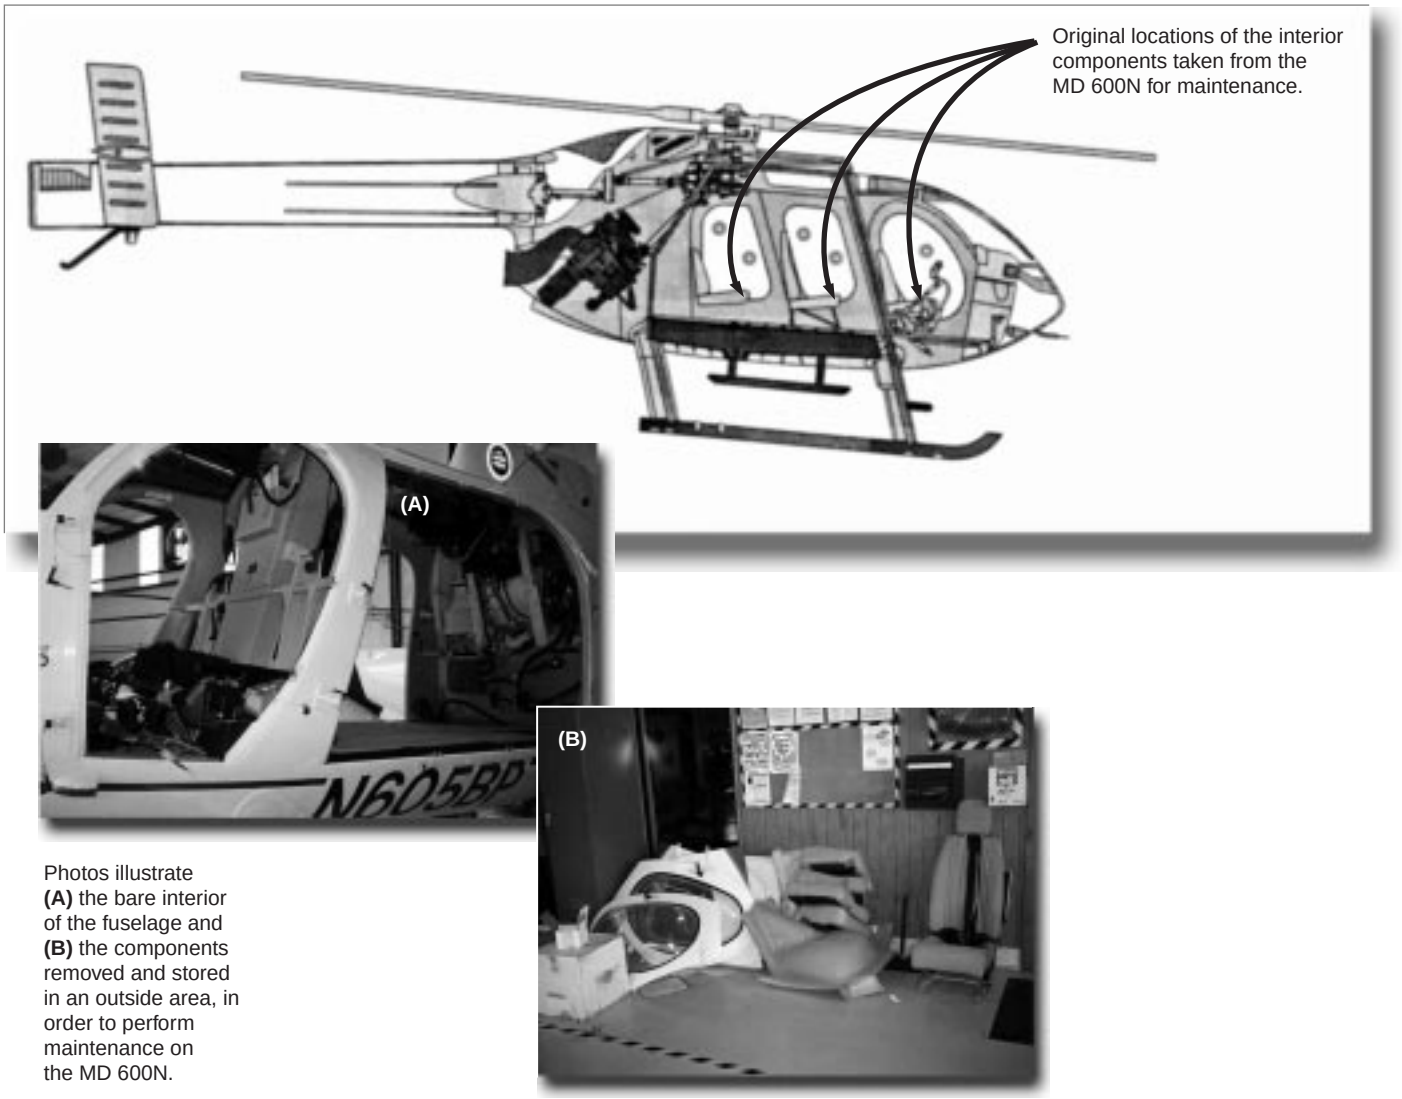
Figure 6: Aircraft Repairs Often Require Interior to Be Removed

Finally, mechanics in two sectors said that the design of the helicopter makes working on it time consuming because many repairs require that the aircraft be taken apart. One mechanic stated, for example, that often carpet must be pulled up, seats removed, and the interior vinyl removed in order for mechanics to access the aircraft's parts for a 100-hour inspection. Helicopters by other manufacturers, such as Bell, have their transmissions and drive trains located externally and would not need to have the interiors removed for a routine inspection, he said. The interiors have also experienced unusually high levels of wear and tear because of the need to remove them, one mechanic said.

Photos illustrate **(A)** the bare interior of the fuselage and **(B)** the components removed and stored in an outside area, in order to perform maintenance on the MD 600N.
