# Problems In Constructing Segments Of Interstate Route 71 In Ohio B-118653

Federal Highway Administration  
Department of Transportation

BY THE COMPTROLLER GENERAL  
OF THE UNITED STATES

MARCH 16, 1972

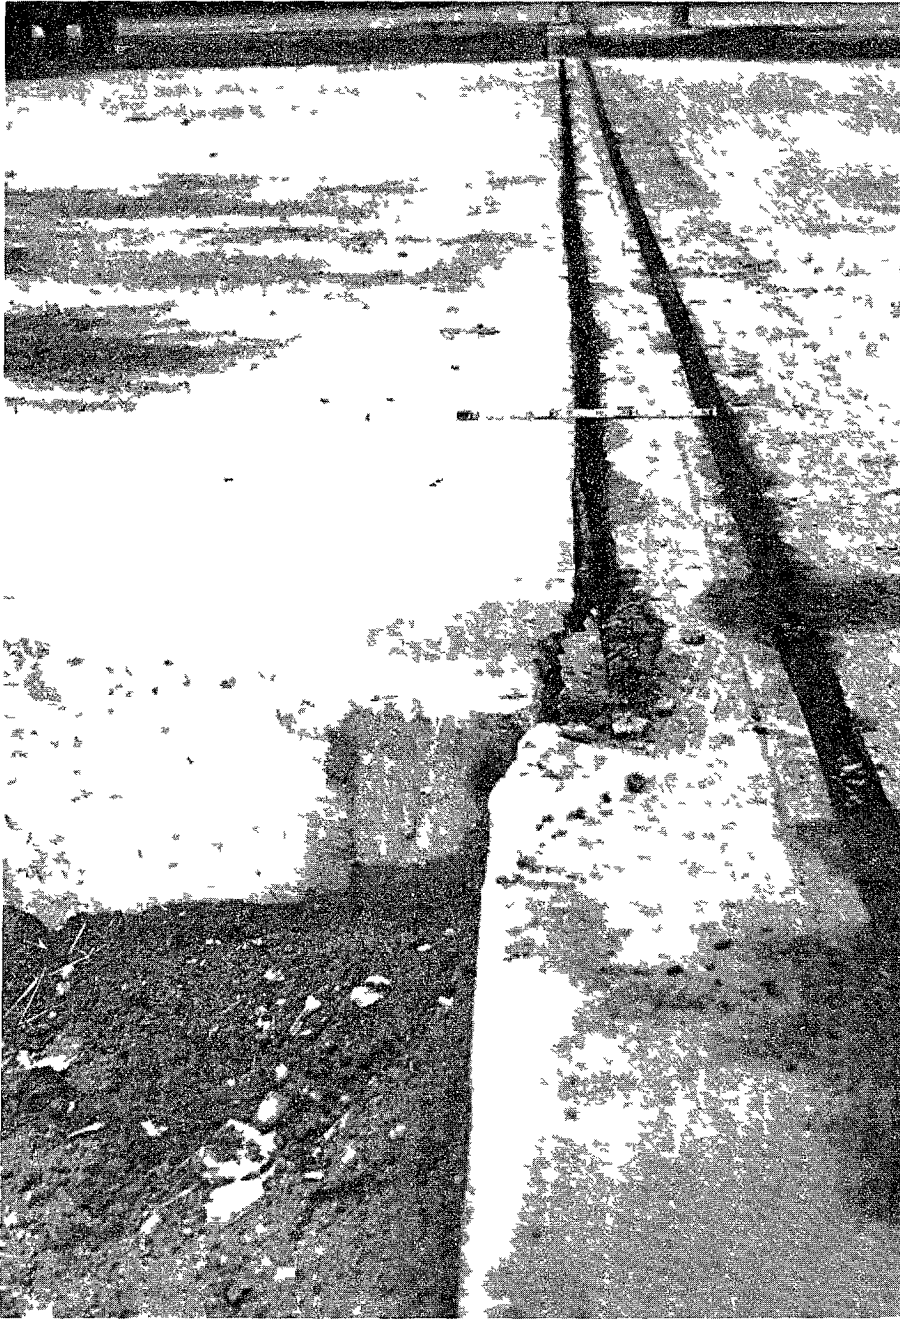
As of July 1971 the roadway had settled about 2 feet and was continuing to settle. State officials informed us, however, that they believed that the roadway was structurally sound. They also said that the State was not monitoring the continuing settlement or its effects on the bridge abutment. Continuing maintenance to achieve an acceptable, rideable surface does not appear to be a satisfactory solution. Also the roadway has at times represented a traffic hazard. We noted that on one occasion the Cleveland Police Department had attributed the cause of an accident to the defective road.

**Separation of roadway and bridge abutment**
