CED-77-66

Poor Design Reviews And
Construction Inspections Of
Apartment Project In Rhode Island

Department of Housing and Urban Development

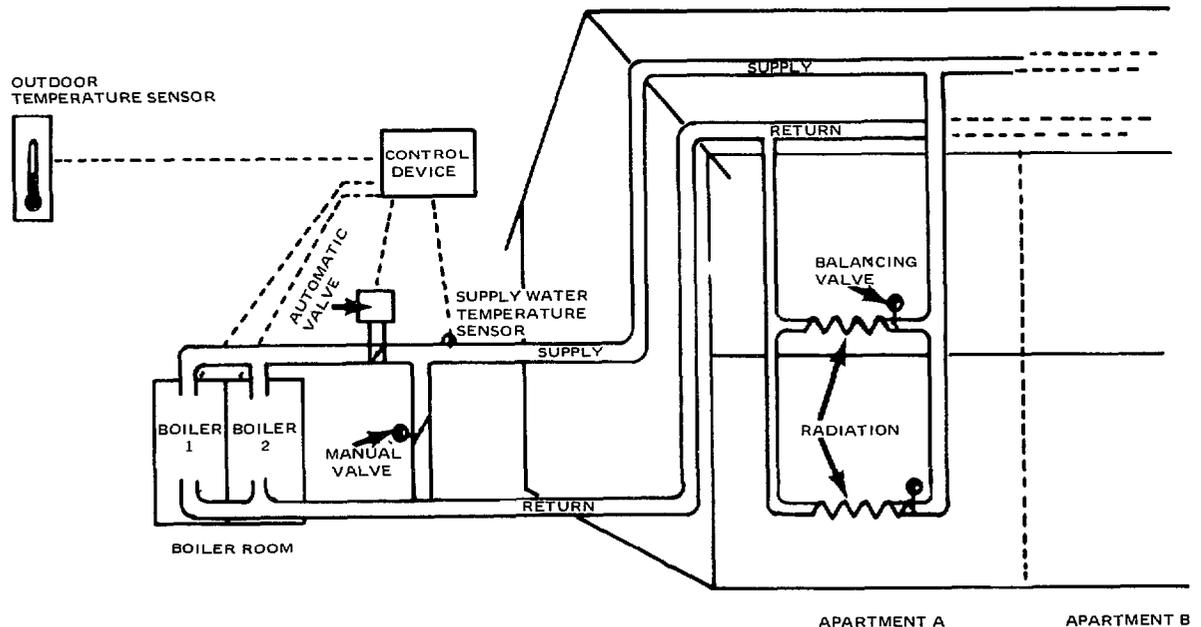
The design for the heating system provides for balancing the hot water flows to apartments by adjusting the valves on individual radiation units. Once balanced and set, the central controls would vary the quantity and temperatures of hot water recycled through the systems. Tenants cannot control the temperature, except by adjusting flaps over the radiation housings that can be closed to reduce the flow of air over the radiation elements.

The central controls include sensors to measure outdoor temperatures and heating supply water temperatures. A circulator pump sends heated water to apartments whenever outside temperatures drop below a set point. Controls activate boilers as needed to attain appropriate supply water temperatures. An automatic valve stops the flow of water from the boilers when a desired water temperature is reached.

Diagram illustrates the project's heating system controls. (Piping loops to apartment have been simplified for illustration.)
