**Actions Needed To Increase
The Safety Of Dams Built By
The Bureau Of Reclamation And
The Corps Of Engineers**

CED-77-85

JUNE 3, 1977

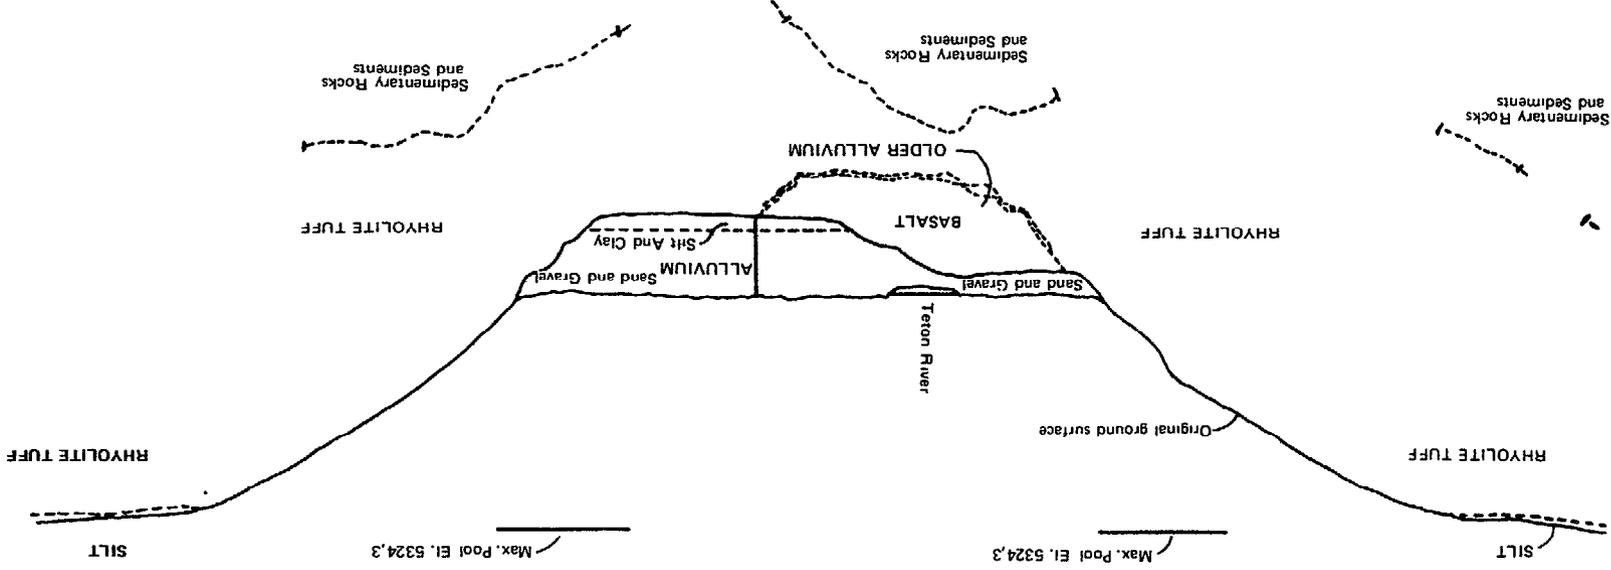
TETON DAMSITE
SIMPLIFIED GEOLOGIC CROSS SECTION ALONG DAM AXIS
(VIEW DOWNSTREAM)

During excavation of the foundation, large openings or fissures in the rock were found in both the left and right abutments. One opening, for example, was explored by a Bureau employee for a distance of about 100 feet both downstream and upstream of the dam's axis. He described the cavity on the downstream side as being about 4 feet wide. He said further exploration was blocked by a large rock. He said a room or passage could be seen beyond but that the opening into it was too small to enter. The Independent Panel concluded that these cavities increase the permeability of the foundation.

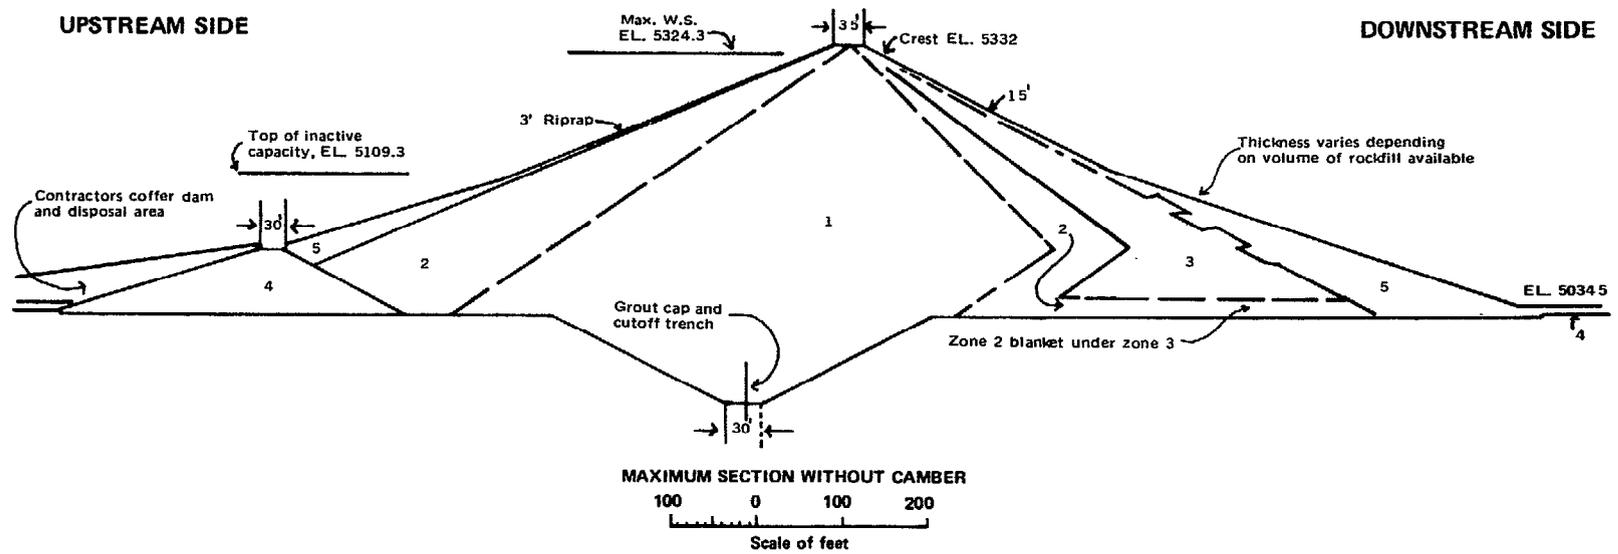
EMBANKMENT EXPLANATION

For economic reasons, designers like to use materials for construction of earth dams that are at or near the damsite. Available building materials at Teton included a fine grained windblown silt material, and alluvial deposits containing sand and gravel. The sand and gravel was used to provide drainage in the dam and the silt material formed the dam's water barrier. Characteristics of the silt material include low permeability; however, it is also brittle when compacted, subject to cracking, and highly erodible.

protection from wave action. Zones 1 and 2 were the most significant zones from the standpoint of leakage.

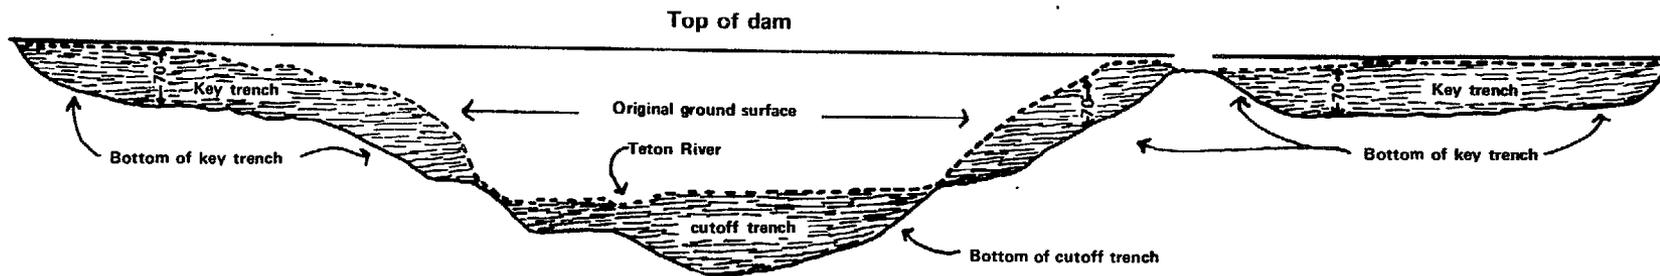
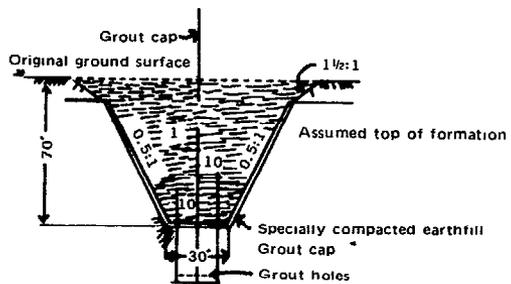
PROFILE OF KEY AND CUTOFF TRENCHES

said that the shape of a deep trench, called "key trench", excavated in the canyon walls to control seepage was conducive to the development of cracks.

Bureau designers concluded it would be more economical to remove the upper 70 feet of rock on the abutments rather than try to seal or grout the cracked rock there. As the result, the Teton design called for the excavation of a deep trench--key trench--into the rock on both abutments. As shown on the drawing on page 30, the key trench was to be constructed about 70 feet into the abutment walls, with a base width of 30 feet and steeply sloping sides. Bureau designers told us that the key trench was contained within the cutoff trench. They told us the cutoff trench in the abutments was only excavated a few feet into the rock. The key trench was backfilled with the silt material to provide a seepage barrier.

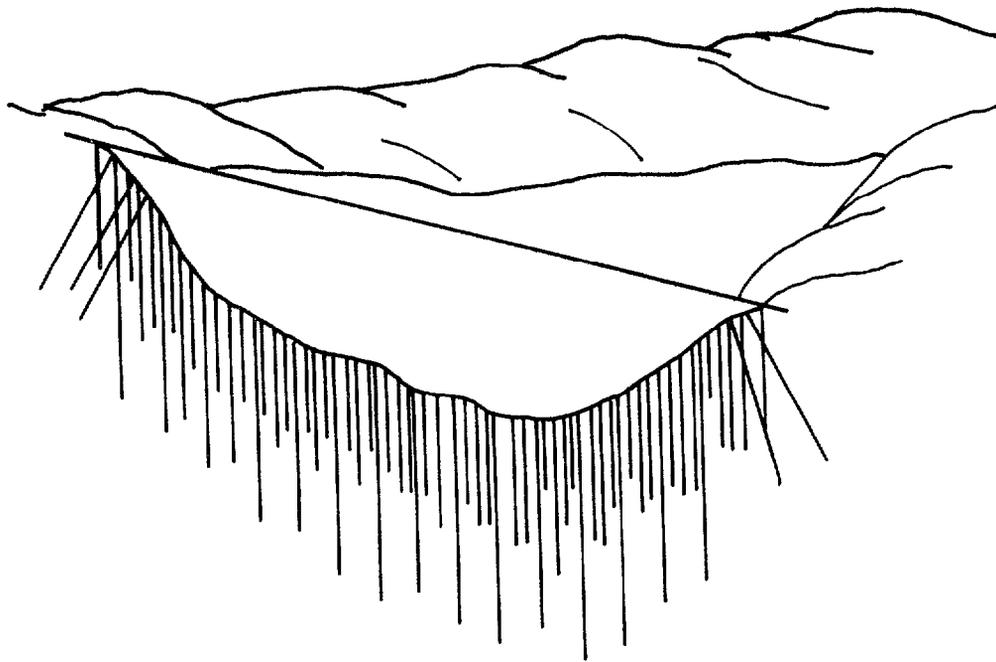
GROUT CURTAIN

and other materials into the foundation at a cost of about \$4 million. Yet, the grout curtain may not have been effective in controlling seepage as intended. The Independent Panel concluded from its postfailure tests that water could pass through the grout curtain at several locations. Thus, it concluded that the grout curtain may not have been fully effective in controlling seepage in the critical key trench area. The Independent Panel questioned the adequacy of the design of the grout curtain as well as the heavy reliance placed on it to control seepage. In addition, there is a question whether additional measures should have been taken to test the adequacy of the grout curtain after it had been constructed.
