NUCLEAR REGULATION

Preventing Problem Plants Requires More Effective NRC Action

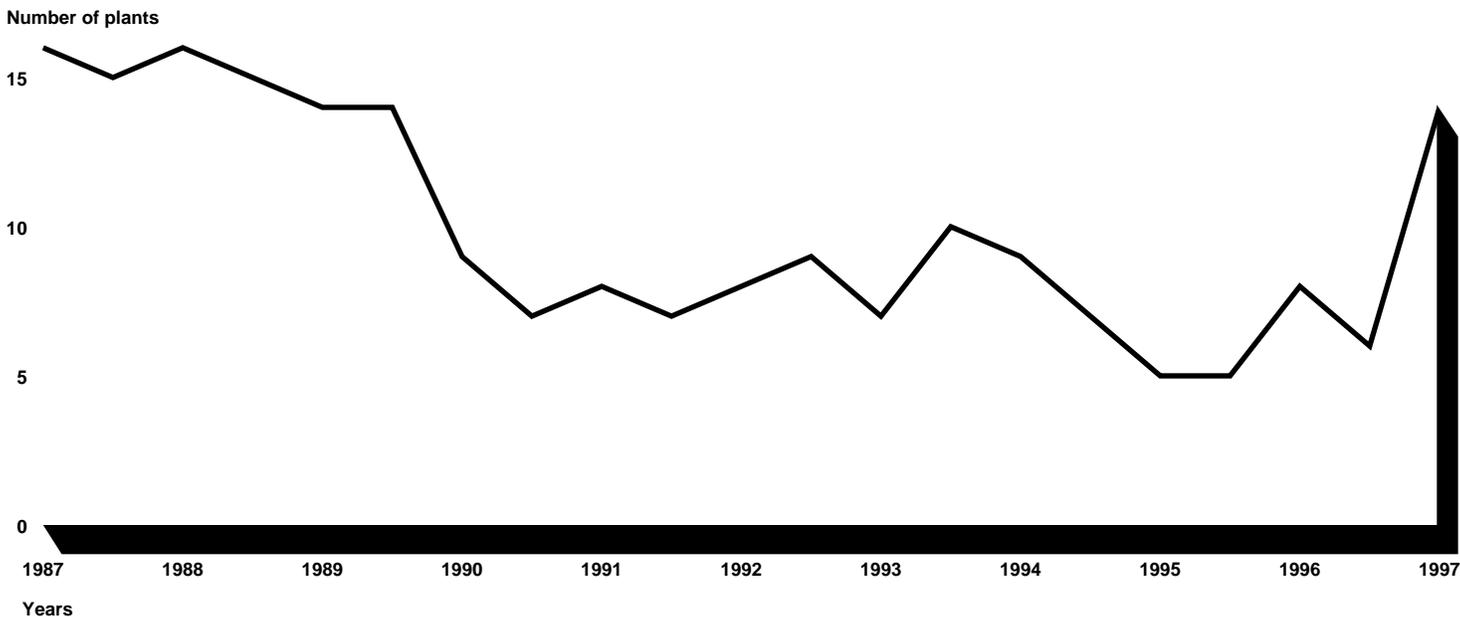
Figure 1: The History of NRC's Watch List

While NRC's indicators show generally improving safety conditions throughout the nuclear power industry, the indicators on a plant-specific basis also show that several nuclear power plants continue to plague NRC with chronically poor performance. Currently, 14 plants are on NRC's Watch List, which contains those plants identified by NRC as needing close attention because of their declining performance.³ This is the highest number of problem plants listed since 1988 (see fig. 1).

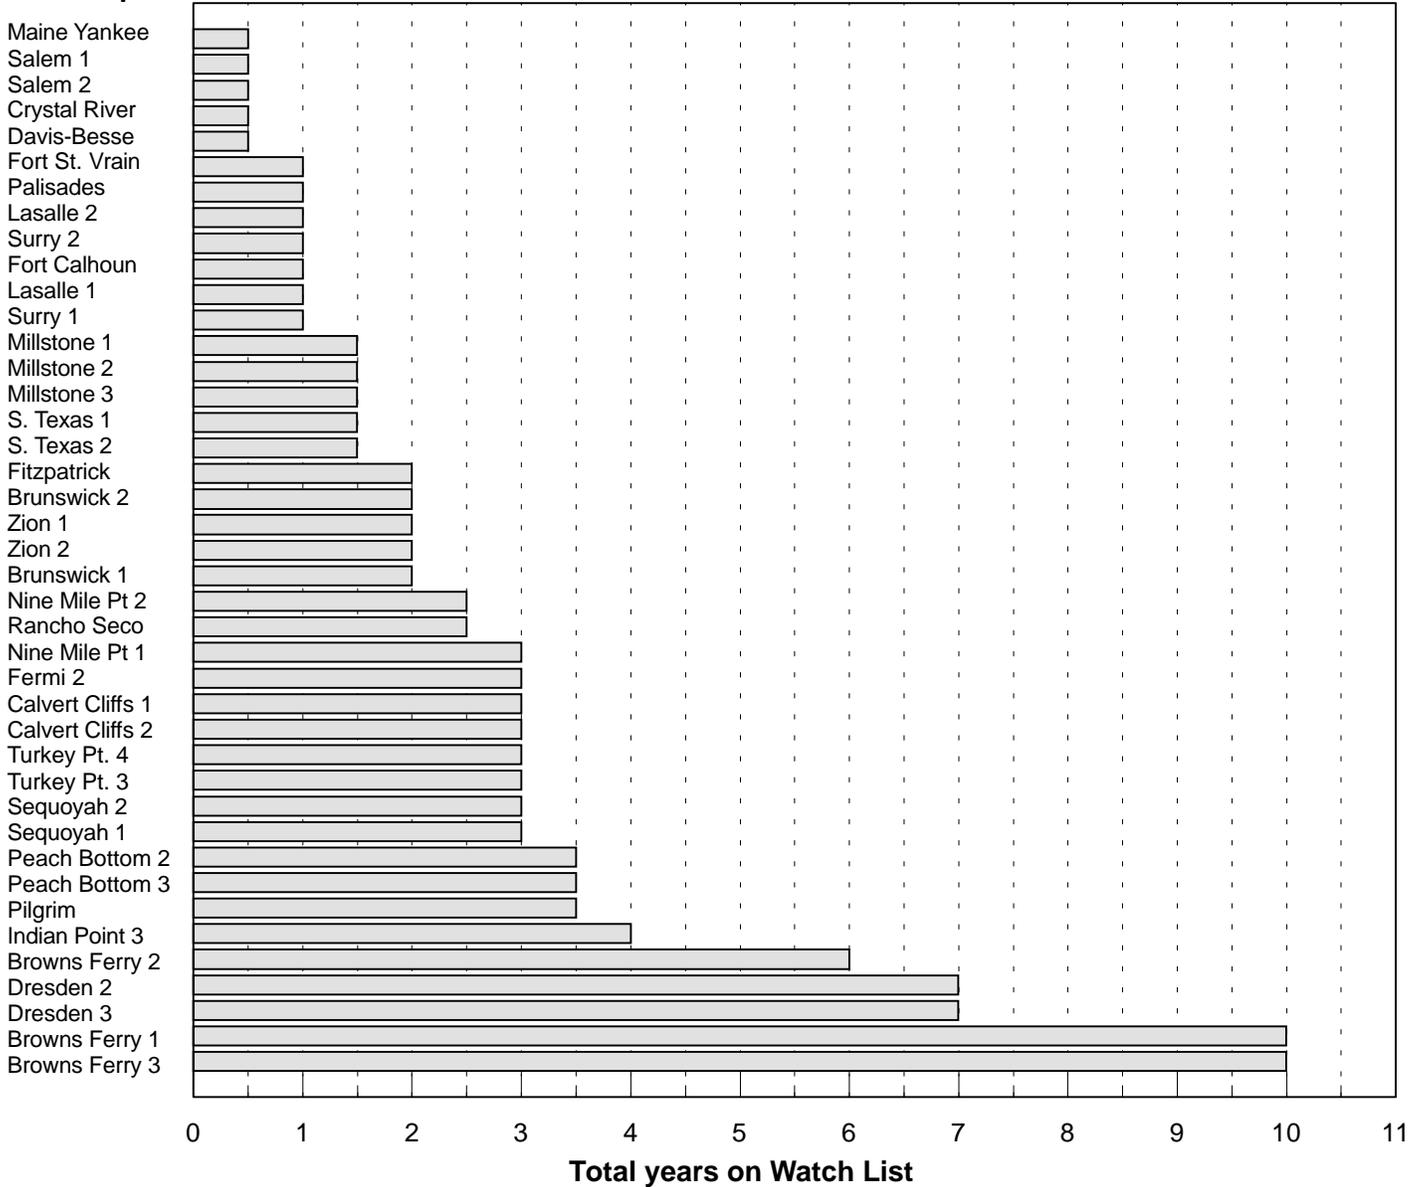
Figure 2: The Nuclear Plants on NRC's Watch List

Over the past 11 years, 41 plants, or 37 percent of the nation's nuclear power plants, have been placed on the Watch List by NRC, as shown in figure 2.

Twenty-four plants have been on the Watch List for 2 or more years. However, about half of the plants that NRC placed on the Watch List were known by NRC to be poor performers long before they were placed on the list. NRC's senior managers formally discuss plants that are experiencing declining safety performance. Although about half of these plants are eventually placed on the Watch List, NRC has not precisely defined the criteria for when a plant is formally discussed and/or placed on the Watch List. Salem and Millstone were under discussion by NRC for 3 to 4 years before they were placed on the Watch List in 1996 and 1997, respectively. NRC discussed Cooper as a problem plant but never placed it on the Watch List. In their letter commenting on a draft of this report, NRC said that 43 other plants have been discussed but not placed on the Watch List (see app. V for NRC's letter).

11 Figure 2: Nuclear Plants on NRC's Watch List. We recommend the following changes be made to this bar chart:

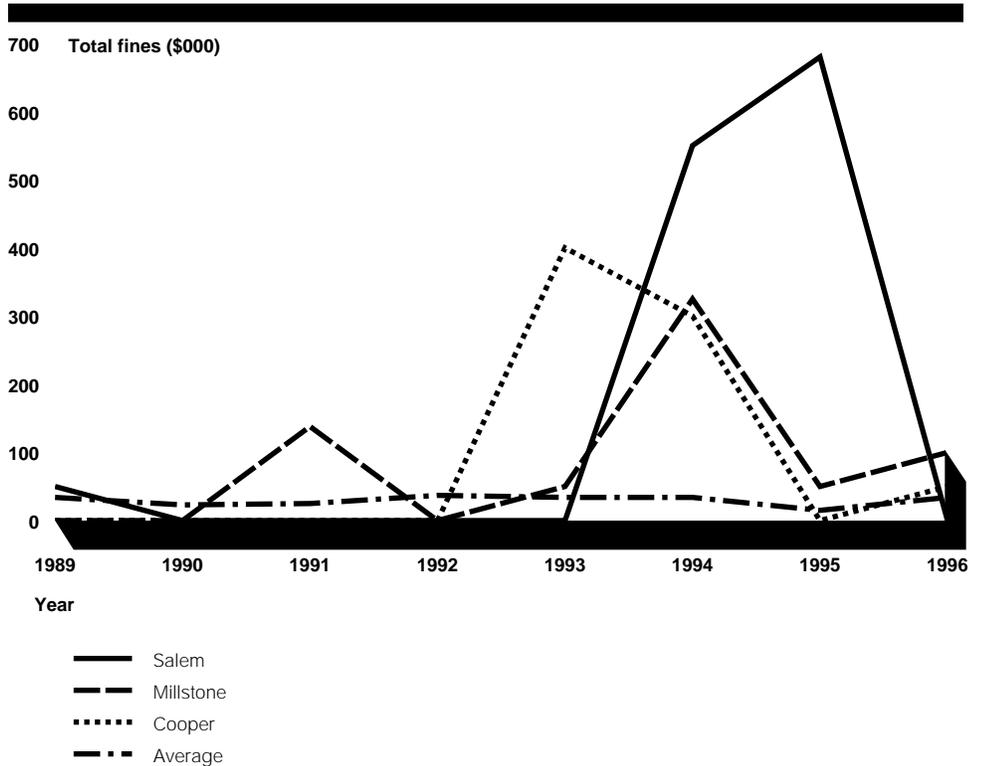
Figure 3: Fines That NRC Levied Against Three Nuclear Plants

NRC’s enforcement program is designed to ensure compliance with NRC’s regulations, obtain prompt correction of violations, deter future violations, and encourage licensees to operate their plants safely. Salem, Millstone, and Cooper were all fined amounts well above the industry average (see fig. 3). However, Salem’s fines were levied by NRC well after the plants were in periods of significant decline. Furthermore, NRC still has not completed its enforcement action against Millstone for violations that were first discovered in 1995, partially due to, according to NRC, the need for close coordination with the U.S. Attorney for consideration of criminal prosecution.

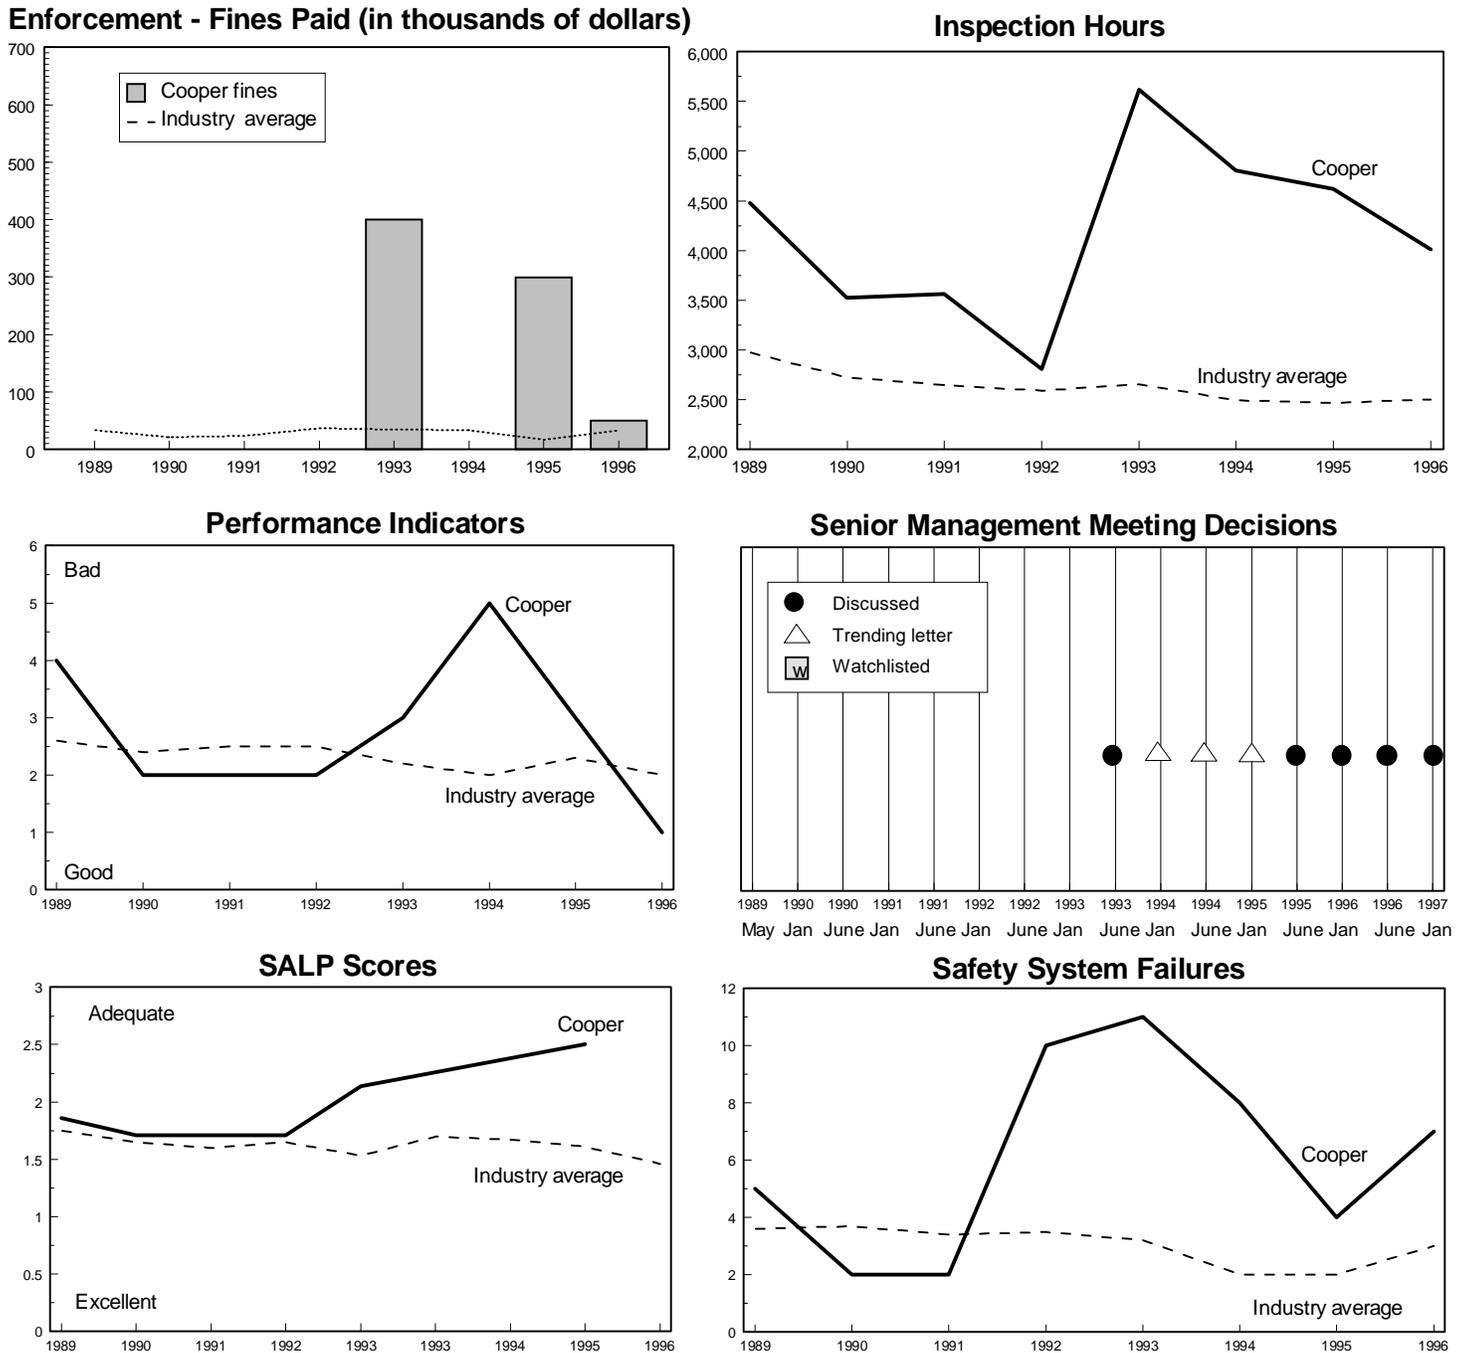
Figure IV.1: Cooper's Performance History Against the Industry Average

through 1996. Furthermore, NRC discussed Cooper's performance at every SMM from June 1993 through January 1997. Also, from 1989 through 1996, Cooper had an average of about six safety system failures per year compared to an industry average of about three per year. Since 1989, the nuclear power industry's average SALP scores, performance indicators, and the number of safety system failures have shown an overall improvement, while the number of inspection hours devoted to a plant have decreased. Figure IV.1 compares the performance of Cooper to the nuclear industry as a whole.
