February 2012

DOD SUPPLY CHAIN

Suspect Counterfeit Electronic Parts Can Be Found on Internet Purchasing Platforms

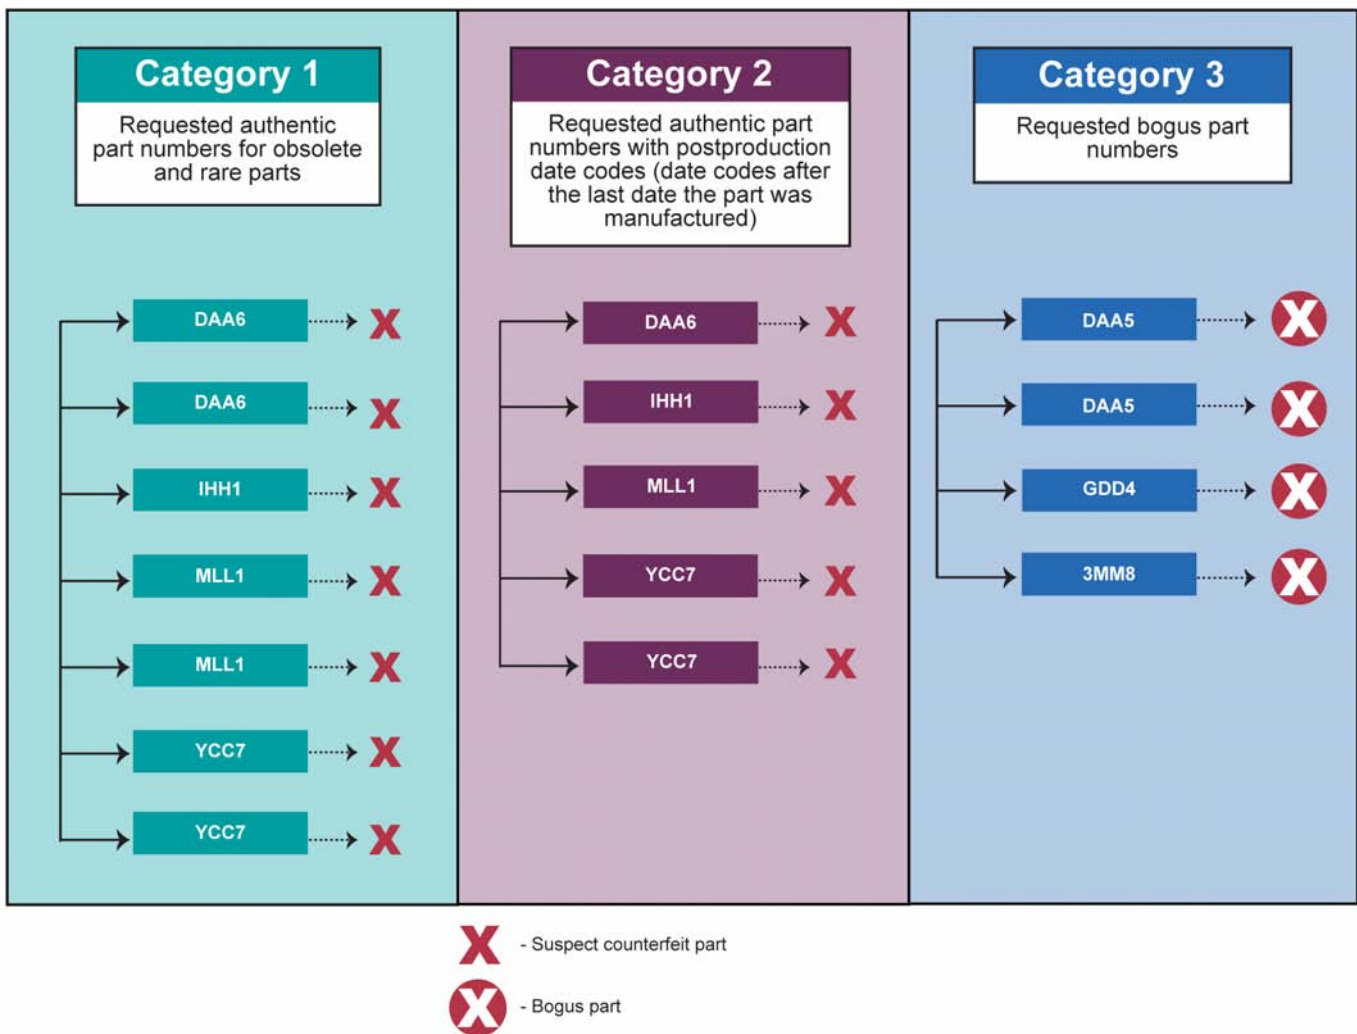
Figure 1: Status of Parts Purchased and Tested

As shown in figure 1, each of the 16 parts we purchased was either suspect counterfeit or bogus. Specifically, all 12 of the parts we received after requesting authentic part numbers (either with valid or invalid date codes) were suspect counterfeit, according to SMT Corp. In addition, vendors provided us with 4 bogus parts after we requested invalid part numbers, which demonstrates their willingness to sell parts that do not technically exist. The following sections detail our findings for each of the three categories of parts we purchased.

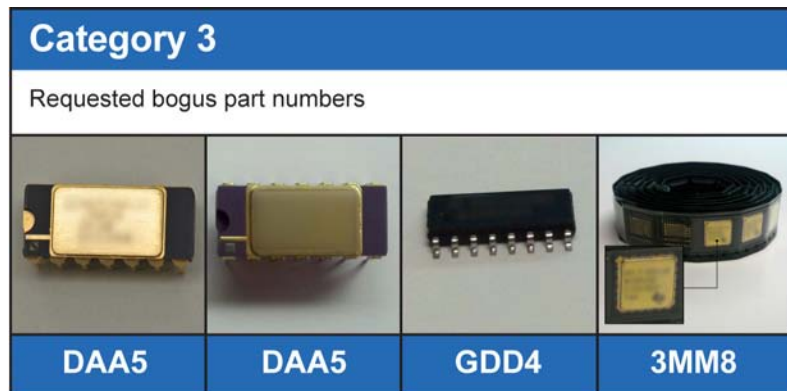
Figure 4: Photos of Parts Received Despite Request for Invalid Part Numbers

We received the four bogus parts after requesting invalid part numbers DAA5, GDD4, and 3MM8. We made two orders using DAA5, one from each Internet purchasing platform, which were fulfilled by different vendors. The parts we received from each vendor appeared similar, as shown in figure 4. The similarity may be due to a number of factors. For example, the vendors could have simply ignored the invalid portion of the

part numbers we requested (they did not contact us to inform us that the numbers were invalid). Another possible explanation could be that the parts happened to be fulfilled by the same vendor operating under two different names.
