PIPELINE SAFETY

Information on Keystone Accidents and DOT Oversight

Highlights of [GAO-21-588](#), a report to congressional requesters

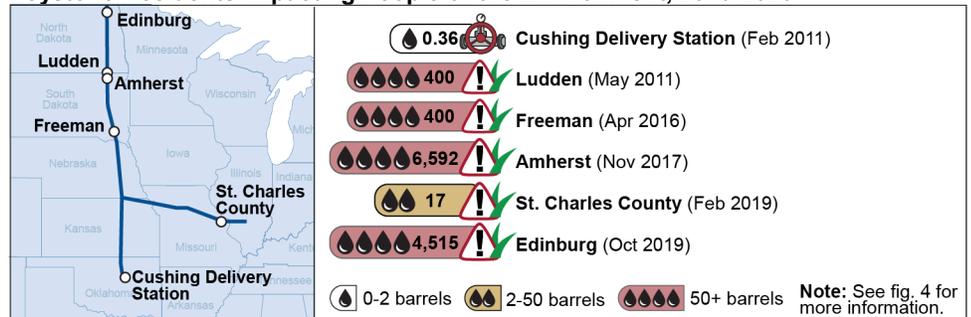
Keystone Accidents Impacting People or the Environment, 2010-2020

Keystone's accident history has been similar to other crude oil pipelines since 2010, but the severity of spills has worsened in recent years. Similar to crude oil pipelines nationwide, most of Keystone's 22 accidents from 2010 through 2020 released fewer than 50 barrels of oil and were contained on operator-controlled property such as a pump station. The two largest spills in Keystone's history in 2017 and 2019 were among the six accidents that met PHMSA's criteria for accidents "impacting people or the environment." According to PHMSA's measures for these more severe types of accidents, from 2010 to 2020 TC Energy performed better than nationwide averages, but worse in the past five years due to the 2017 and 2019 spills.

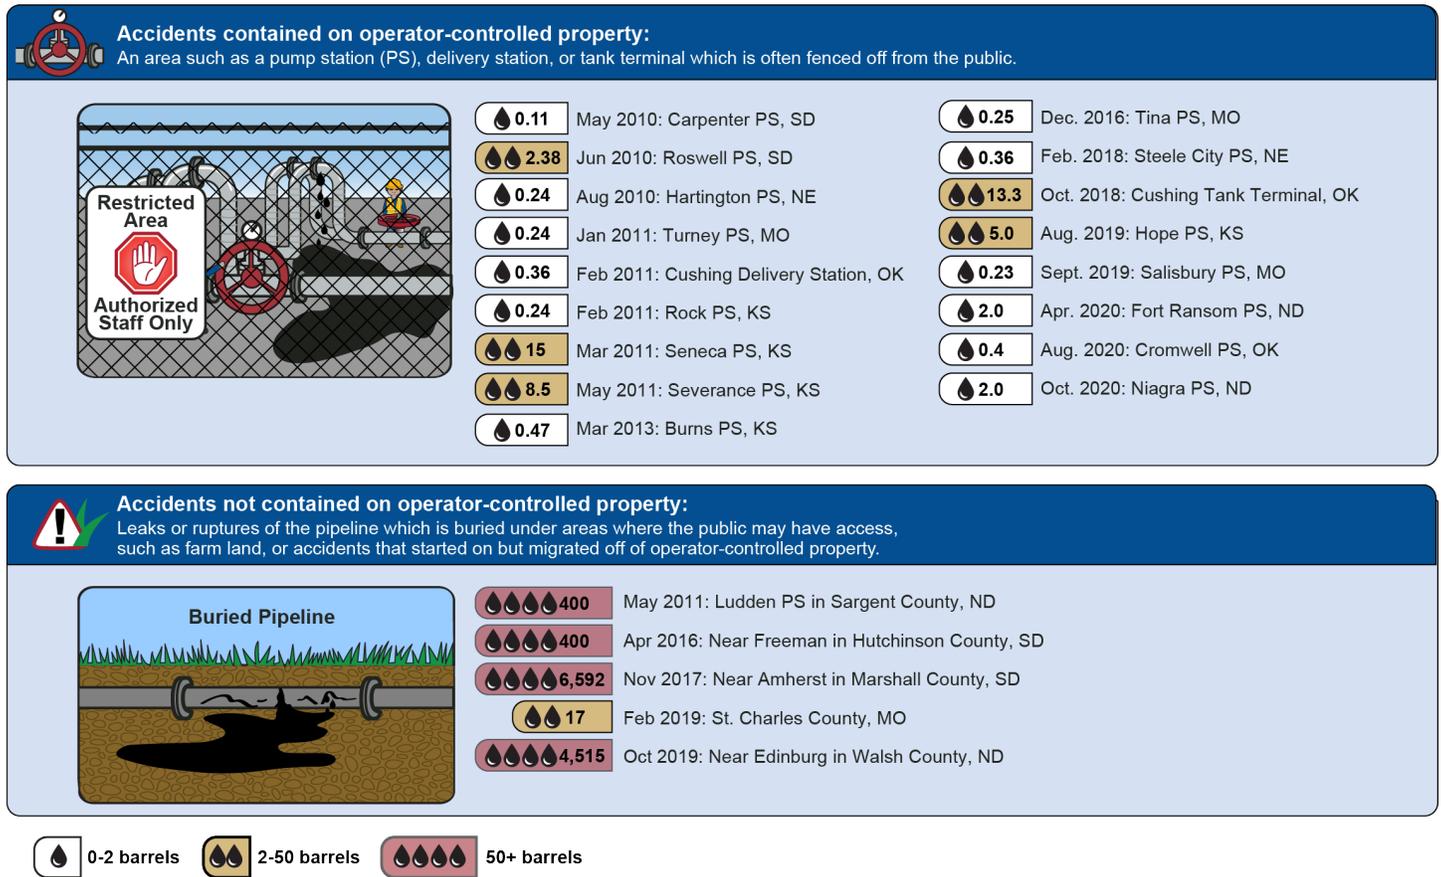
Figure 2: Keystone Pipeline Accidents, 2010–2020

Accident type	Barrels spilled	Date/Location
Accidents contained on operator-controller property: An area such as a pump station (PS), delivery station, or tank terminal which is often fenced off from the public.	0.11	May 2010: Carpenter PS, SD
	2.38	Jun 2010: Roswell PS, SD
	0.24	Aug 2010: Hartington PS, NE
	0.24	Jan 2011: Turney PS, MO
	0.36	Feb 2011: Cushing Delivery Station, OK
	0.24	Feb 2011: Rock PS, KS
	15	Mar 2011: Seneca PS, KS
	8.5	May 2011: Severance PS, KS
	0.47	Mar 2013: Burns PS, KS
	0.25	Dec. 2016: Tina PS, MO
	0.36	Feb. 2018: Steele City PS, NE
	13.3	Oct. 2018: Cushing Tank Terminal, OK
	5.0	Aug. 2019: Hope PS, KS

Accident type	Barrels spilled	Date/Location
	0.36	Feb. 2018: Steele City PS, NE
	13.3	Oct. 2018: Cushing Tank Terminal, OK
	5.0	Aug. 2019: Hope PS, KS
	0.23	Sept. 2019: Salisbury PS, MO
	2.0	Apr. 2020: Fort Ransom PS, ND
	0.4	Aug. 2020: Cromwell PS, OK
	2.0	Oct. 2020: Niagra PS, ND
Accidents not contained on operator-controlled property:	400	May 2011: Ludden PS in Sargent County, ND
	400	Apr 2016: Near Freeman in Hutchinson County, SD
Leaks or ruptures of the pipeline which is buried under areas where the public may have access, such as farm land, or accidents that started on but migrated off of operator-controlled property.	6,592	Nov 2017: Near Amherst in Marshall County, SD
	17	Feb 2019: St. Charles County, MO
	4,515	Oct 2019: Near Edinburg in Walsh County, ND

The four largest Keystone accidents each released more than 50 barrels of oil, but did not occur in areas that met the regulatory definition for a high consequence area, such as areas that are highly populated or unusually sensitive to environmental damage:

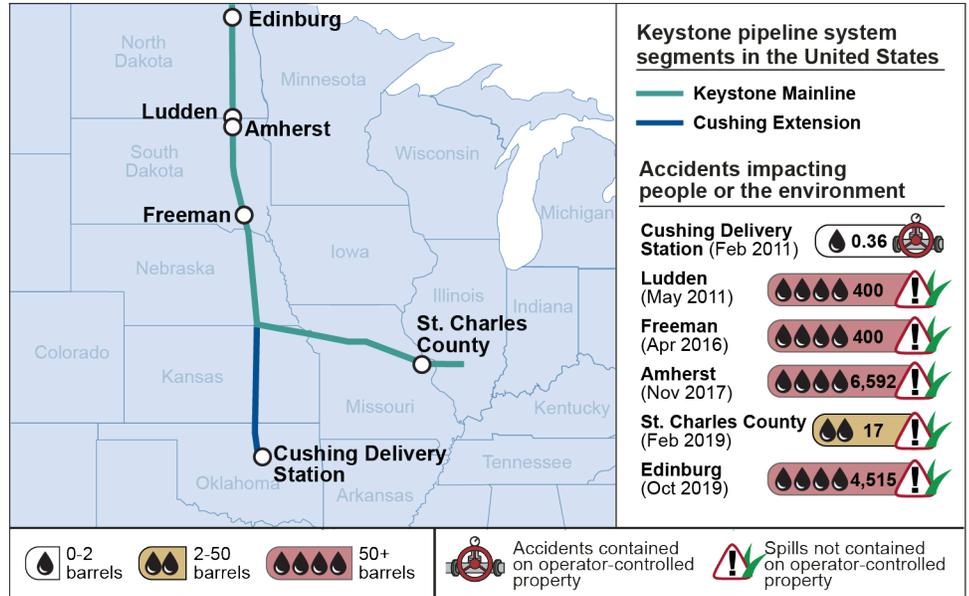
Figure 4: Location of Keystone Accidents Impacting People or the Environment, 2010-2020

Note: PHMSA defines an accident as impacting people or the environment if it meets one of two criteria: (1) Regardless of the accident’s location, any of the following occur: a fatality, injury requiring in-patient hospitalization, ignition, explosion, evacuation, wildlife impact, contamination of specific water sources, or damage to public or private, non-operator property; or (2) Where the accident’s location is not totally contained on operator-controlled property, any of the following occur: an unintentional release equal to or greater than 5 gallons in a high consequence area, an unintentional release of 5 barrels or more outside of a high consequence area, surface water contamination, or soil contamination.

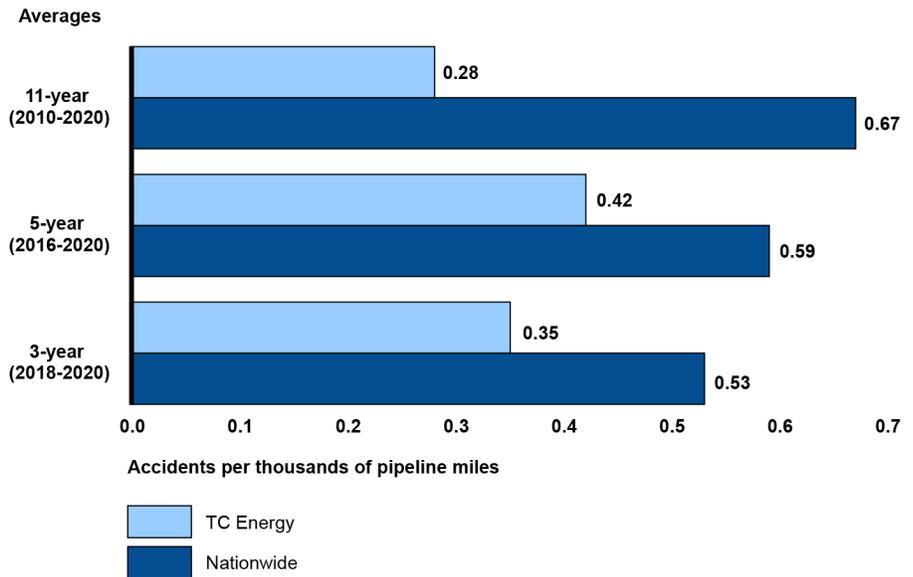
Figure 5: Comparison of the Keystone Pipeline’s Operator, TC Energy, to Nationwide Performance Measure of Accidents Impacting People or the Environment per Thousands of Pipeline Miles

year averages, as well as a 11-year average we calculated using PHMSA data, TC Energy was consistently below the nationwide average of accidents impacting people or the environment per pipeline mile, although less so for the most recent 3- and 5-year averages (see fig. 5). PHMSA reports that when ranking operators' 5-year averages from lowest to highest, TC Energy ranked 43rd out of 80 operators.

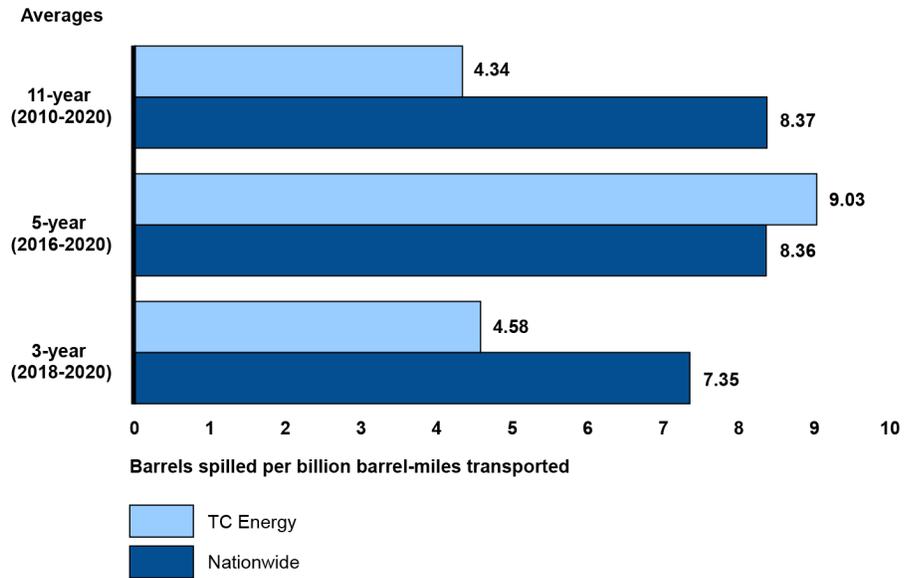
Figure 6: Comparison of the Keystone Pipeline’s Operator, TC Energy, to Nationwide Performance Measure of Barrels Spilled per Billion Barrel-Miles Transported

According to PHMSA's other performance measure—the volume of oil spilled per billion barrel-mile transported—despite being better than the national average over the past decade, Keystone's pipeline ruptures in 2017 and 2019 put TC Energy worse than the nationwide average over the past 5 years (2016-2020).²⁸ According to PHMSA officials, this measure takes into account the total amount of oil released by accidents impacting people or the environment relative to the amount of oil transported by the operator. Although TC Energy was better than the national average over the decade and for the 3-year average (2018-2020) for this measure, it was worse for the 5-year national average (see fig. 6). PHMSA reports that when ranking operators' 5-year averages from lowest to highest, TC Energy ranked 57th out of the 80 pipeline operators with 300 or more miles of pipeline carrying crude oil, refined oil products, or biofuels. TC Energy's 5-year average ranking reflects the fact that the two largest oil spills in Keystone's history occurred in 2017 and 2019.
